Solid Collection Efforts: Ta Collimator Evaluation

J. M. Gostic

November 22, 2011

Ta collimator sets that were part of the gated x-ray detector diagnostic (GXD) at NIF were analyzed for debris distribution and damage in 2011. These disks (ranging in thickness from 250 to 750 μm) were fielded approximately 10 cm from target chamber center (TCC) on various symcap, THD and re-emit shots. The nose cone holder and forward Ta collimator (facing target chamber center, TCC) from all shots show evidence of surface melt. Non-destructive analysis techniques such as optical microscopy, surface profilometry, scanning electron microscopy (SEM), energy dispersive spectroscopy (EDS), and x-ray fluorescence (XRF) were used to determine debris composition and degree of deformation associated with each Ta disk. Molten debris from the stainless steel nose cone contaminated the surface of the collimators along with other debris associated with the target assembly (Al, Si, Cu, Au and In). Surface elemental analysis of the forward collimator Ta disks indicates that Au hohlraum debris is less concentrated on these samples versus those fielded 50 cm from TCC in the wedge range filter (WRF) assembly. It

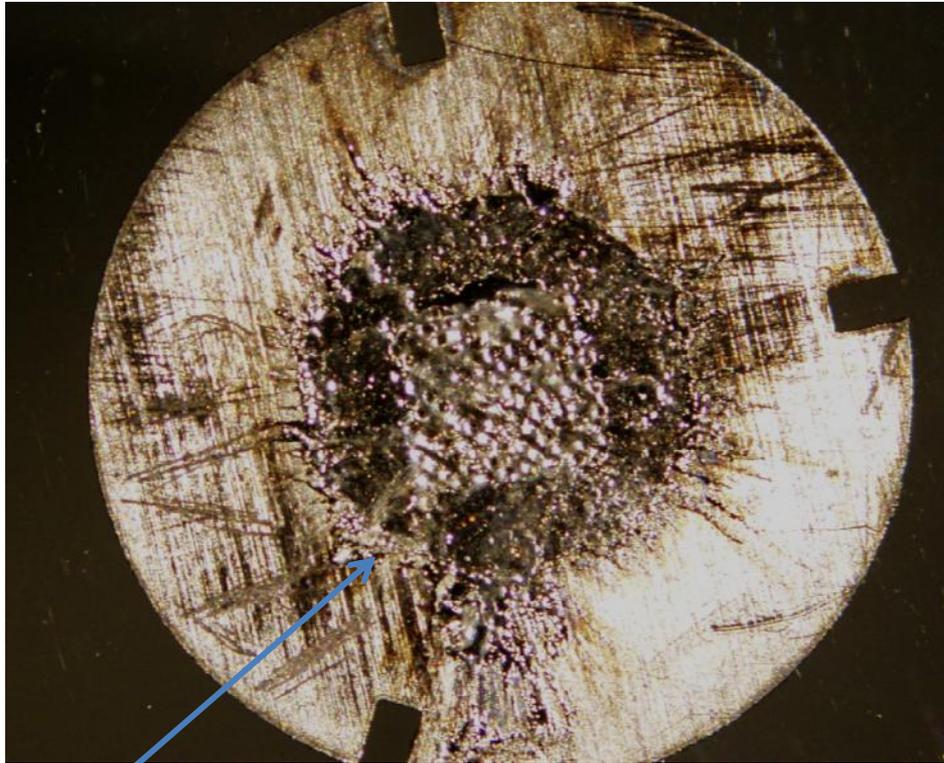
0-0 Disk 1 (100mm)

Stainless steel melt on surface

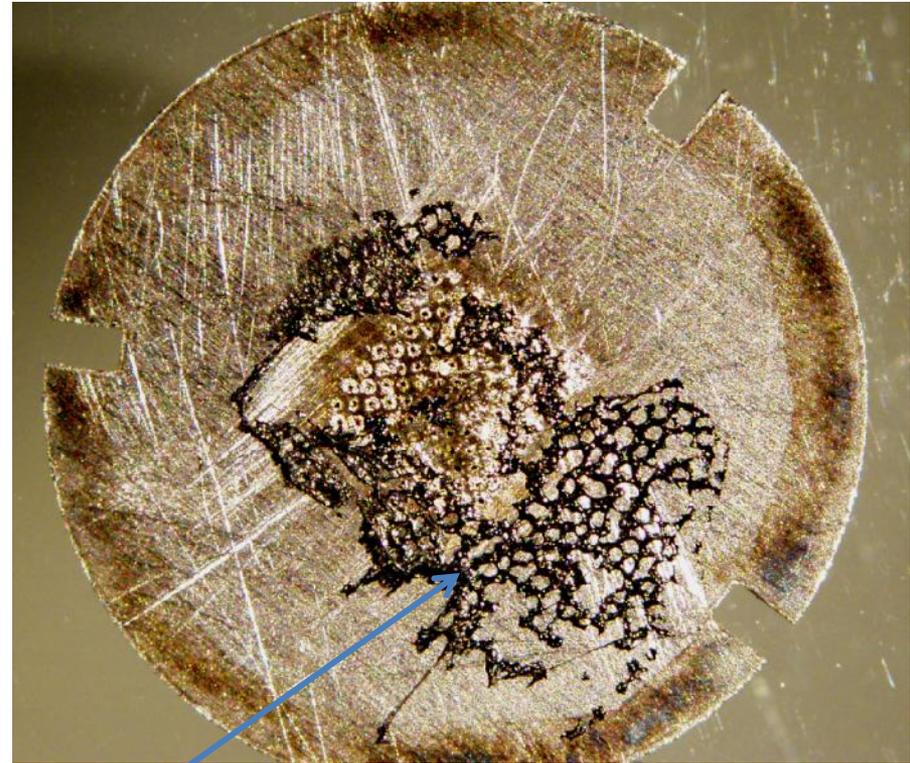
Glue residue from Carbon tape, from SEM analysis

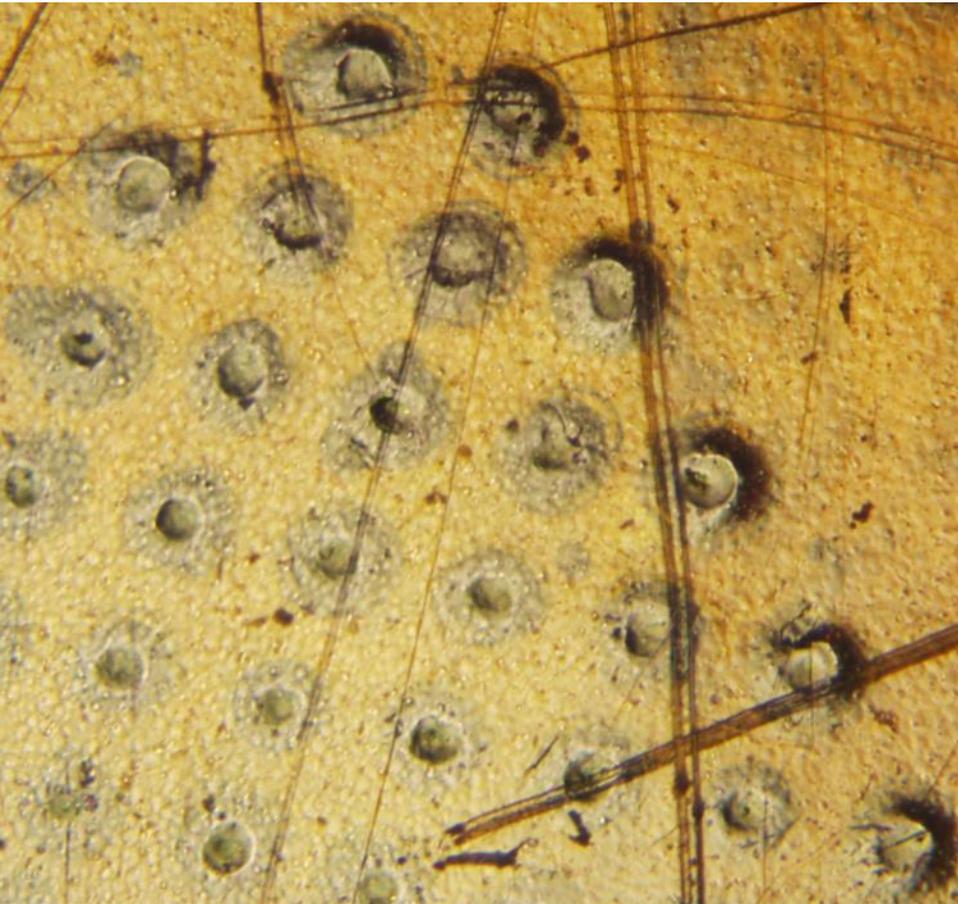
0-0, Kapton Disk 1 Surface Deformation

Surface penetration, back side crater formation

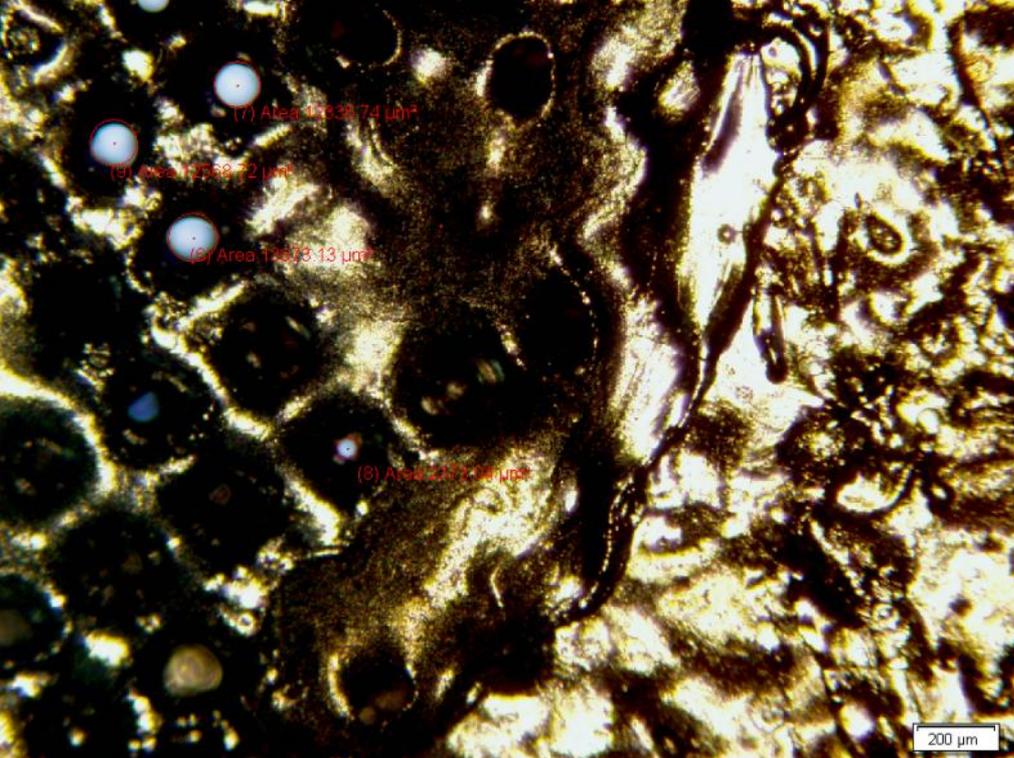
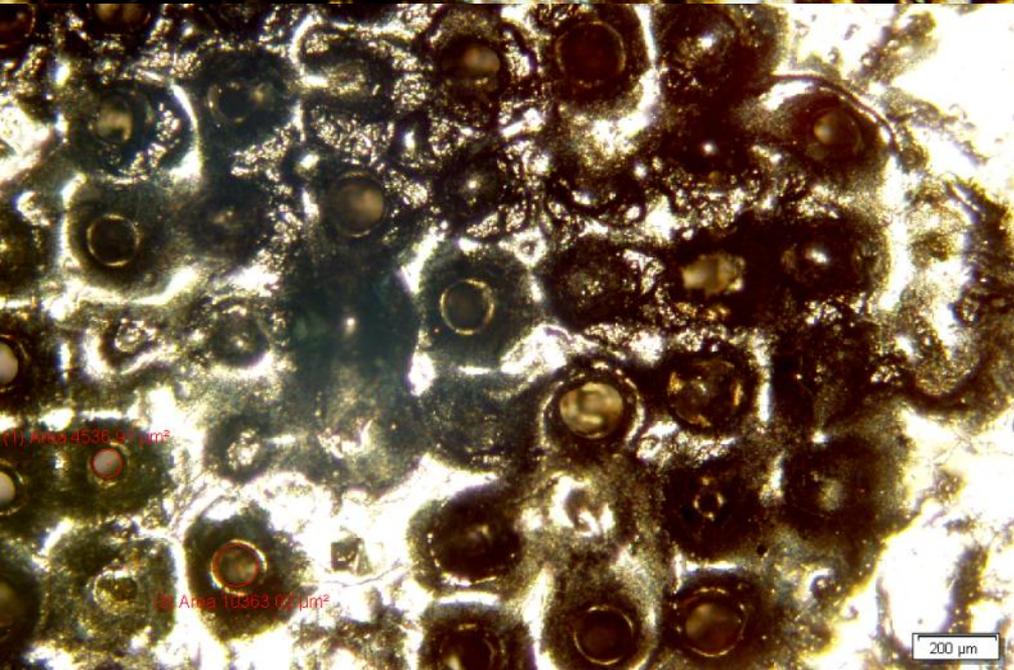
Disk 1, 0-0 (100 mm)

- High degree of surface melt
- Holes were covered by the melt and irregular in shape
- Area of holes ranged from 700 to 14,000 μm^2

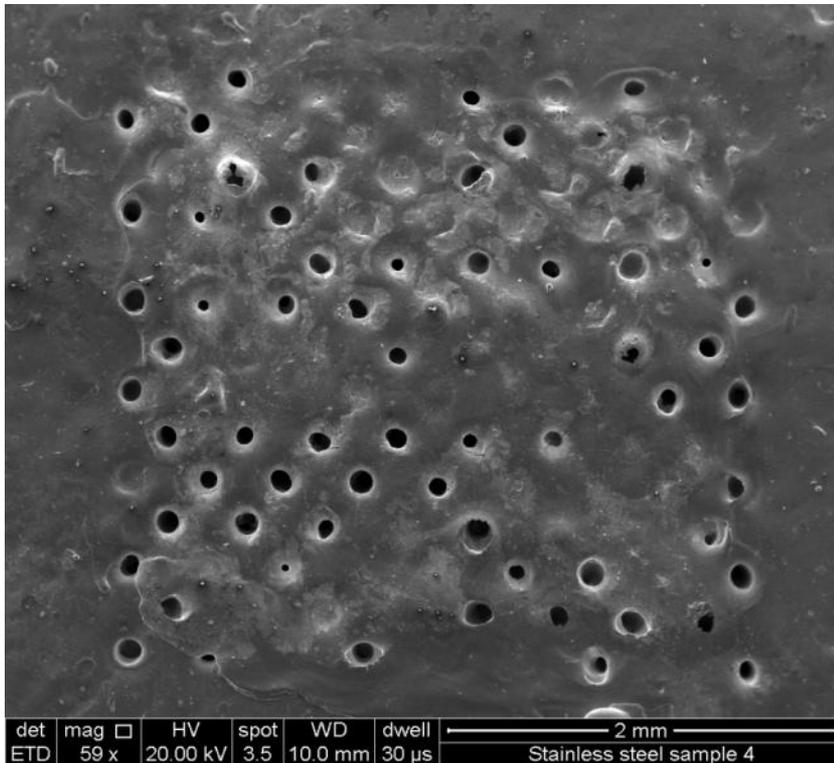
Collimator Region

N = 65 holes remaining

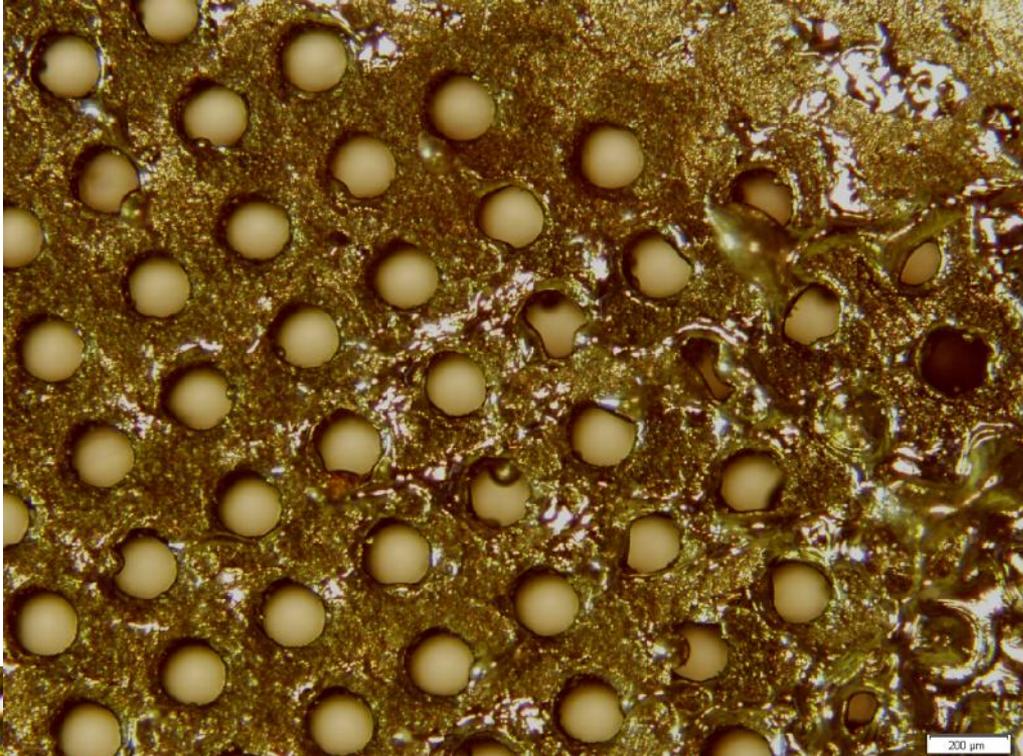
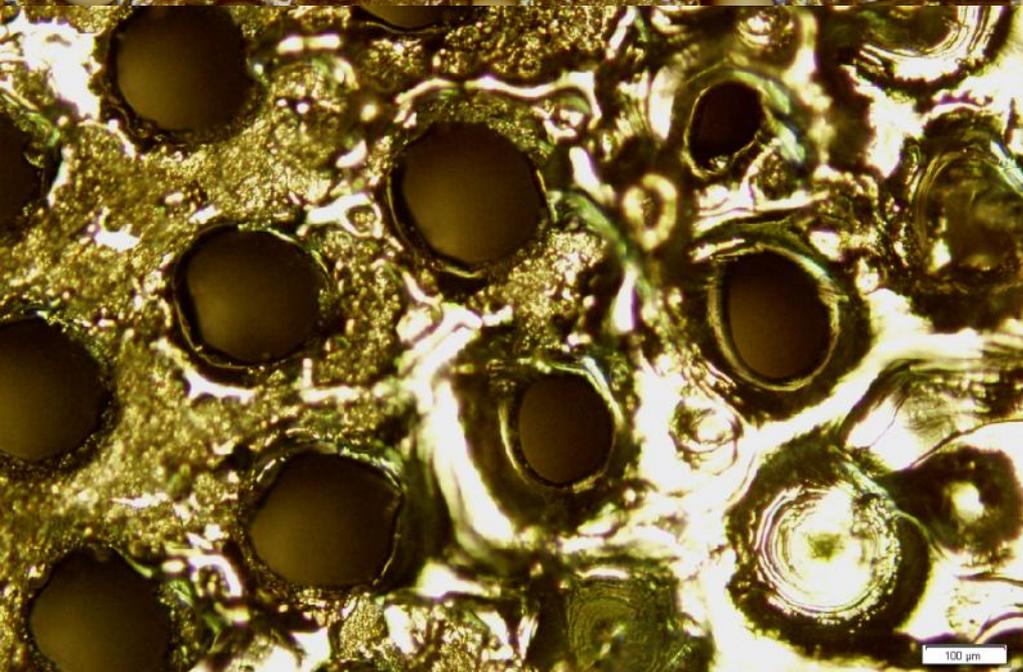
Disk 1, 0-315 (80 mm)

- High degree of surface melt, covered entire disk
- Most of the holes are still visible, some irregular holes in edge region
- Area of holes ranged from 19,200 to 24,500 μm^2

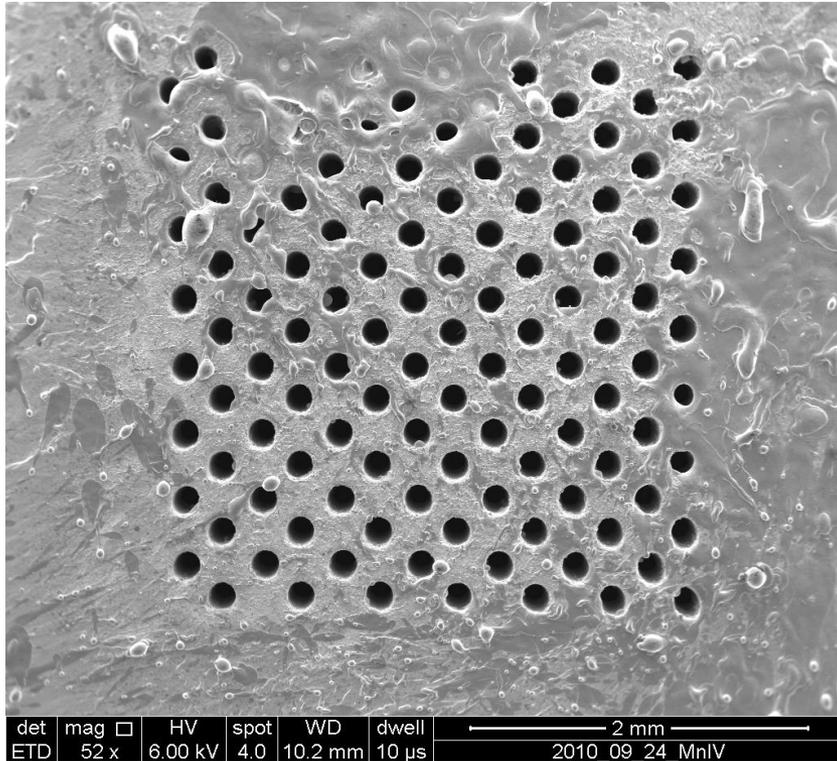
Collimator Region
N = 111 holes remaining

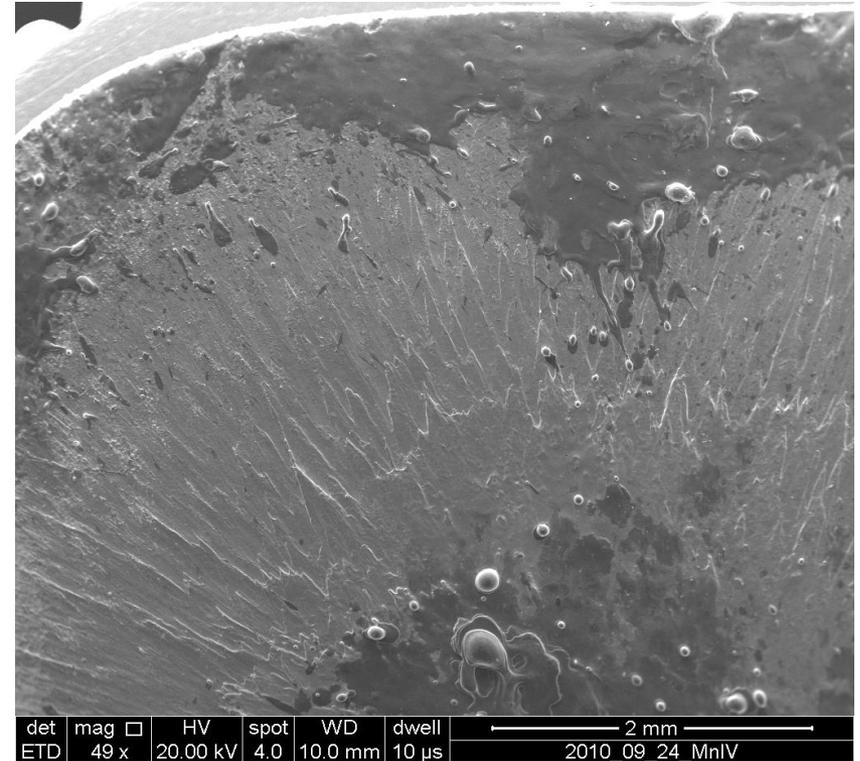
Edge Region, surface melt
extends to outer
boundary

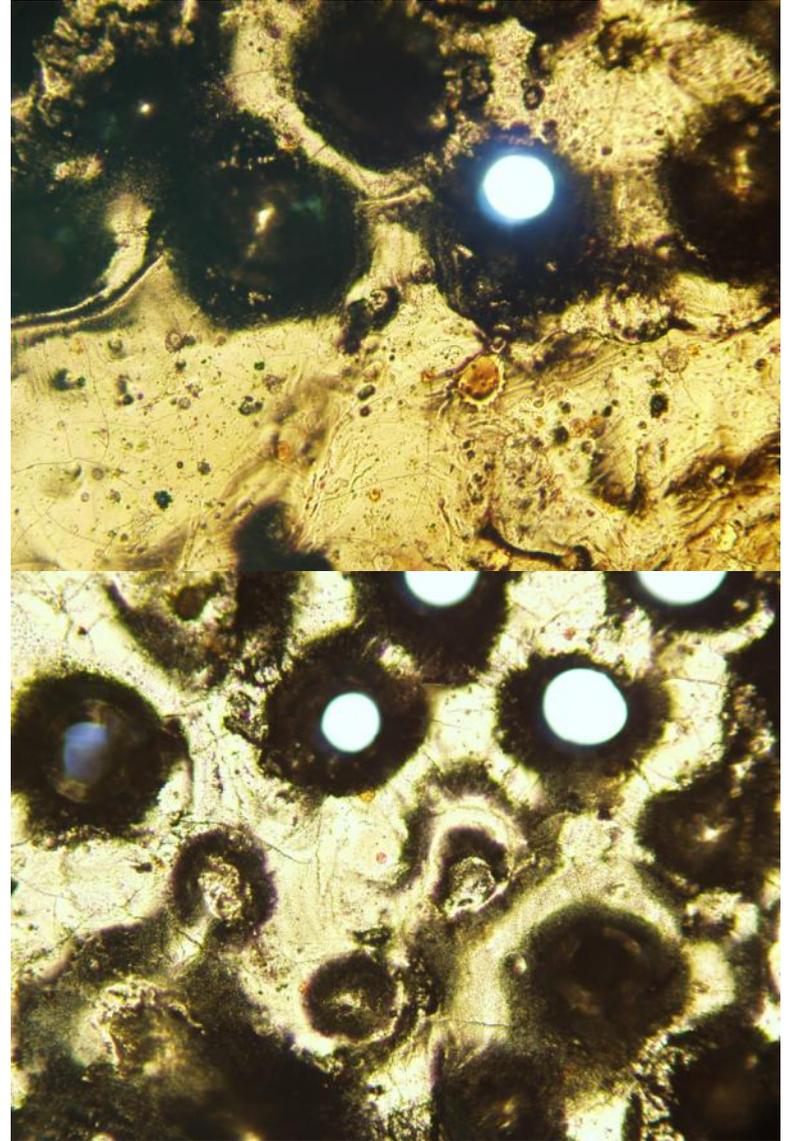
Stainless Steel

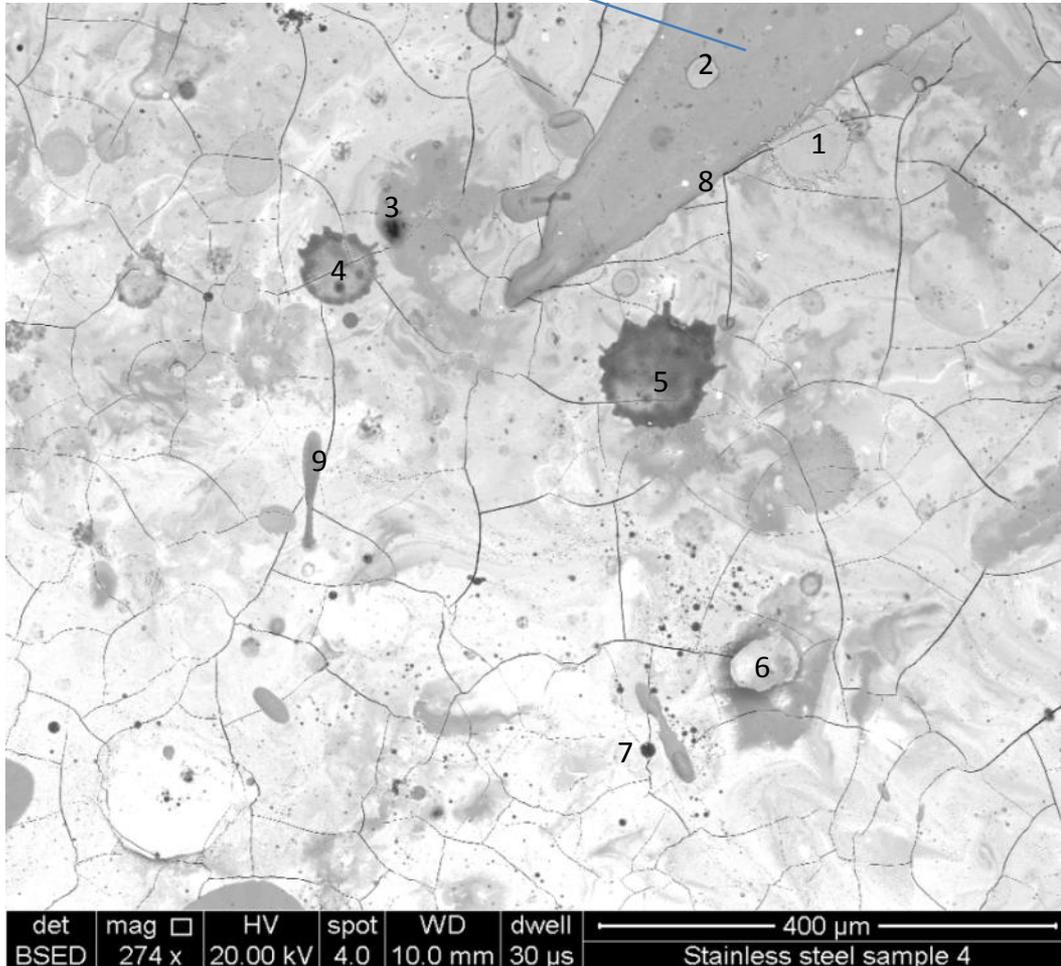
Disk 1, 0-0

1. Cu (64), Fe (21), Cr (6), Si (6), Ni (3)
2. Cu (84), Fe (7), Al, Si, In, Cr (2), Ni (1)
3. Fe (54), Cr (15), Al (12), Au (7), Ni (7), Ta (5)
4. Fe (33), Al (28), Ta (26), Cr (9), Ni (4)
5. Al (61), Fe (23), Cr (7), Ni, Ta, Au (3)
6. Fe (54), Cr (15), Al (13), Ta 11, Ni (6)
7. Al
8. Ta
9. Cu (62), Si (34)

Surface Composition: Ta (62), Fe (26), Cr (7), Ni (3), Al (2)

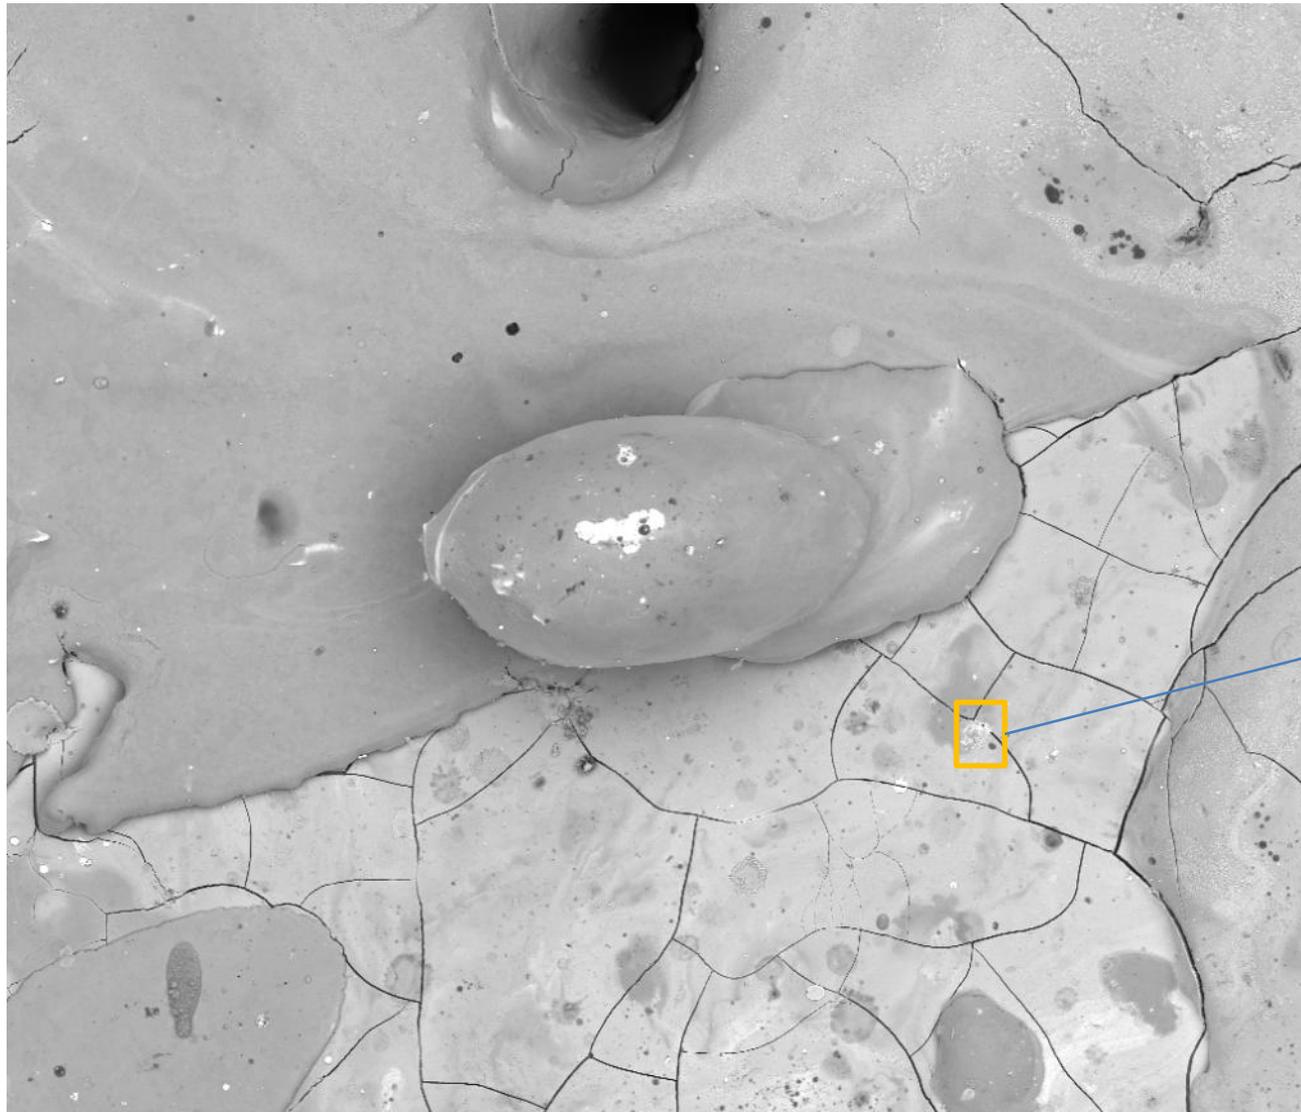
Disk 1, 0-0

Au splat

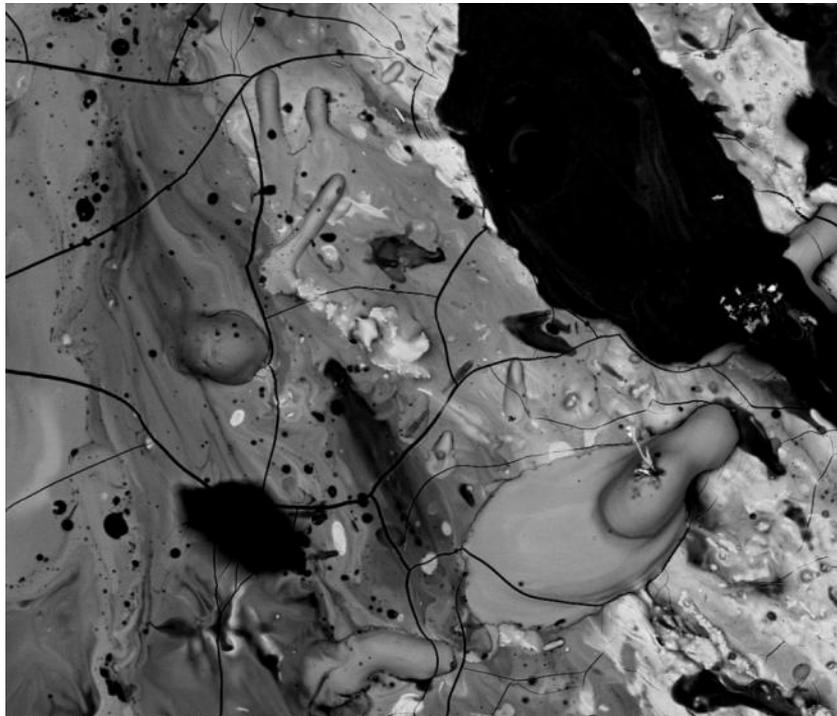
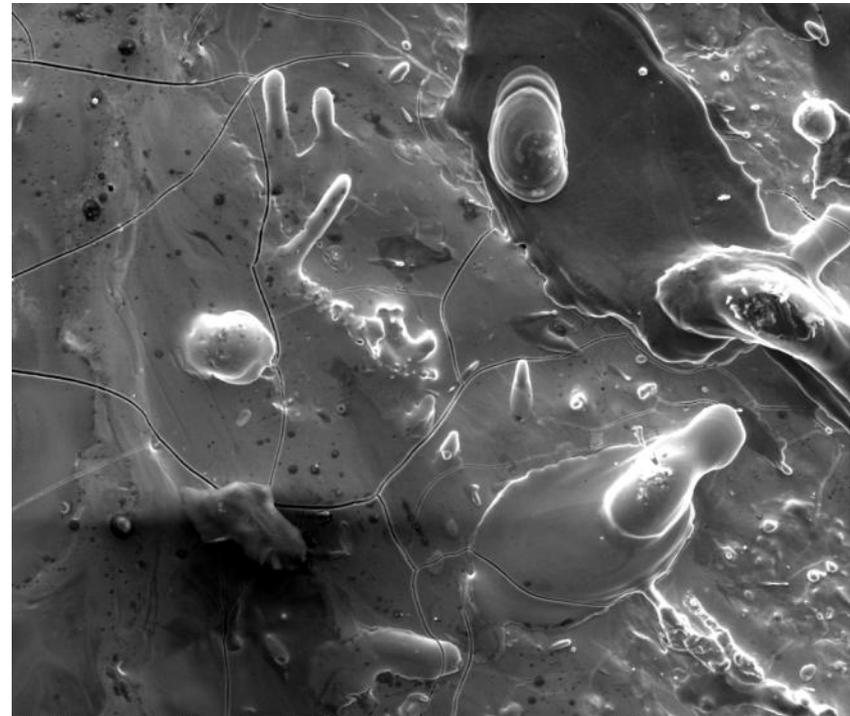
Disk 1, 0-315

Identified splats and particles similar to Disk 1 0-0
