LAWRENCE
LIVERMORE
NATIONAL
LABORATORY

Study of the integrity of pressurized LEH window assemblies at cryogenic temperatures for NIF targets

H. Hamza

August 5, 2016

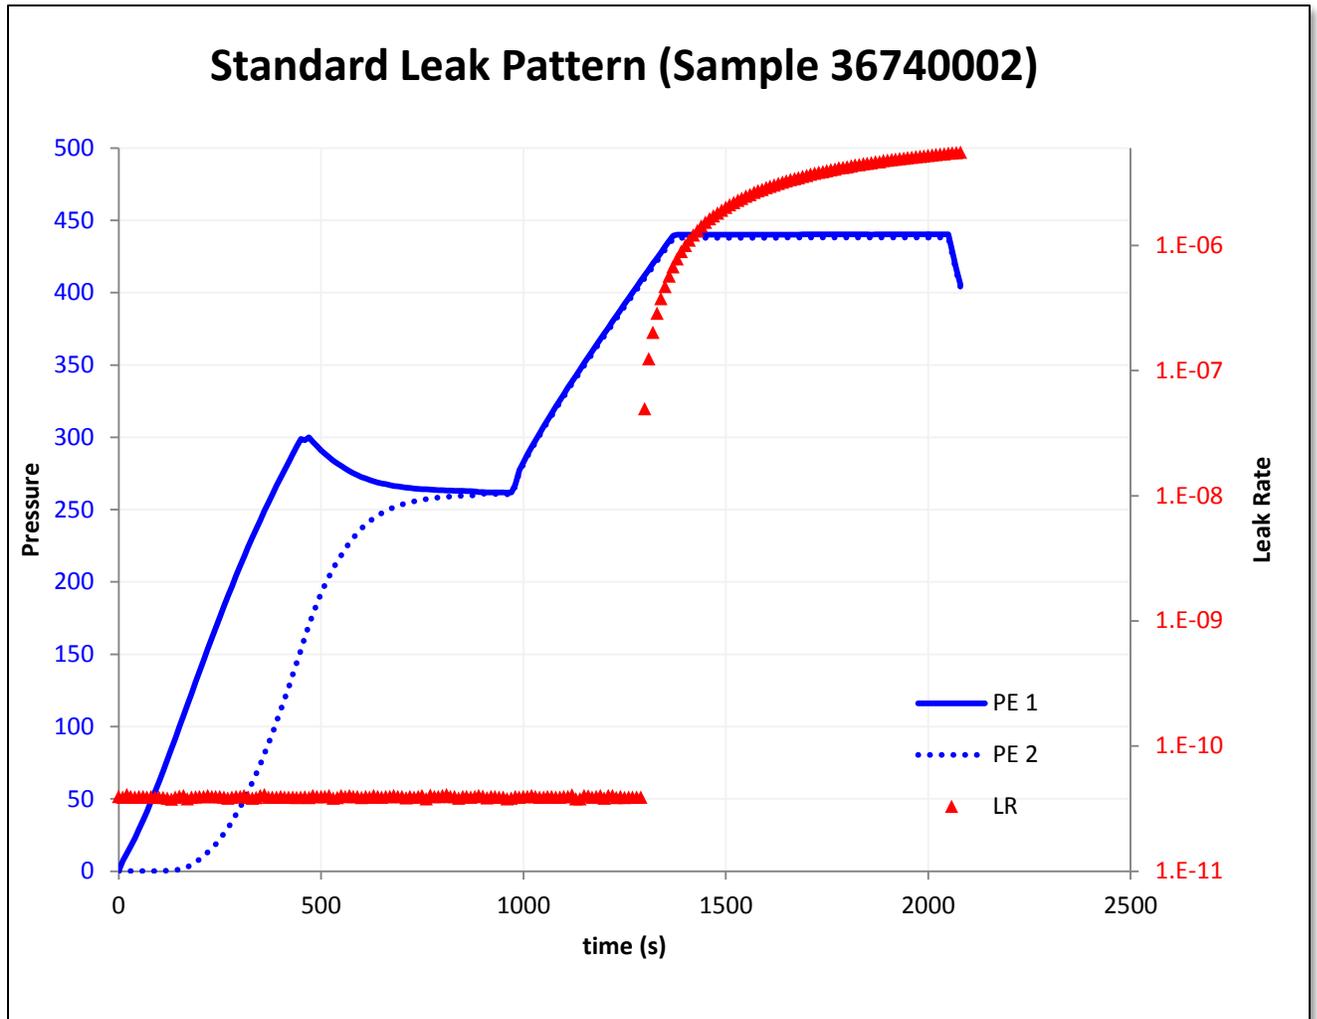
In 2013-14 there was a sharp increase in the number of LEH windows that were leaking at relatively low pressures for reasons unknown. The pattern of the leaks was such that a leak rate would be steady for approximately 300-400 torr and then a jump would occur (See Figure 1). Eventually it was determined that the cause of the problem was the angle by which the UV glue was being cured at. The UV cure glue was being used to attach the LEH window to the thermal mechanical package (TMP) can. Once the angle was corrected the percent yield of sealed LEH windows returned to 100%. However late in 2015, leaks behaving in the same nature began to show up again, and it was unclear why.

In Figure 1 the leak rate remains constant up until about 400 Torr, when a huge jump in leak rate occurs rendering (in this case) the target unusable

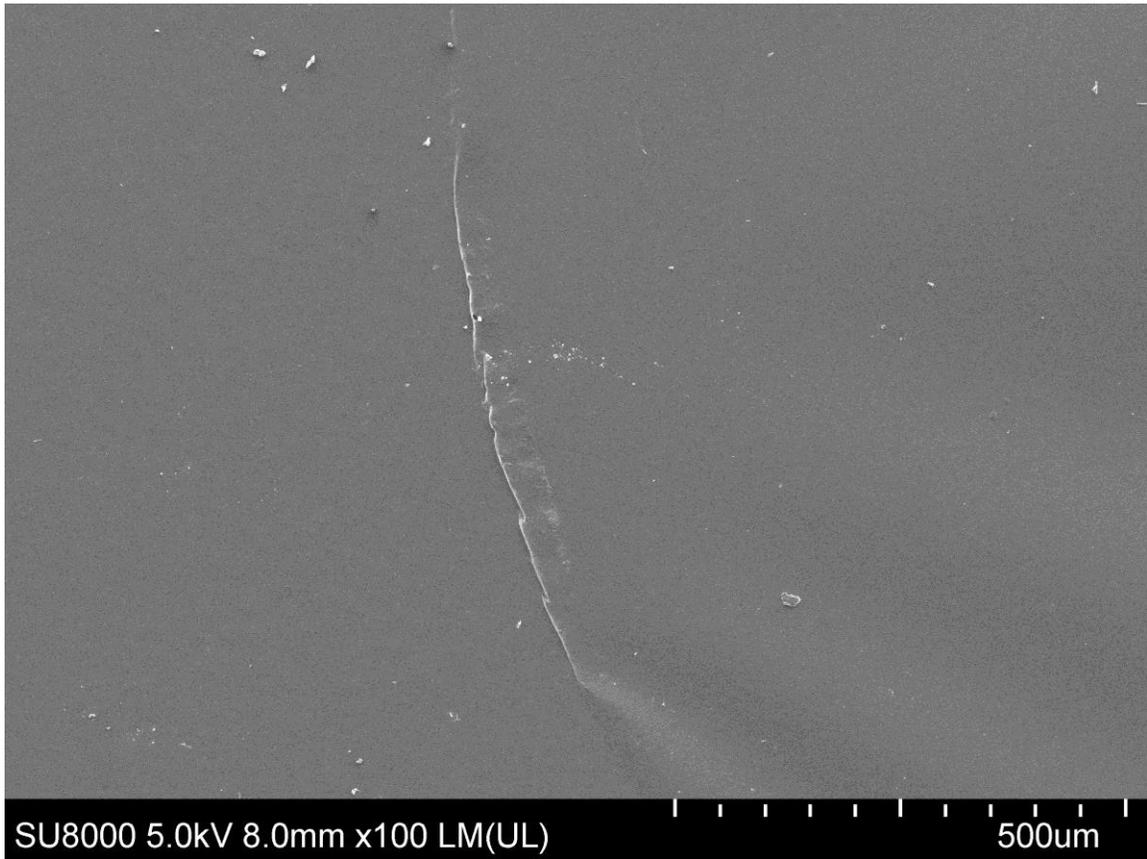
On the left side of Figure 2 is the washer and the right is the free standing portion of the film, the tear is right alongside the edge where the free standing portion begins and the washer ends.

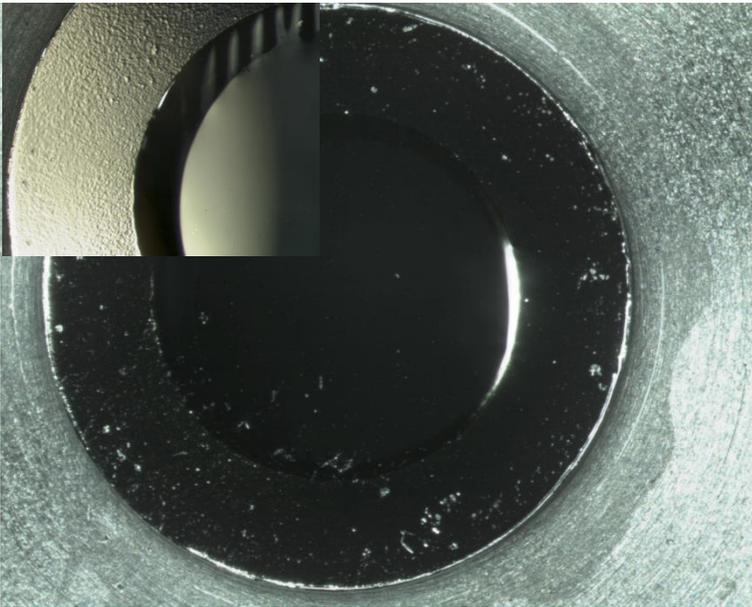
Figure 4 shows an overhead image of the “A” Type window and the inset is higher magnification image of the texture on the surface of the washer

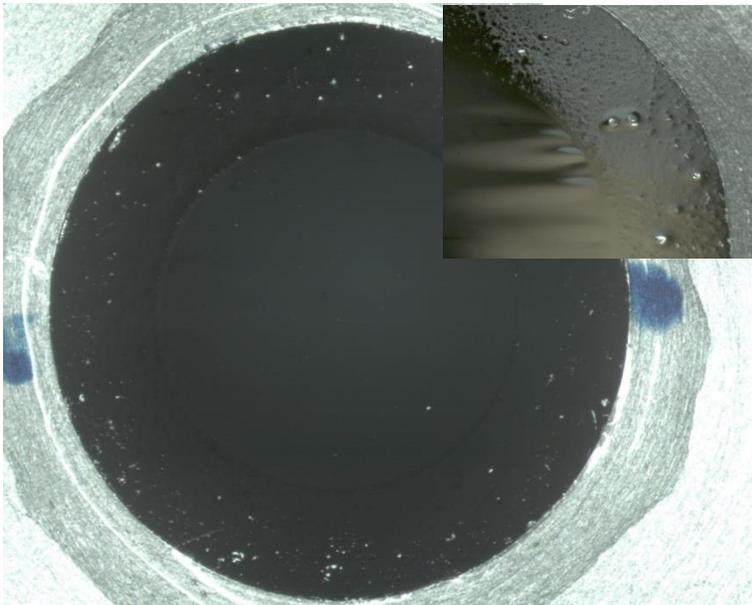
notably the “B” Type windows have many nodules and air bubbles where the “A” Types do not (see Figures 4 and 5 for comparison).

Figure 5 show the “B” type washer and the inset shows the textural features seen on the top of the washer.

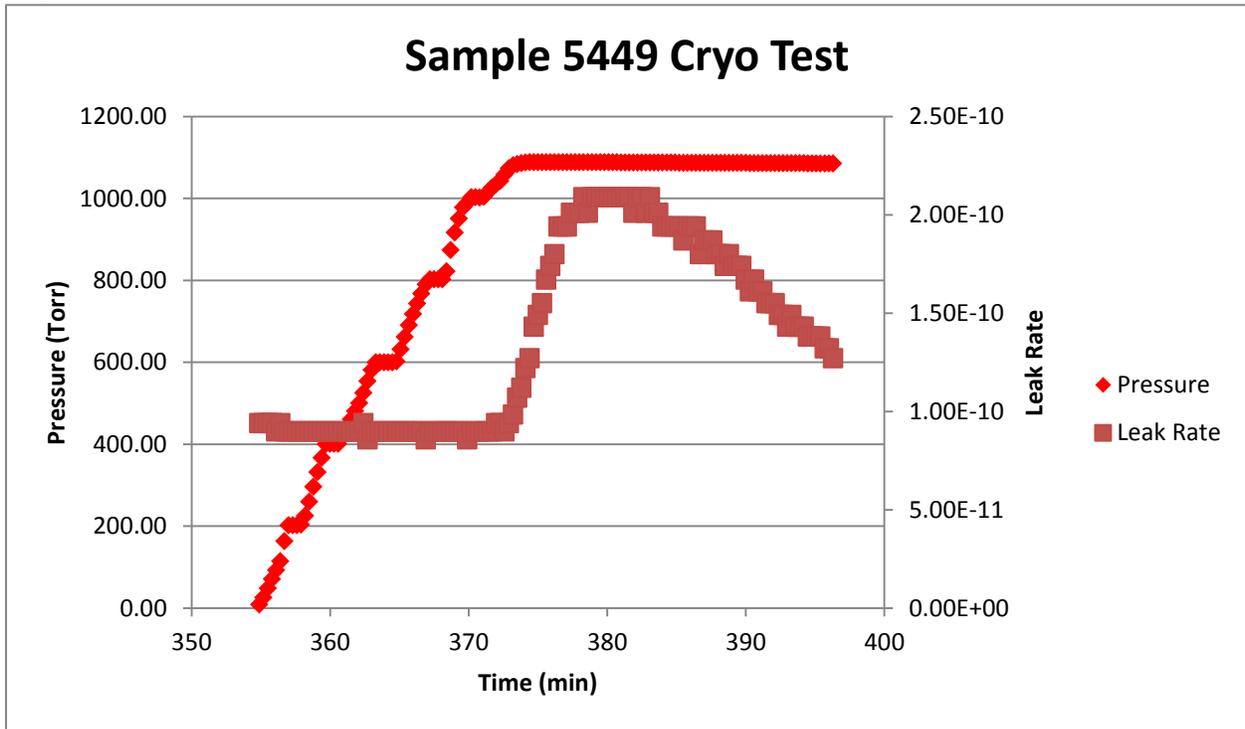
Figure 7

A virtual leak is a fixed small volume, usually a bubble or air pocket, that was formed either during the cooling of the sample or its original manufacturing. When pressure is applied to this bubble it will compress forcing out a stream of air, helium, or another substance that the helium leak detector recognizes as a leak. Observation of these types of leaks has shown that the leak rates go up to a certain point and then begin to decrease if the pressure is held constant. The leaks can dissipate in a matter of minutes or in several hours (See Figure 7).

Sample 5449 stayed constant to a point, then the leak rate increased and as it was left at 1100 torr, the leak rate decreased almost all the way back down to its original baseline leak rate.

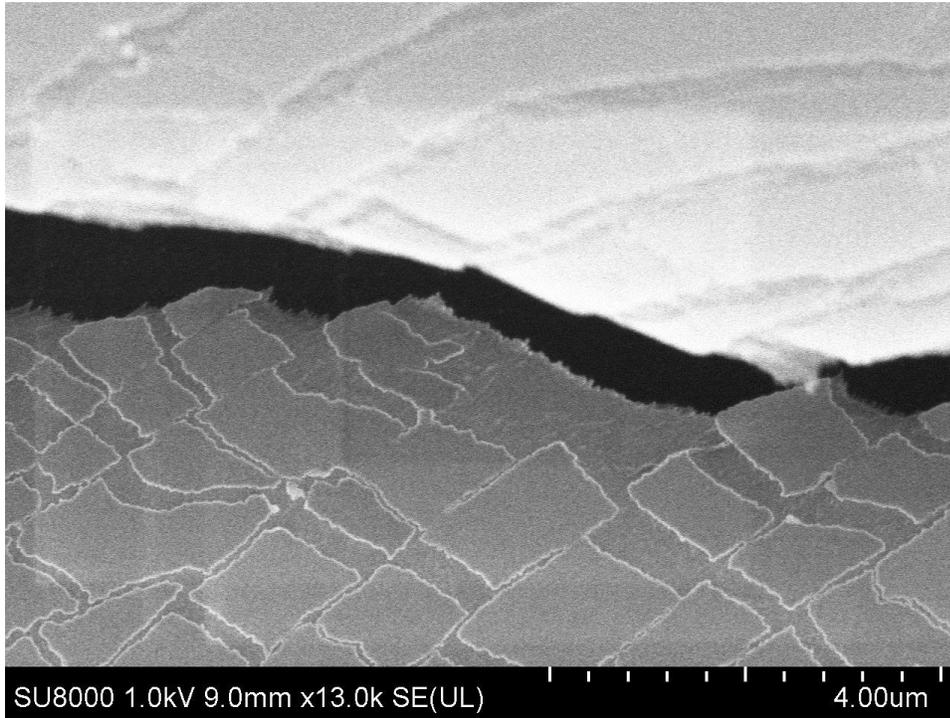
Figure 8

This is an SEM of sample 5 which had a leak rate of $1.32E-3$. The pieces that look like scales are the cracked pieces of Aluminum coating on top of a torn portion of the polyimide film.

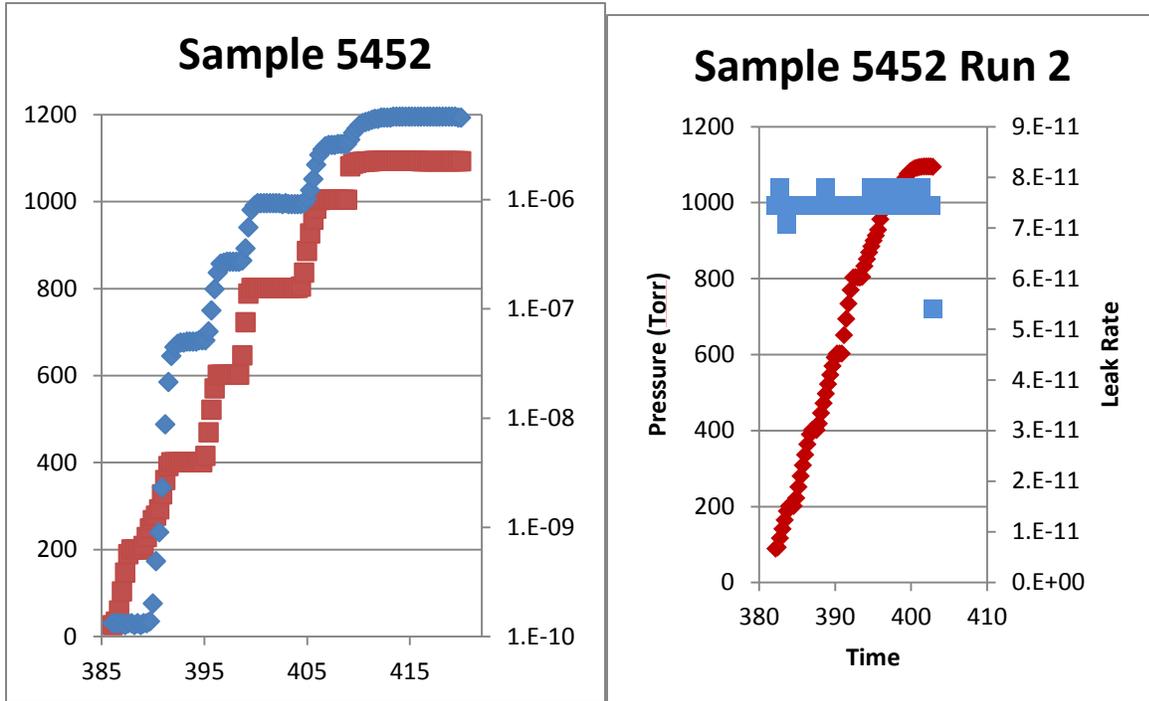
Figure 9

On the left is the first run of sample 5452, in which the red represents pressure and the blue represents leak rate. You can see the leak rate rises with the pressure. On the right after ensuring the temperature was cold enough, you can see there are no virtual leaks and the leak remains constant for the duration of the run.
