## Seismic Evaluation of the U1a Complex at the Nevada Test Site

# **Seismic Evaluation of the U1a Complex at the Nevada Test Site**

## ***Interim Report*** **SM98-24**

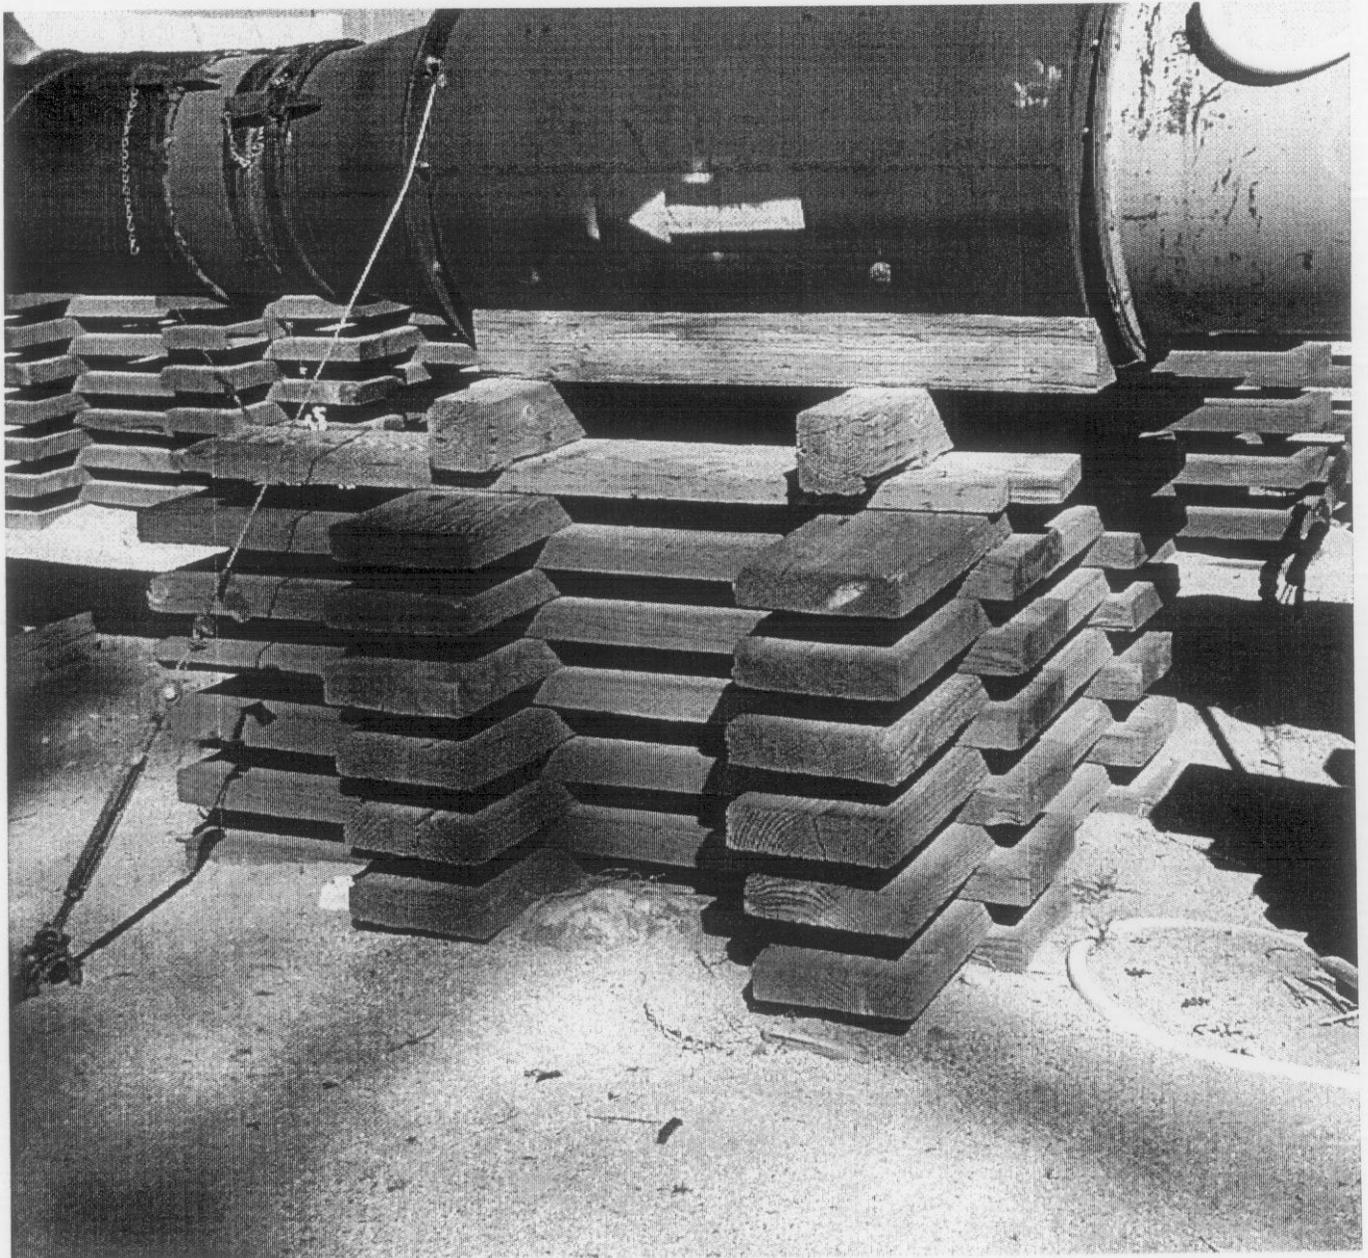
**Figure 4: The timber support and wire restraint for the air line piping.**

Recommendations were made to evaluate the Items #67 through #71 for lateral restraint. Figure 4 shows the air line being supported on timber (crib) and laterally restrained by wire. Such anchorage may not be sufficient for the air line system especially for the attached cantilevered valve (not shown in the Figure). Figure 5 depicts the wood block support for the emergency generator. Note that the block is smaller than the base plate of the generator; thus, evaluation was recommended.

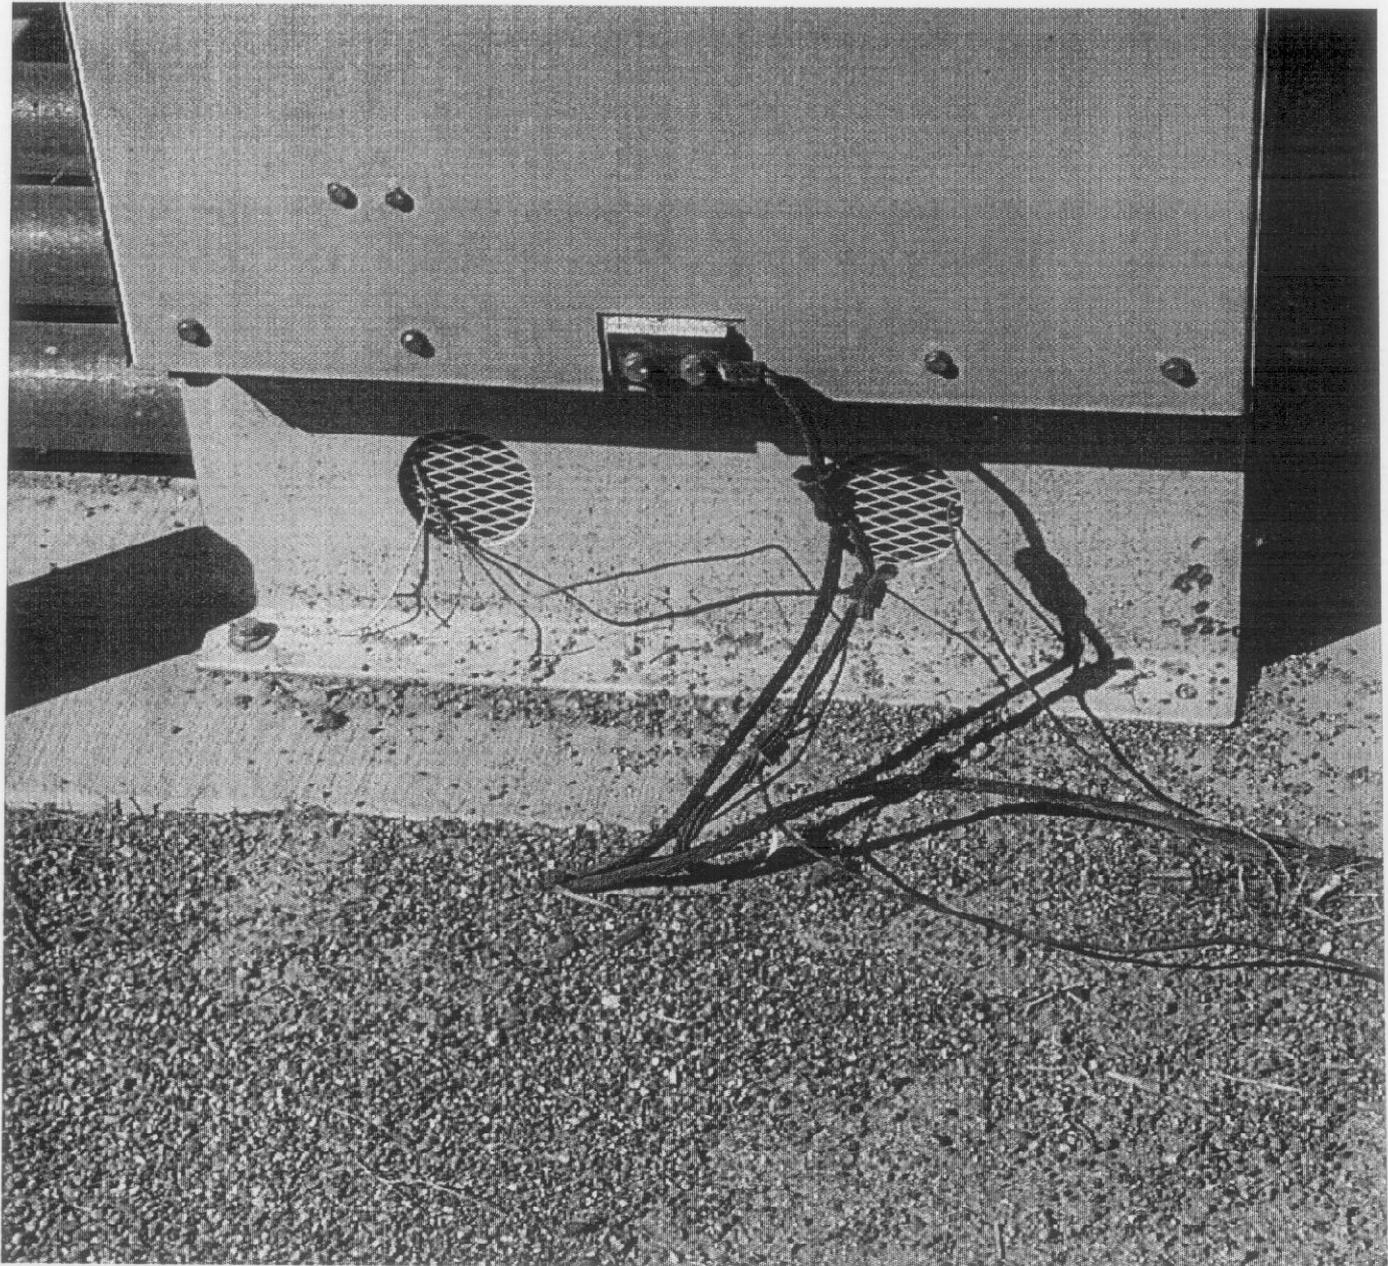
**Figure 6:** An anchor bolt is missing on the right side of the cabinet.

There are 28 PC-1 items marked for evaluation and they are tabulated in the Appendix F for easy access. Most of them are recommended for equipment anchorage. For example, Figure 6 shows missing bolts at the right corner of the cabinet. Figure 7 is an opposite view of Figure 6 showing a missing bolt and three conduits rigidly connected to cabinet on the right-hand-side of the Figure. The rigid connection is vulnerable to damage when the cabinet or the equipment is not properly anchored. Figure 8 is another example of free-standing equipment (high voltage switches) with rigid conduit connections.

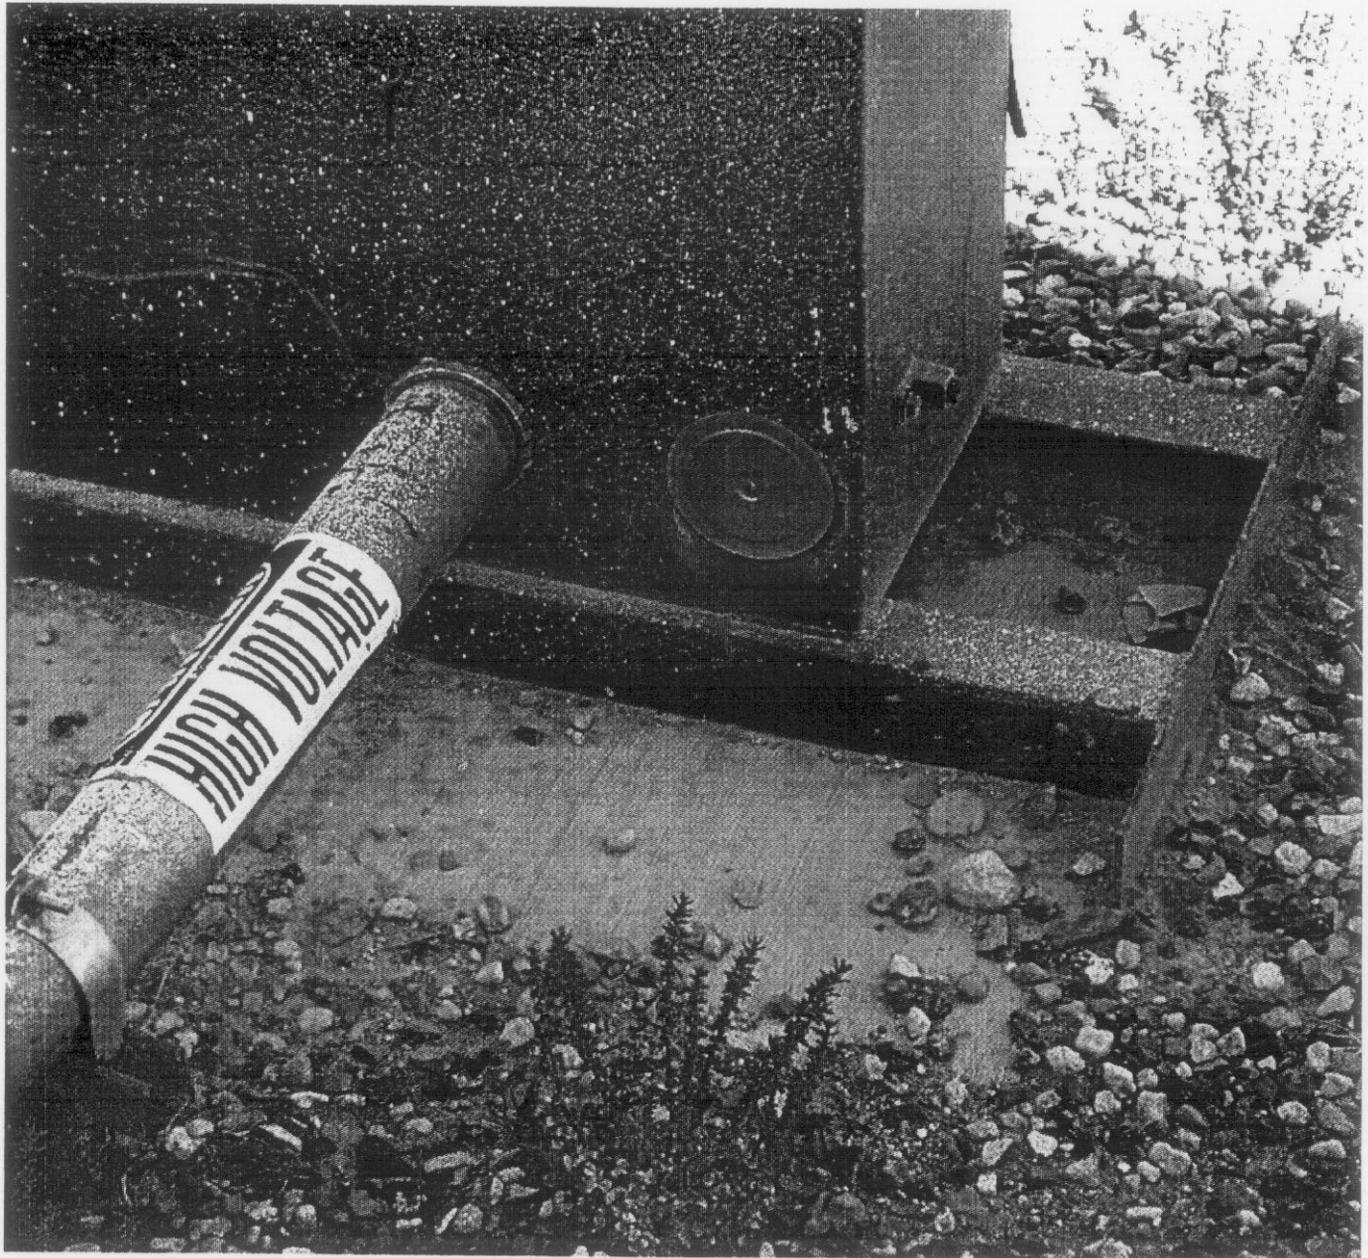
**Figure 8: Free-standing high voltage switch cabinet with rigid connection to conduits.**

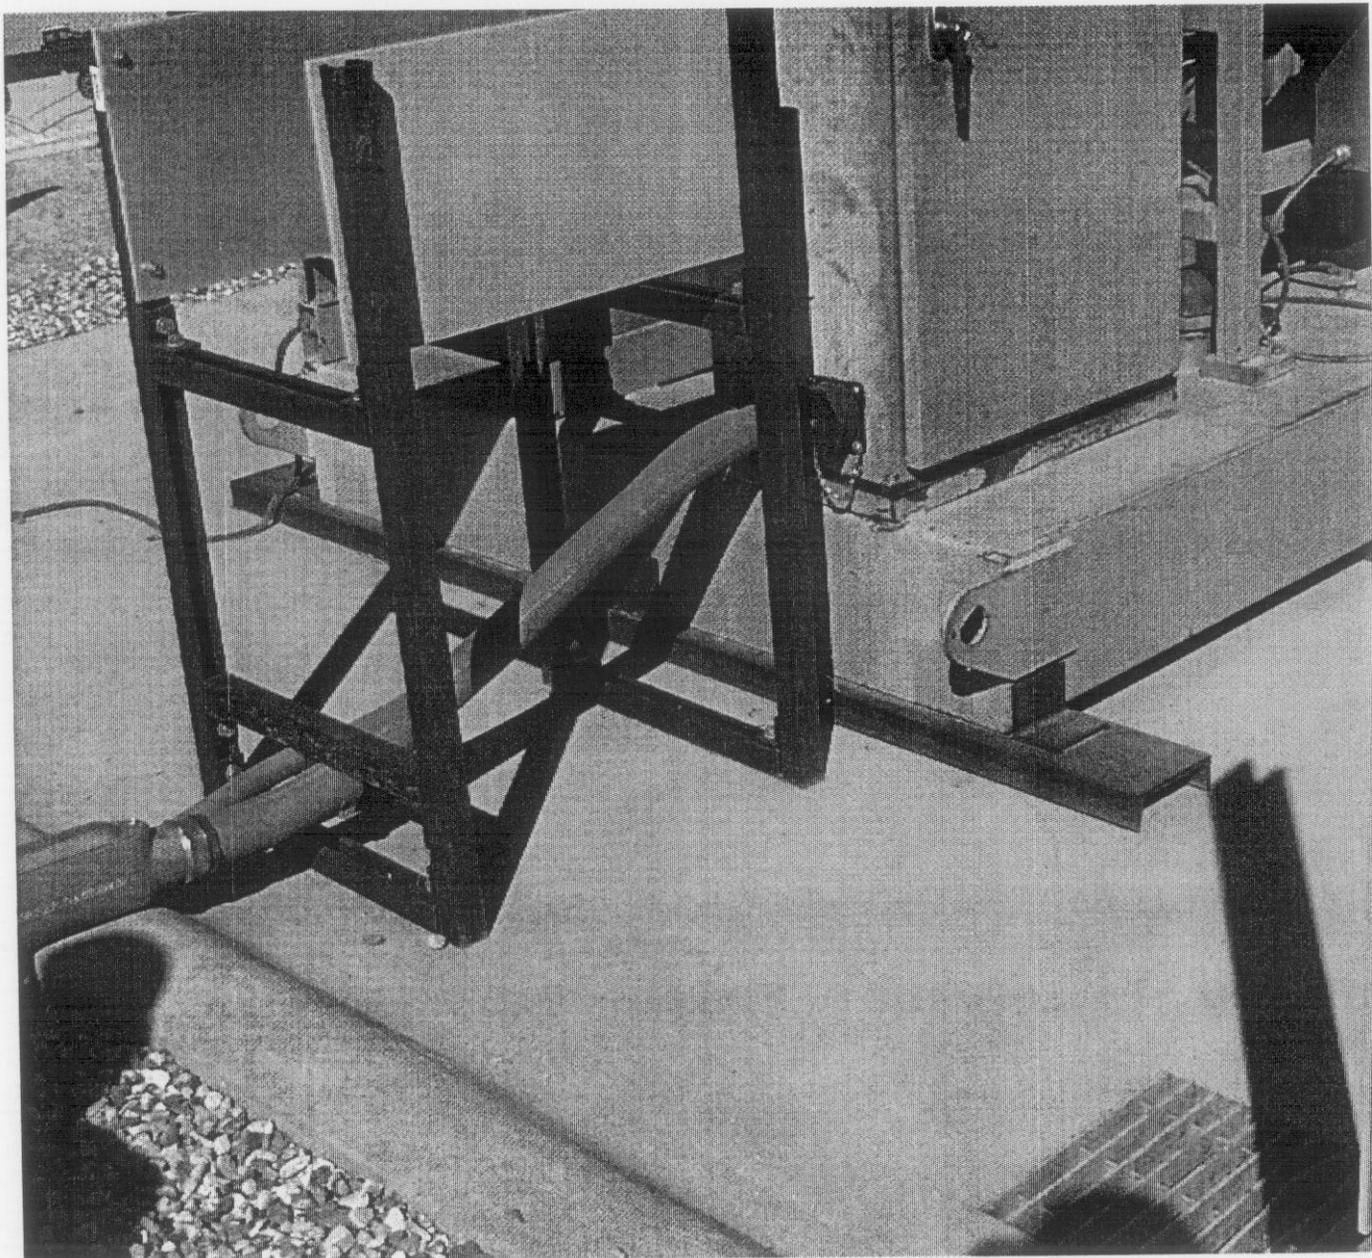
Figure 9 shows a free-standing equipment with flexible cable connection. If uplifting loads exist at the legs the equipment should be tied down to avoid seismic movement. Note that the small rack may have interaction with the flexible cable causing avoidable damage to the cable.

**Figure 9: Free-standing equipment with flexible connection to cable and possible interaction with adjacent rack.**

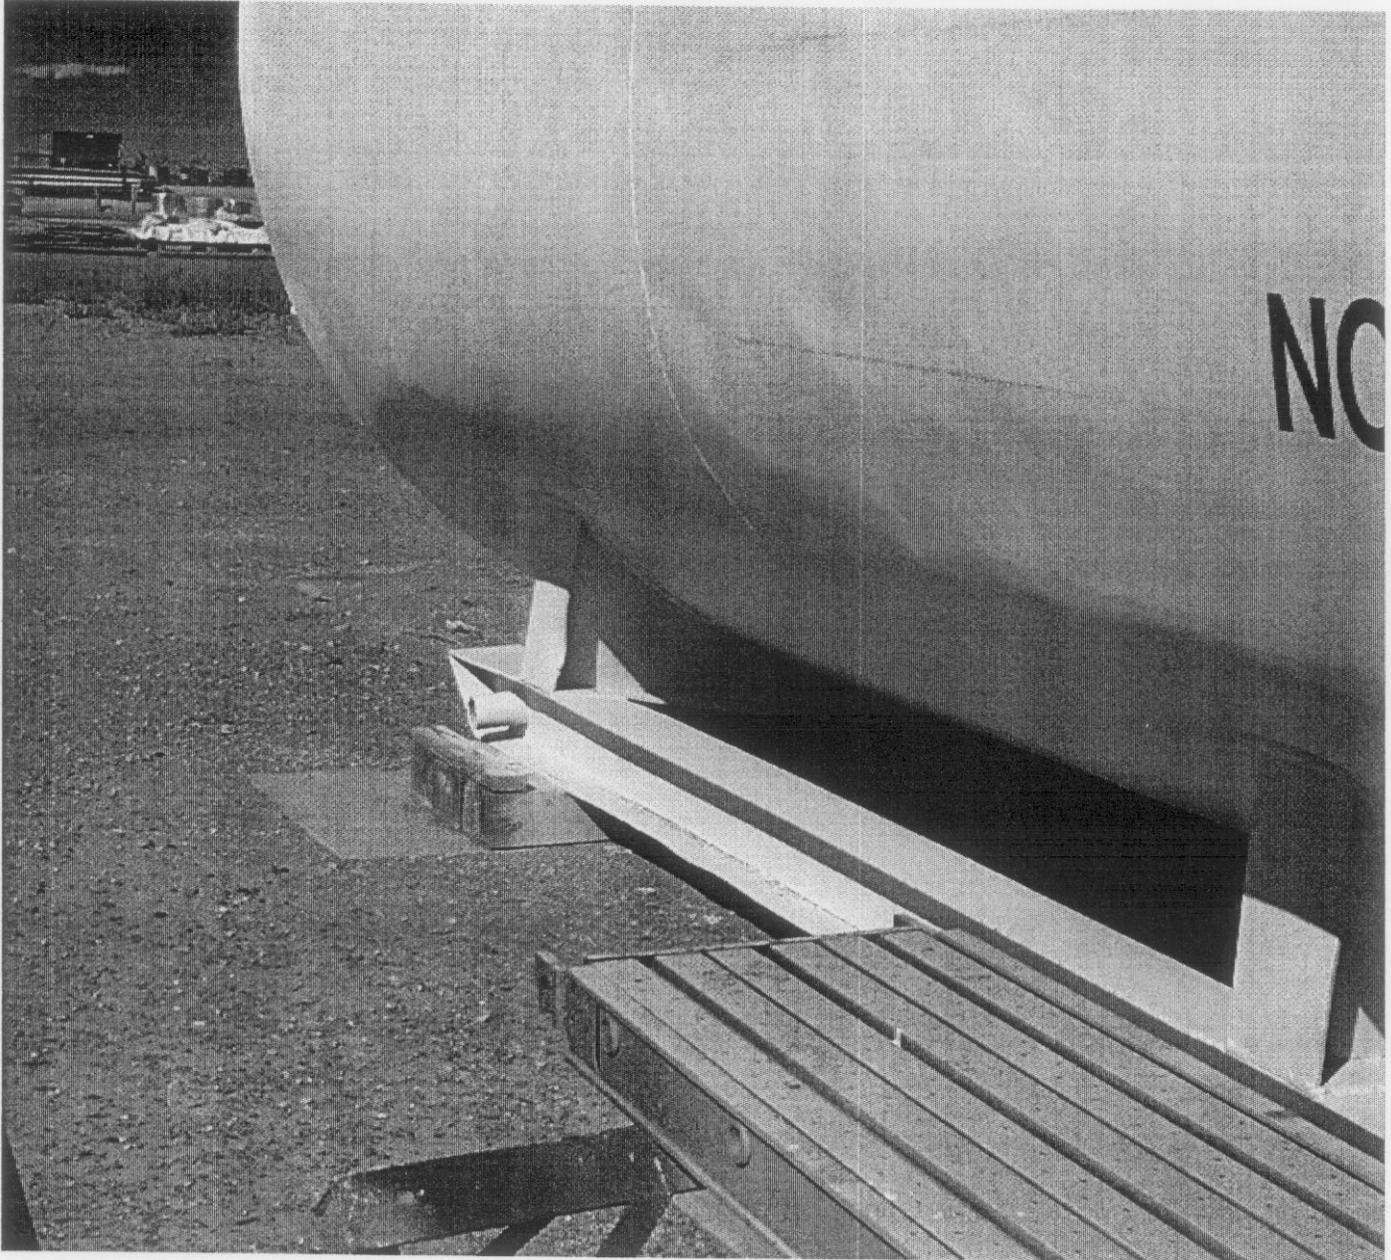
Figure 10: A water tank buckles at the support.

There are several utility water tanks at the surface facility that need to be anchored to the ground. Two water tanks are part of the shaft spray system while two others are the construction water supply. One of the horizontal tanks for the shaft spray system buckled at the supports, as shown in Figure 10, and was marked for evaluation. The weldment on two legs were damaged and should be repaired. Figure 11 is a close-up view of the damaged weldment at the front leg.

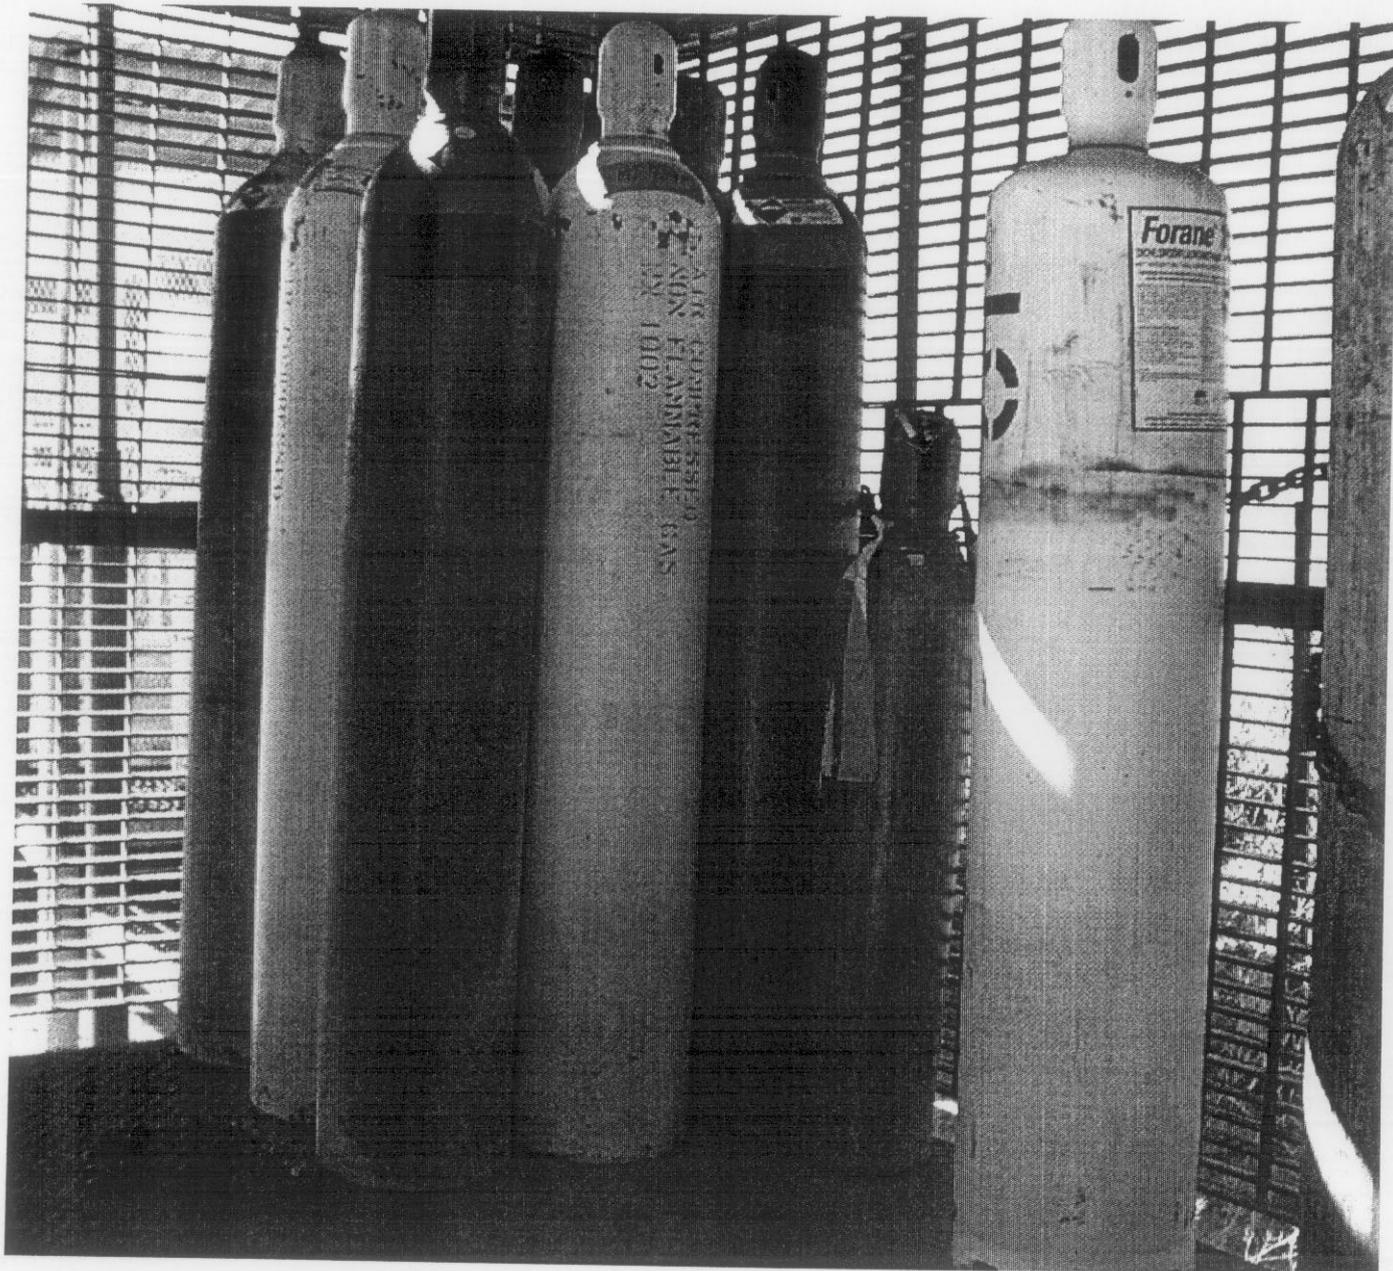
Figure 12: Free-standing bottles need to be restrained from falling.

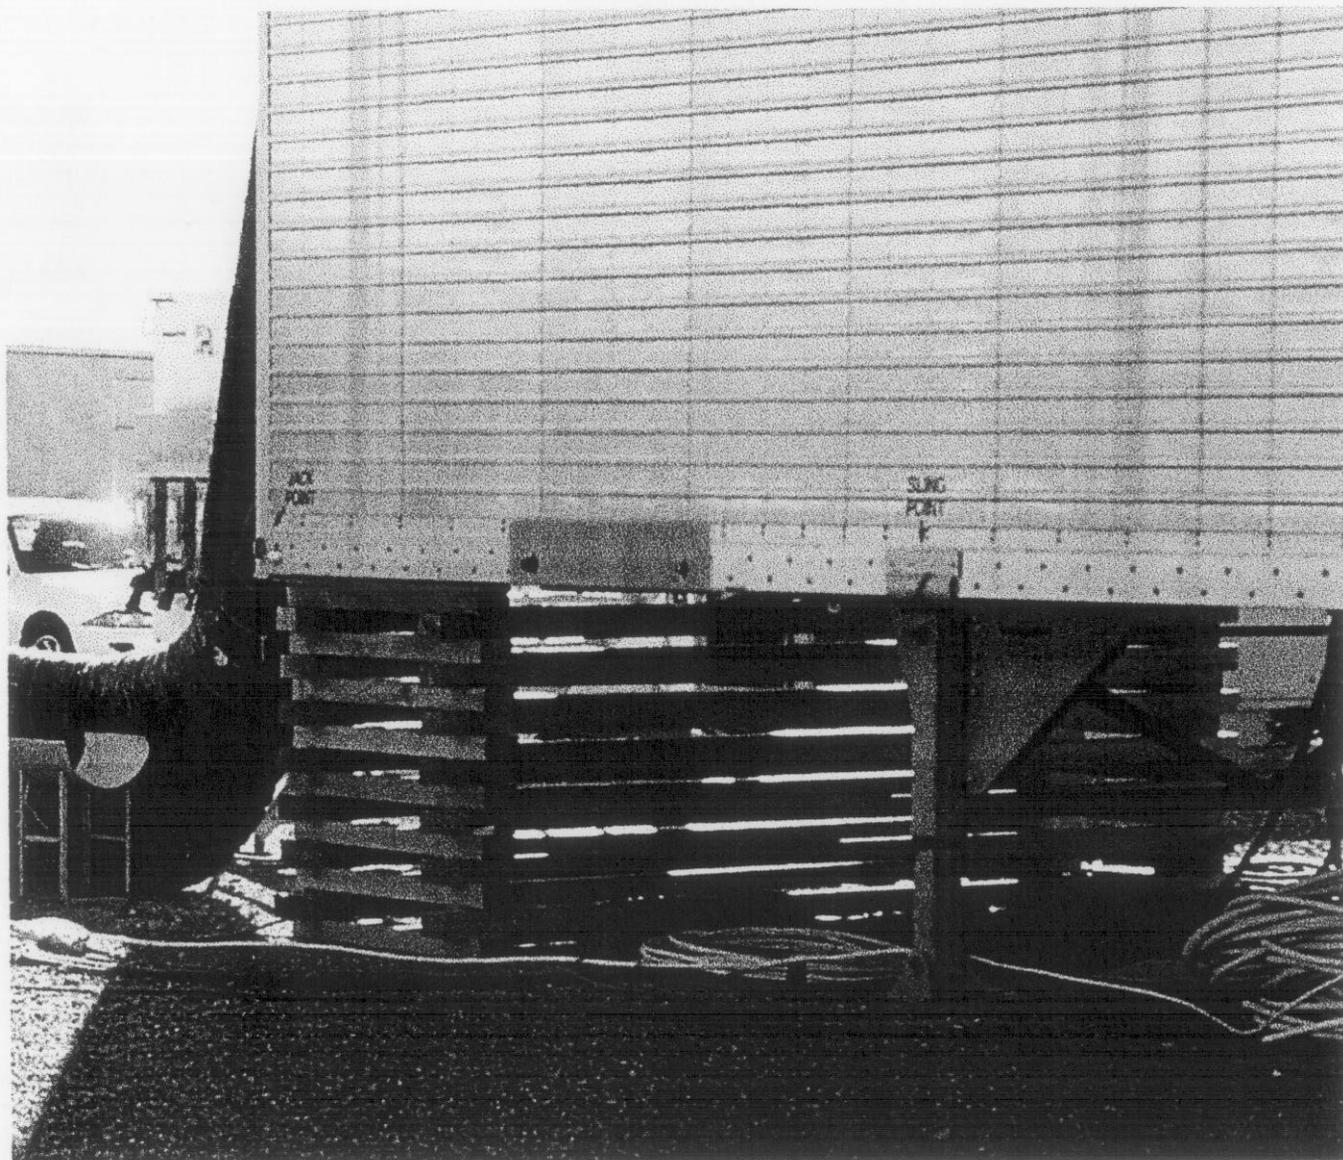
Some trailers are supported on wood cribs up to several feet above ground as shown in Figure 14. It is not clear that the wood cribs could remain intact during an earthquake; therefore, recommendation was made to evaluate the stability of the cribs. Some trailers are supported on wheels on one end and on small tripods on the other end as shown in Figure 15. It is possible that the wheels might experience significant movement that the tripods could overturn. It was recommended to limit the wheel rolling by shimming with blocks.

**Figure 14: Evaluation of the timber-pile response to earthquake motion is recommended.**

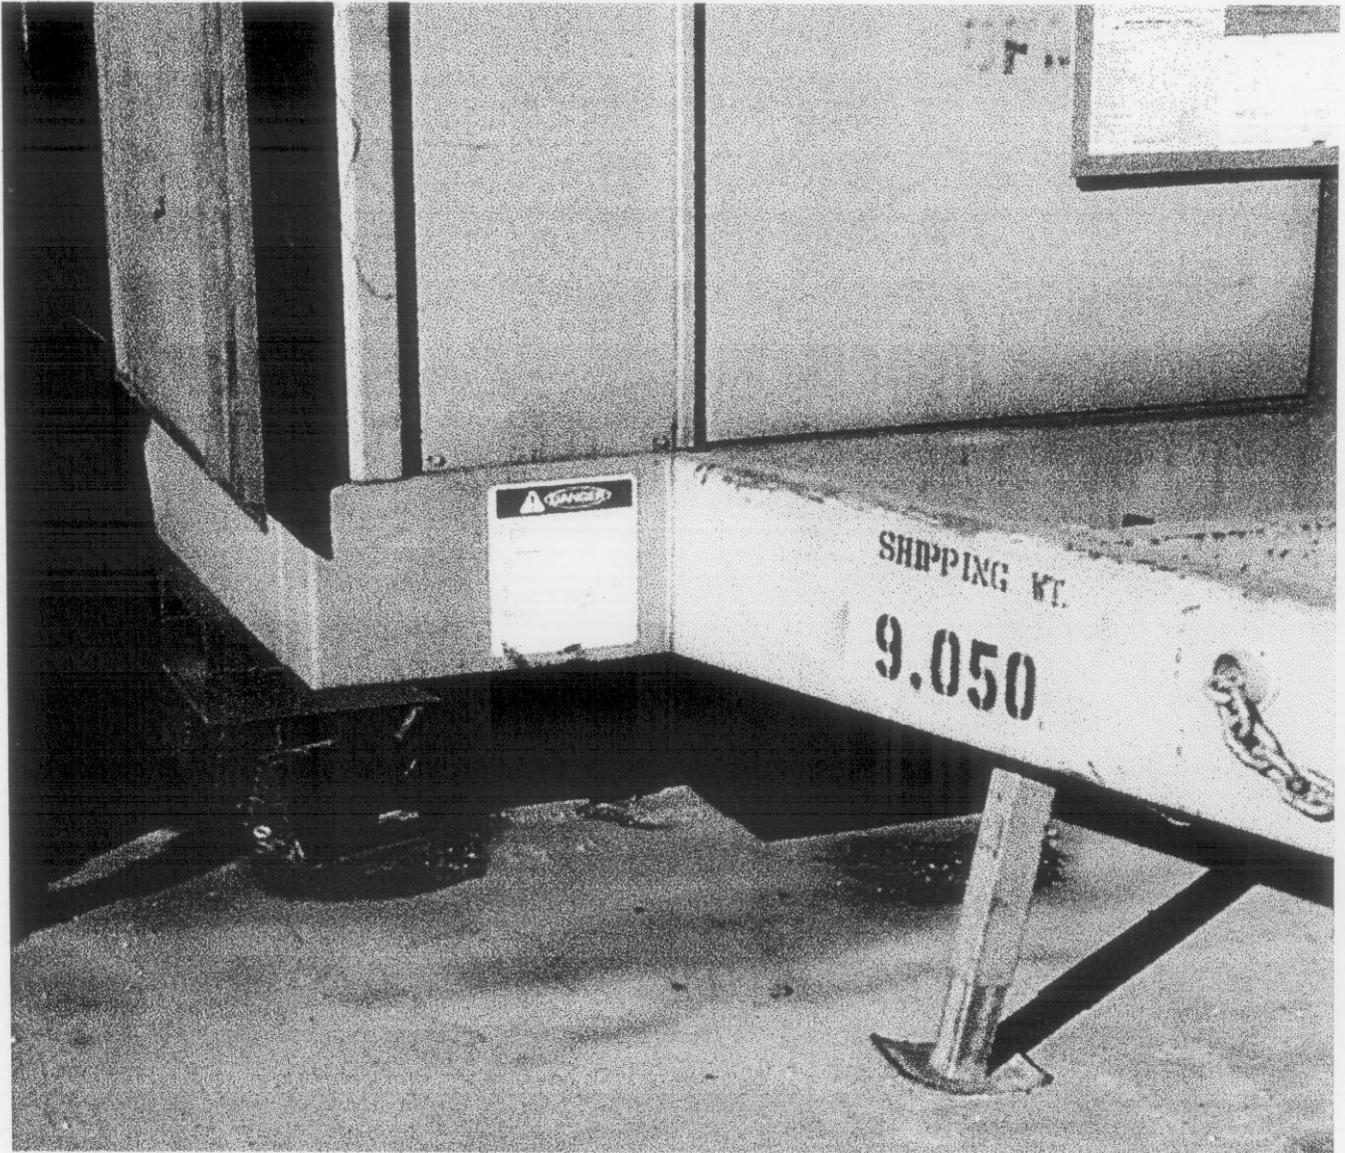
**Figure 15: The trailer wheels may be restrained to limit seismic motion of the trailer.**

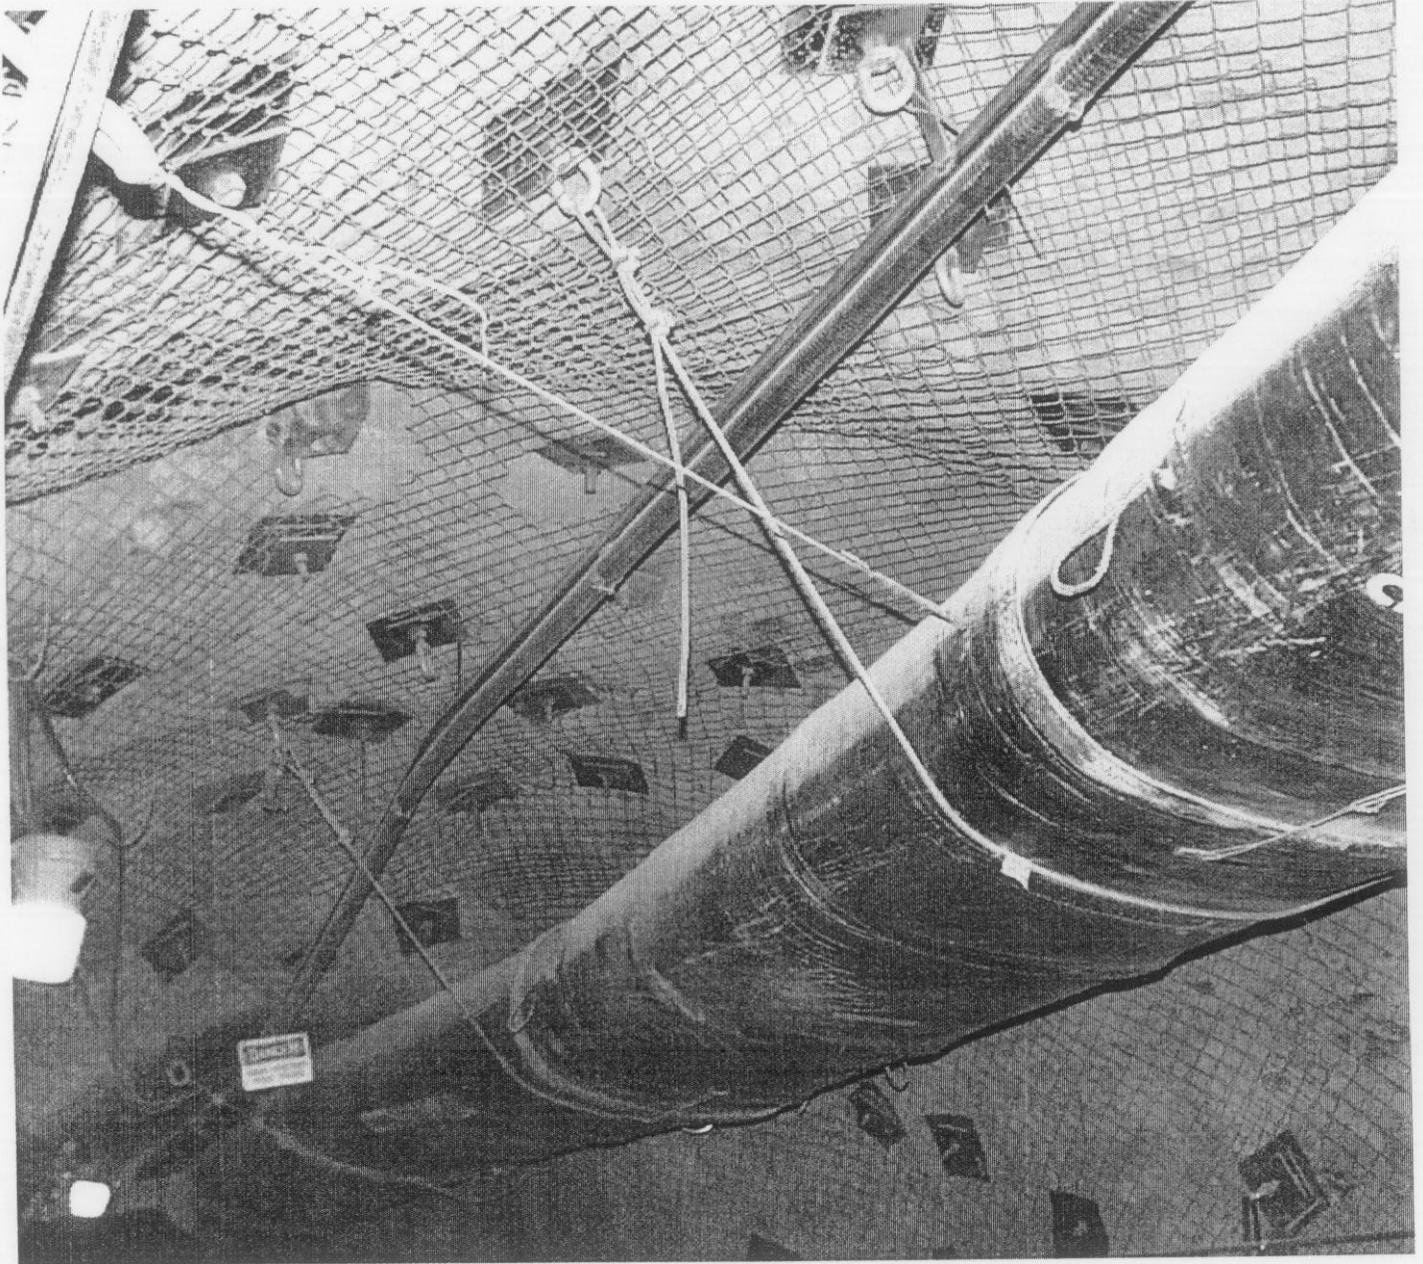
Figure 17 shows a typical redundant anchorage for the vent line. One cable supports from the bottom of the duct while another cable from the side. The weight of the cable is not consistent throughout the entire length of the vent line. Figure 18 is taken at an intersection of the vent line with larger duct sections. The cable is light weight and loosely wraps around the duct. *As shown in Table 8, recommendations for air line anchorage were made in various locations in the tunnel.*

Figure 17: The vent line is supported on different weights of cables and wires.

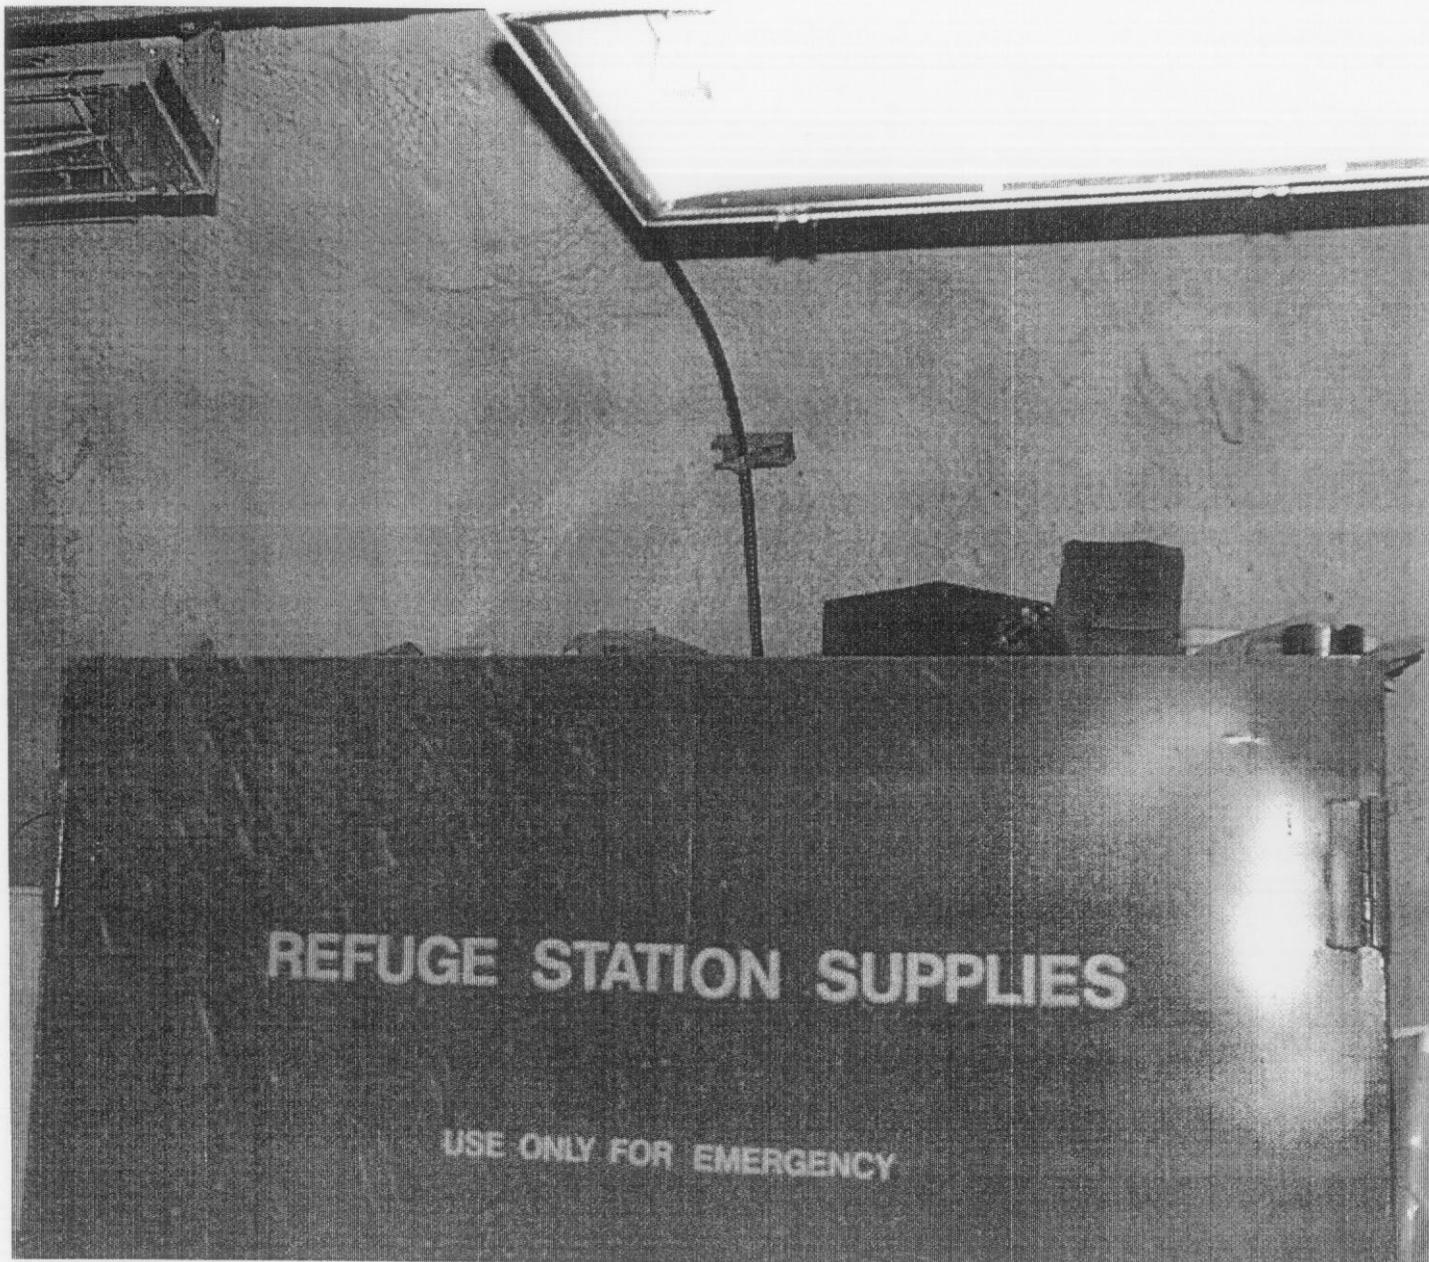
**Figure 19:** Free-standing cabinets are hazardous to worker safety in a refuge area during earthquake.

In the refuge area, refuge station supplies are kept in tall cabinets. Figure 19 shows a free-standing tall cabinet marked for emergency use. Recommendation was made to properly anchor the refuge station supply cabinet to the wall. In Figure 20, two tall cabinets are tied to the wall with loose cables. The interaction between two cabinets and the warning light is a concern to the seismic safety of the workers who take refuge in that area.

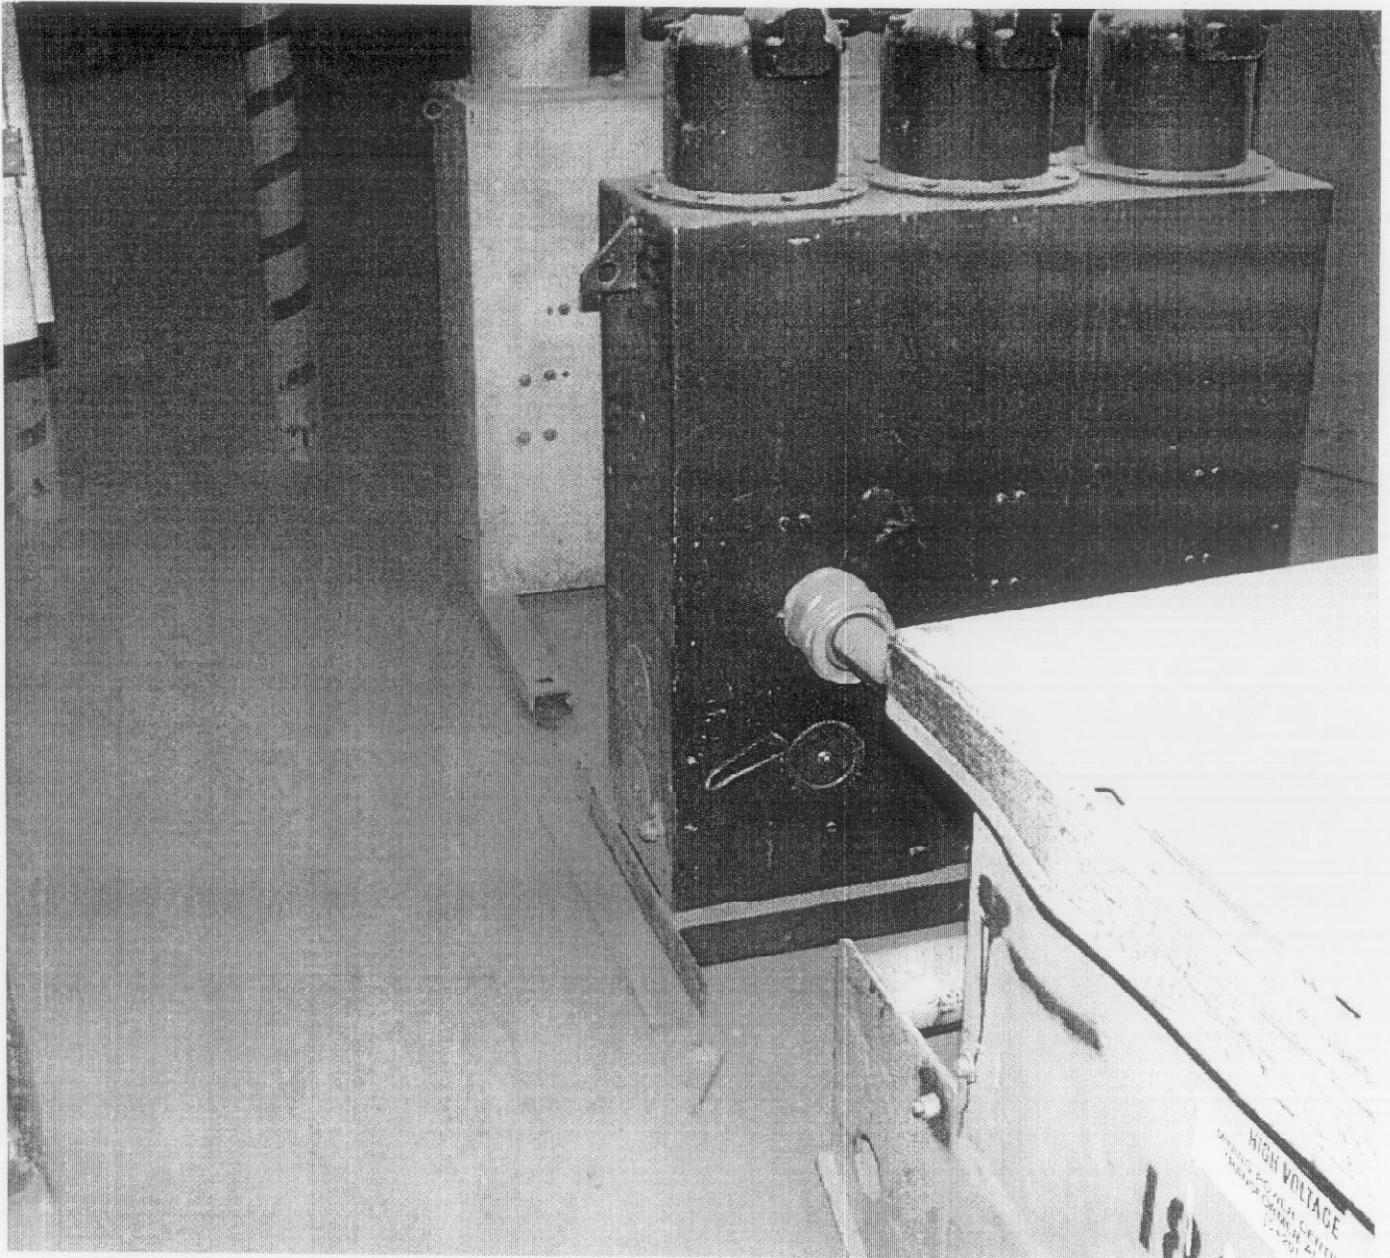
Figure 23 shows a typical, rigid conduit connection between the switches and the diesel generator. Both the switches stand and generator are free-standing and can move out-of-phase during earthquake. The diesel generator might be heavy enough not to have uplifting seismic forces while the switches do. Differential seismic displacement may be inevitably causing damage to the high voltage cables.

**Figure 23: Free-standing switches and diesel generator connected with rigid conduit.**

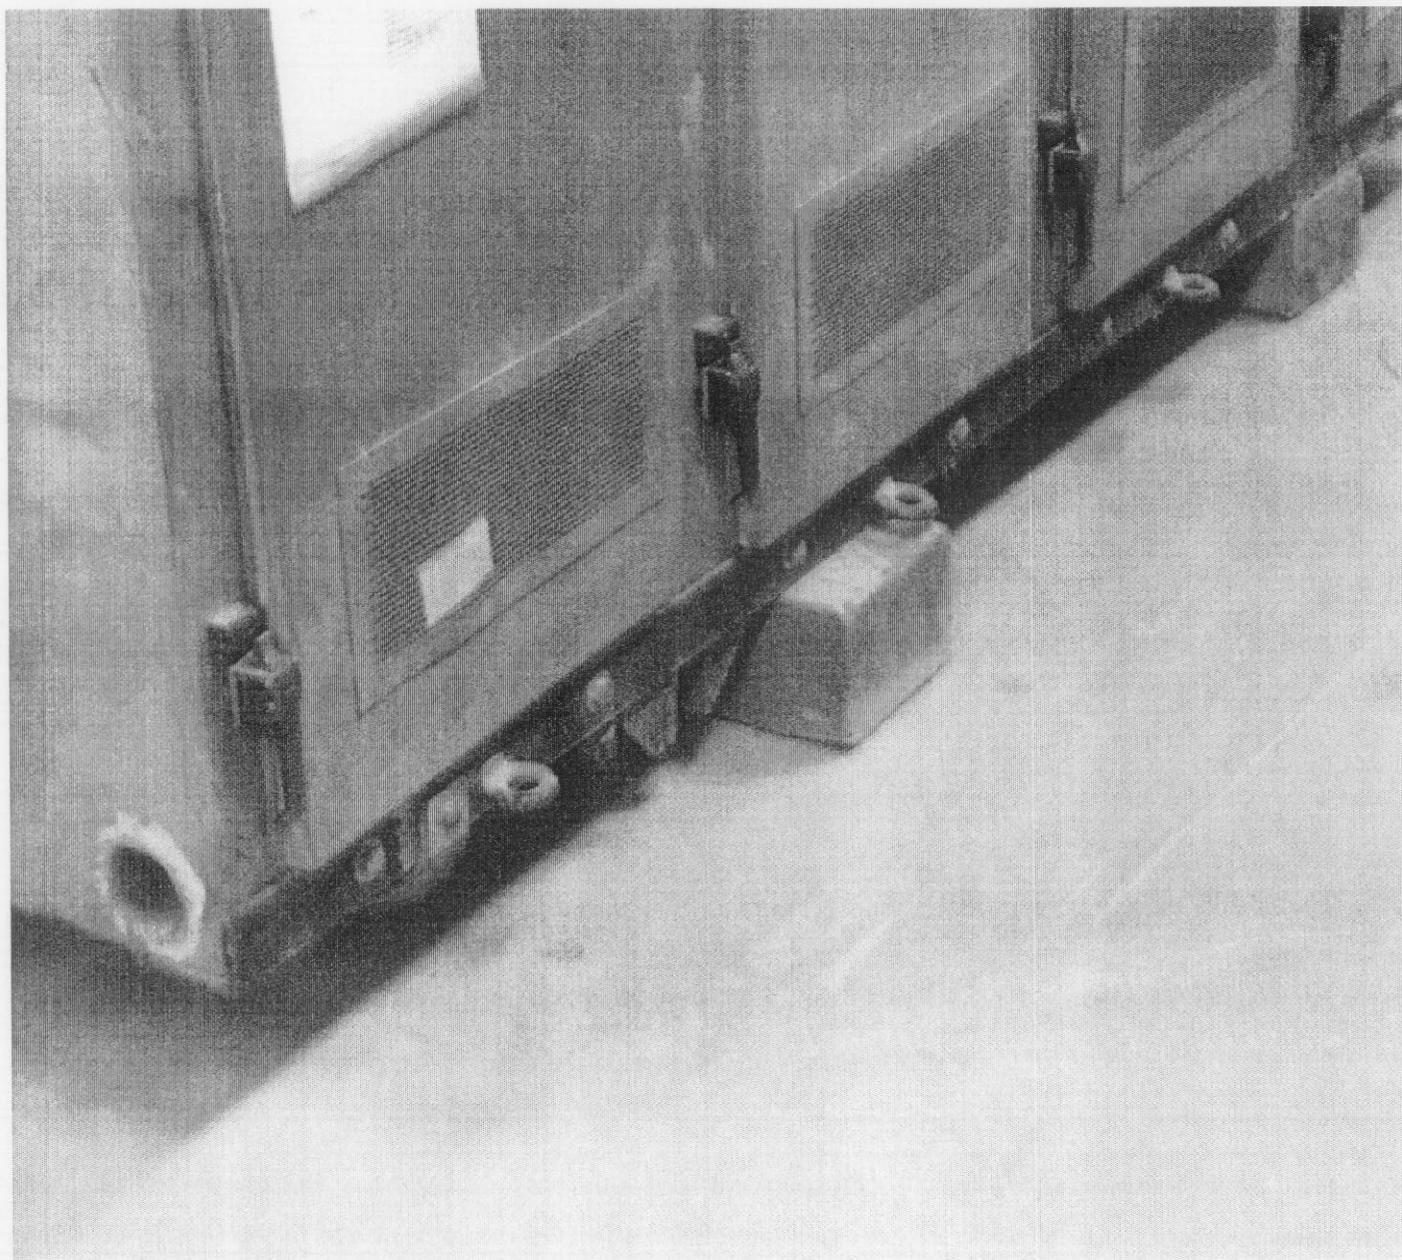
**Figure 24:** Groups of the instrumentation cabinets rest on timber blocks in the DX-12 Alcove.

top of the cabinets. However, evaluation is recommended to determine the stability of the cabinet group to ensure that the cable will not be separated from the instruments.
