## Seismic Evaluation of the U1a Complex at the Nevada Test Site

# **Seismic Evaluation of the U1a Complex at the Nevada Test Site**

## ***Interim Report*** **SM98-24**

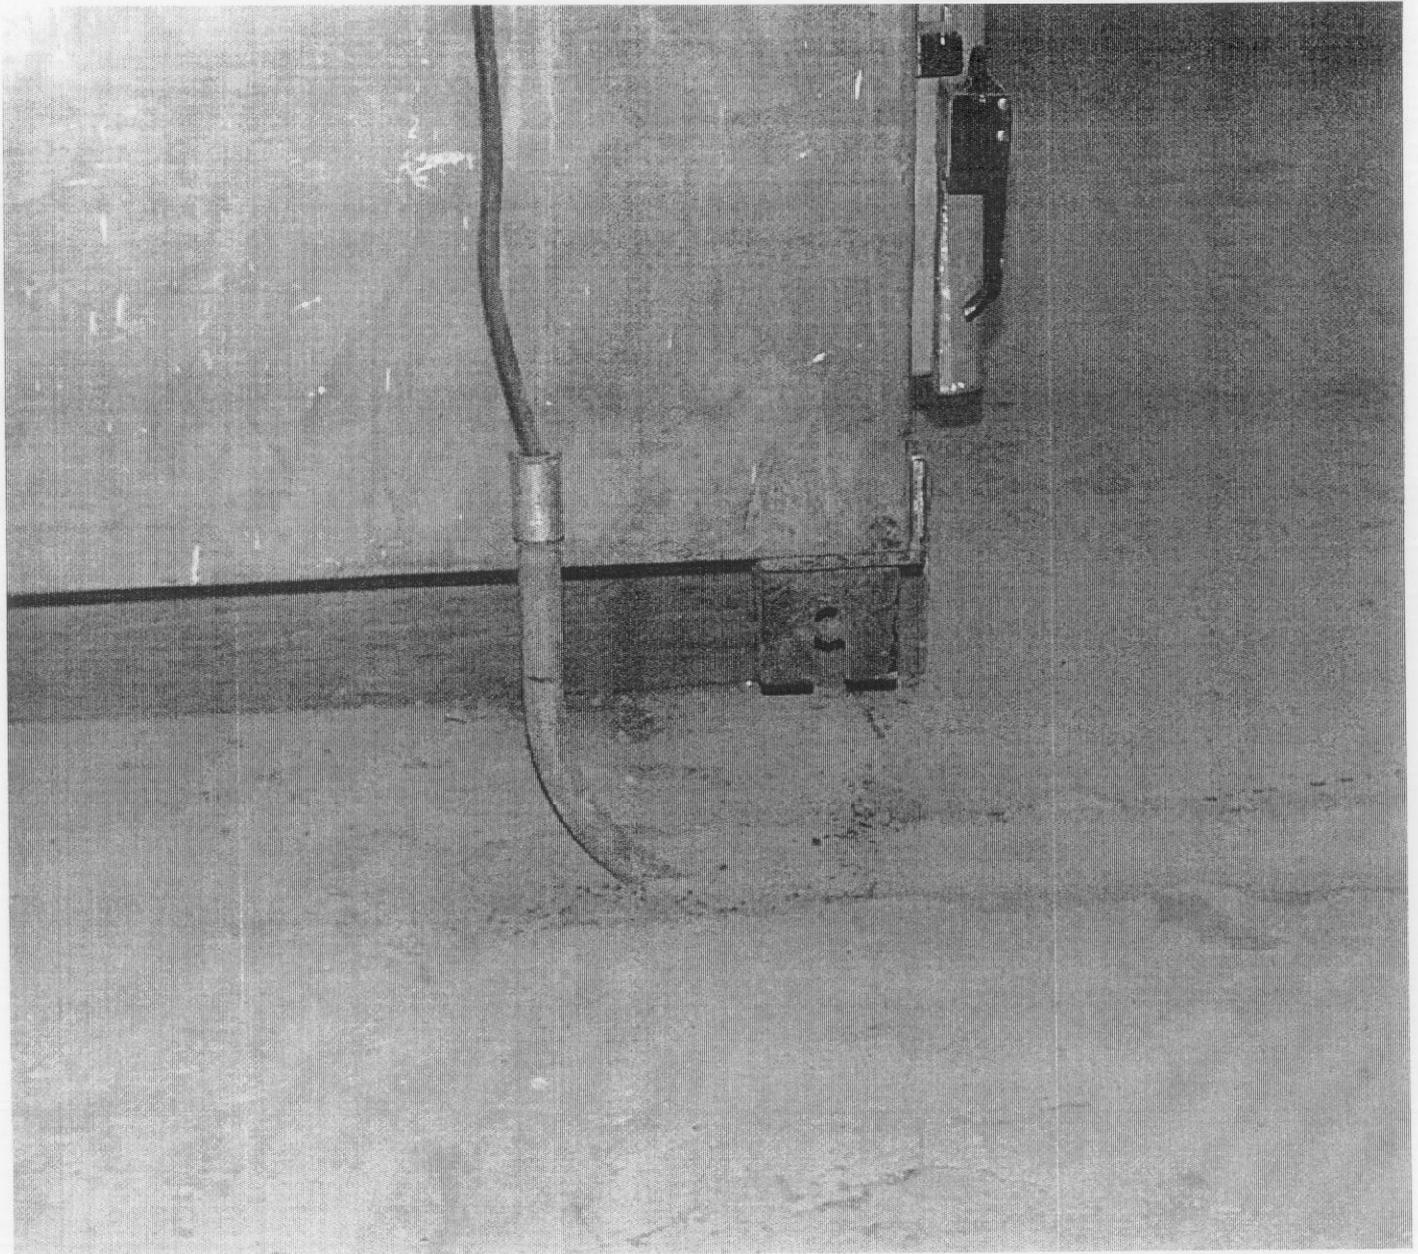
**Figure 25:** Groups of the instrumentation cabinets rest on timber blocks in the U1g Users Alcove.

top of the cabinets. However, evaluation is recommended to determine the stability of the cabinet group to ensure that the cable will not be separated from the instruments.

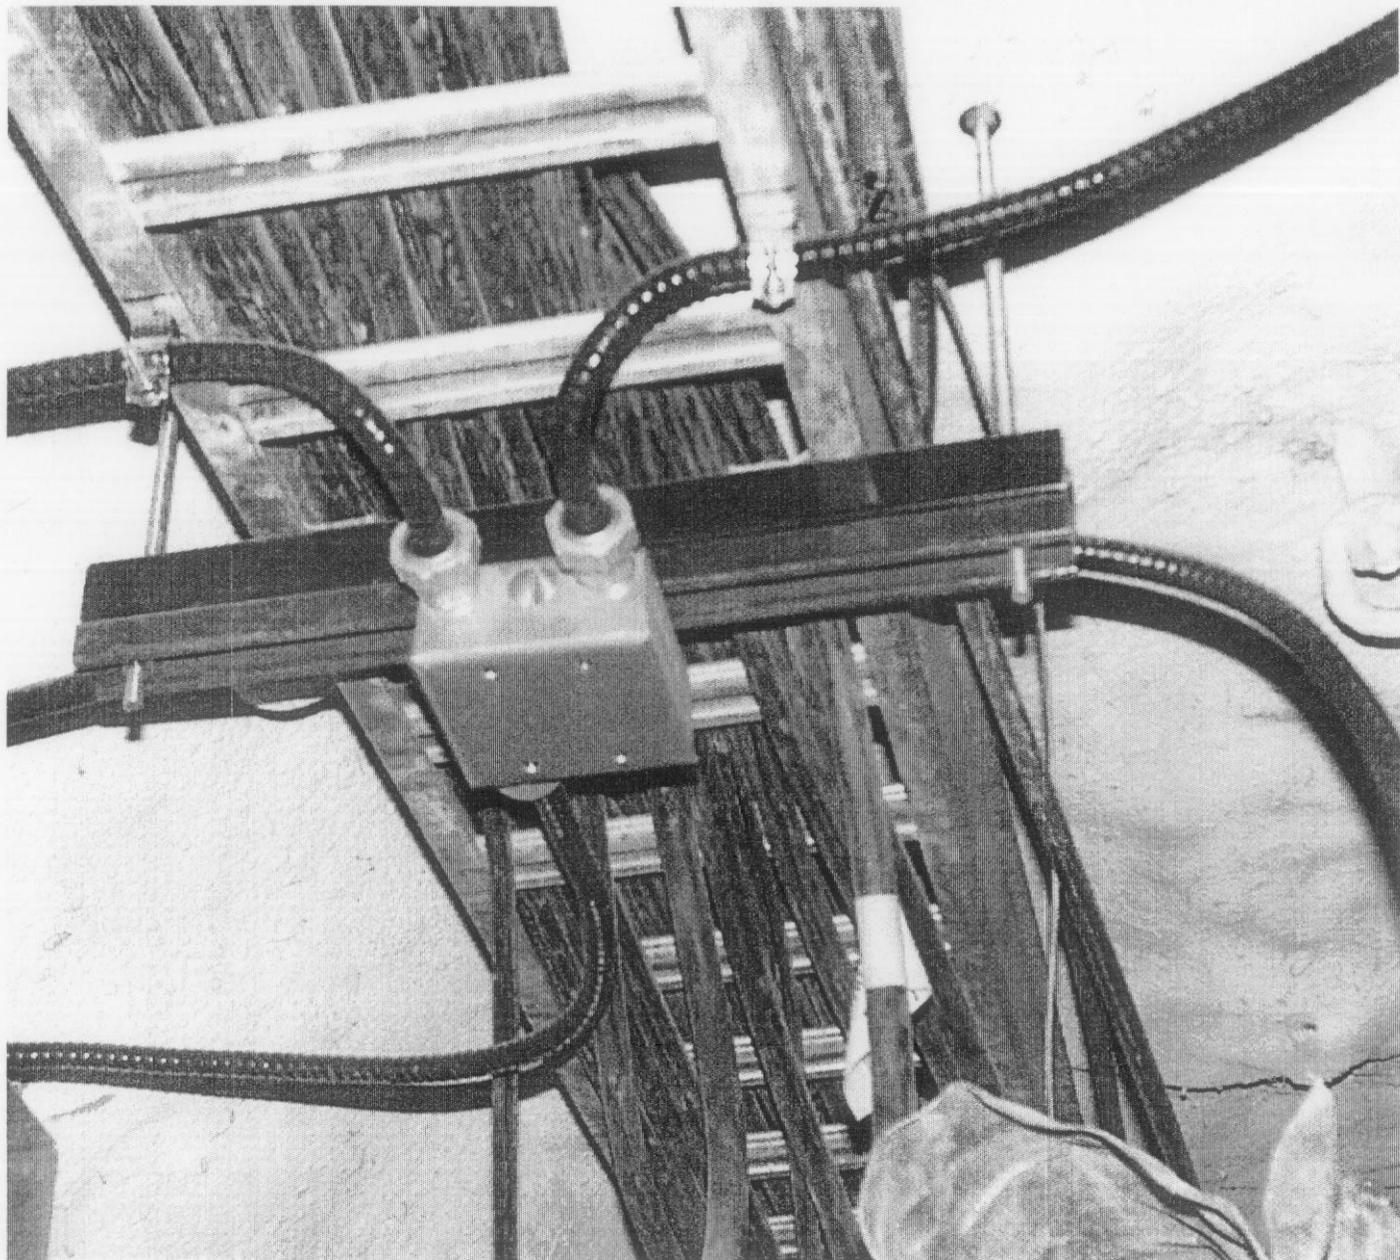
Typical cable tray anchorage is shown in Figure 26. Note that the tray is supported on two vertical rods. No lateral support is seen in this cable tray. Double deck cable trays are used in DX-12 and U1g Users Alcoves. They are also supported off the ceiling with rods and unistruts. Only one lateral support was found in the entire cable tray system in DX-12 Alcove. It is not clear this lateral strut is adequate for the entire system. Similar evaluation is also needed for the cable trays in U1g Users Alcove.

Figure 26: A typical anchorage for cable trays.

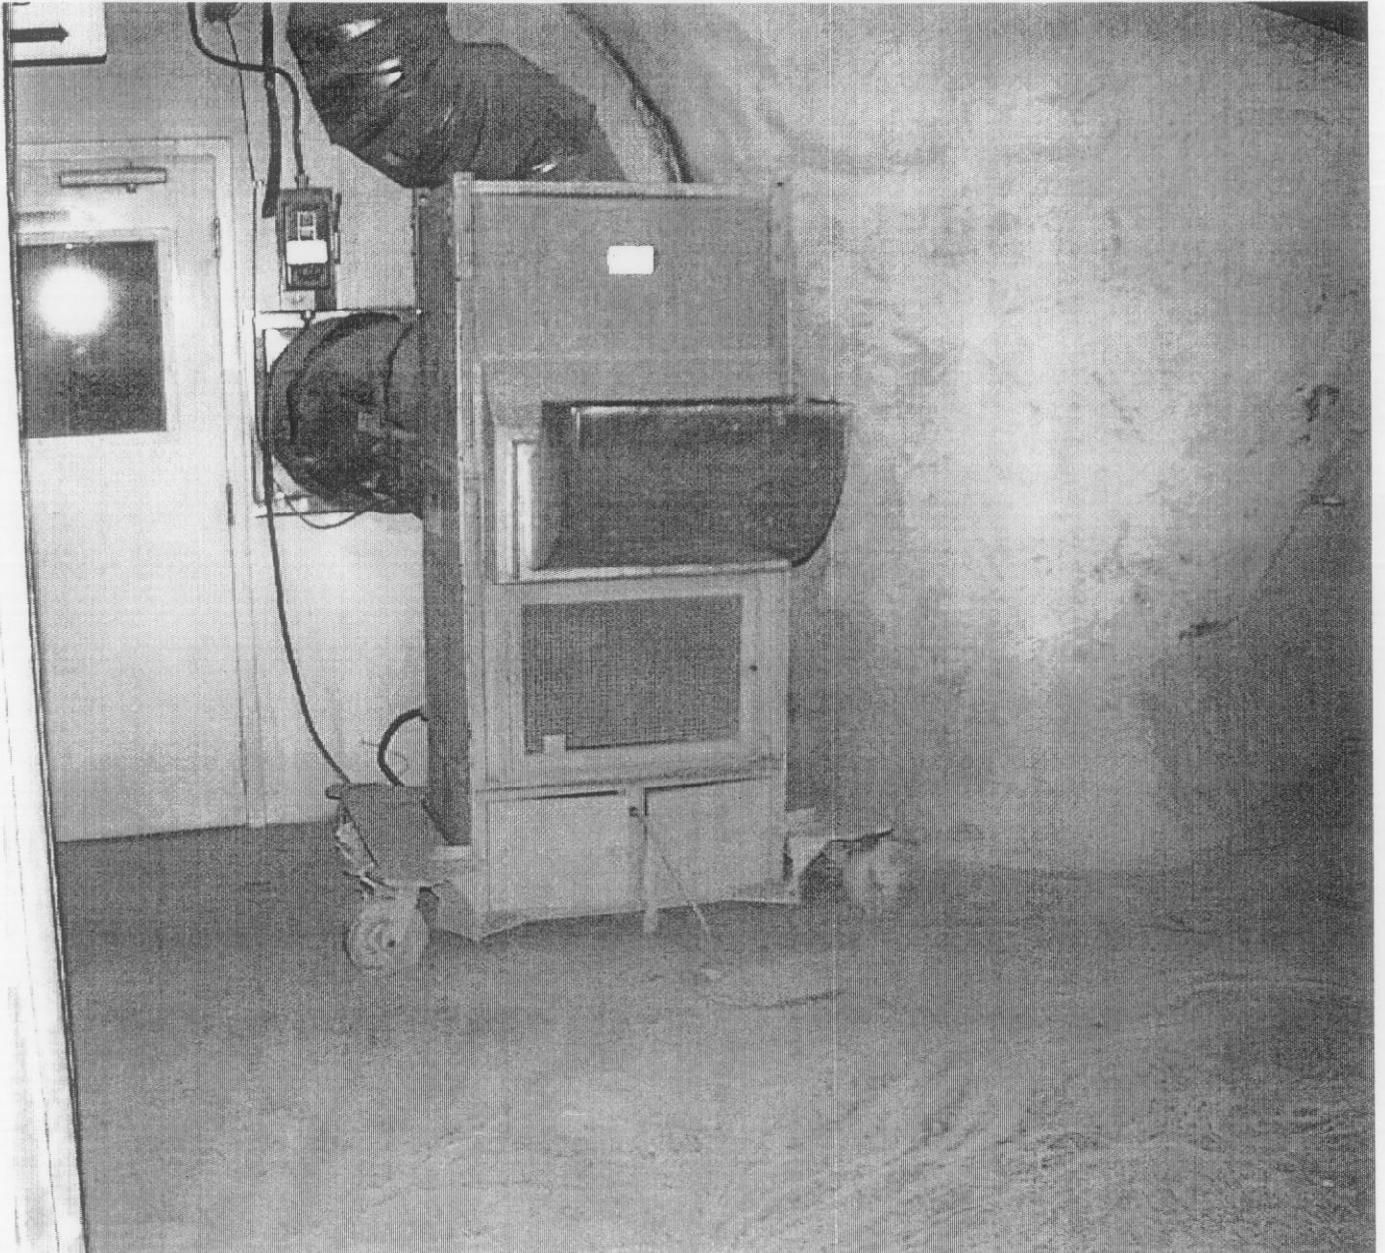
**Figure 27: An A/C unit sits on four wheels and is connected to two ducts.**

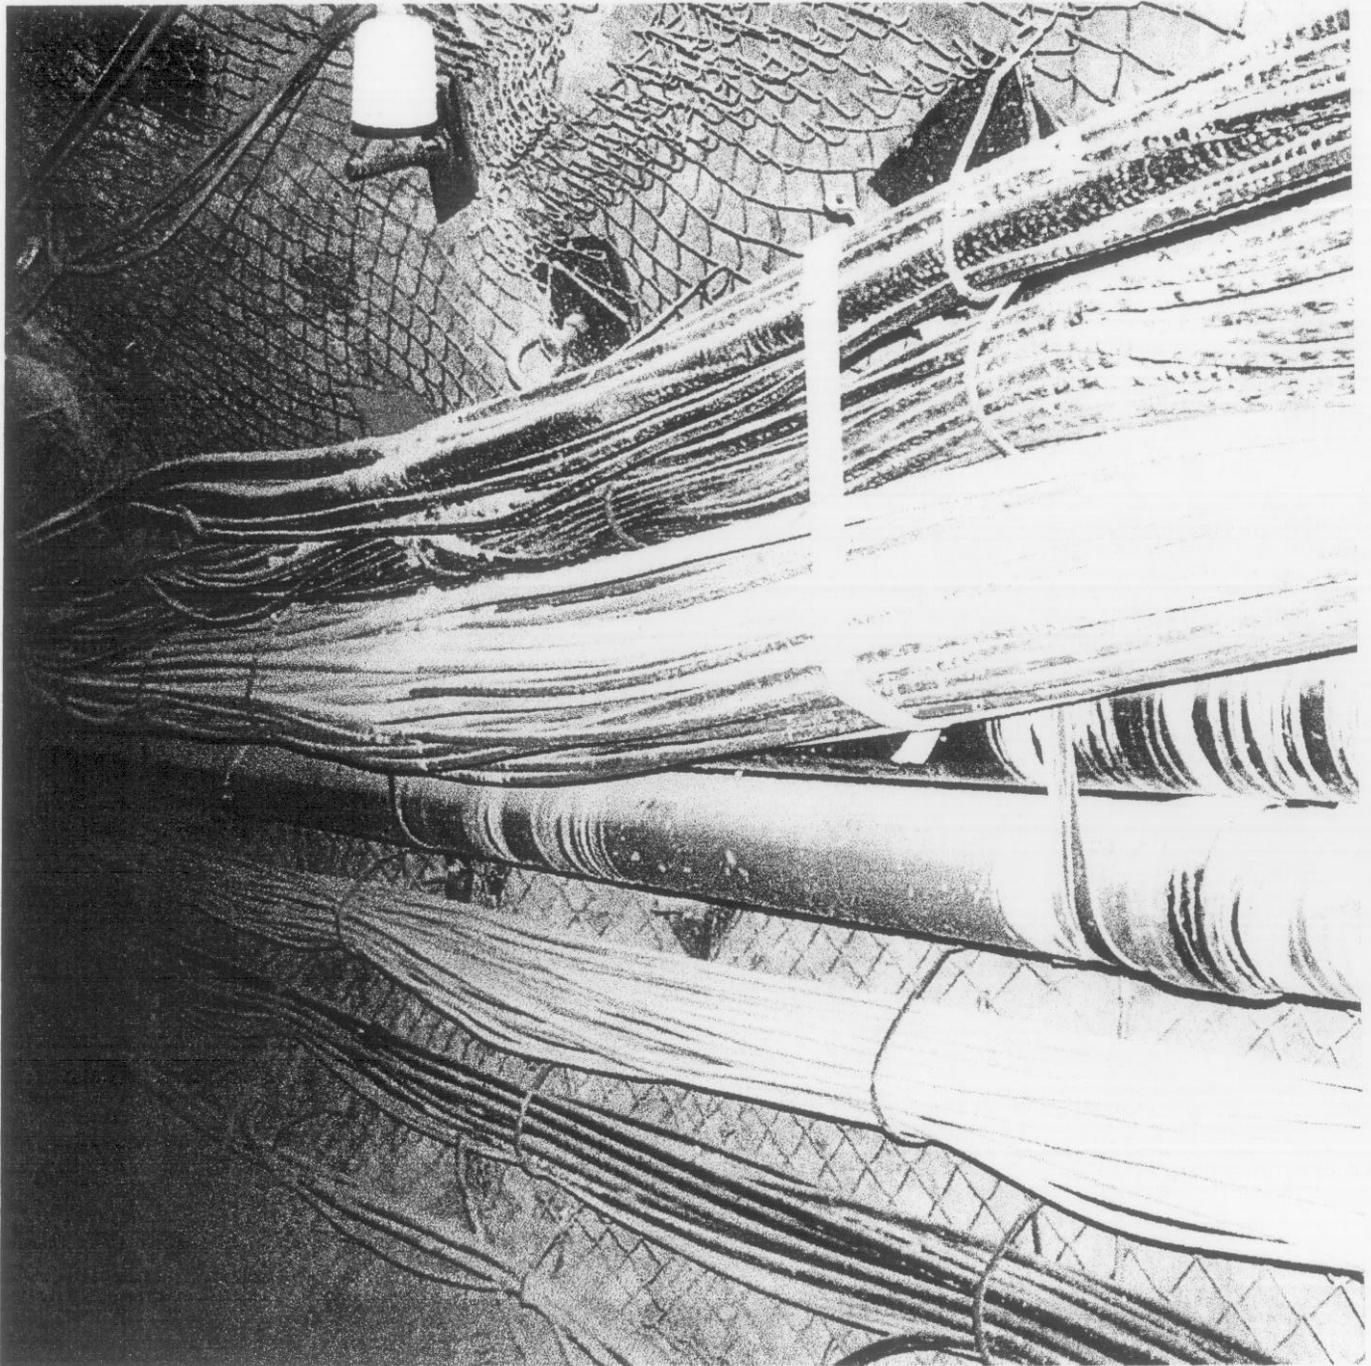
Figure 28: Multiple cable bundles are supported by U-shape hog wire.

Heavy mining and construction were in progress during the walkdown. Several items were identified that proper anchorage was required after the construction was completed. Installation of new conduit for cables was also in progress. Figure 28 was taken along the 02-drift showing programmatic cable bundles along the drift wall. It was understood that many cables held by removable U-shape hog wires along the tunnel walls would be replaced with permanent supports.

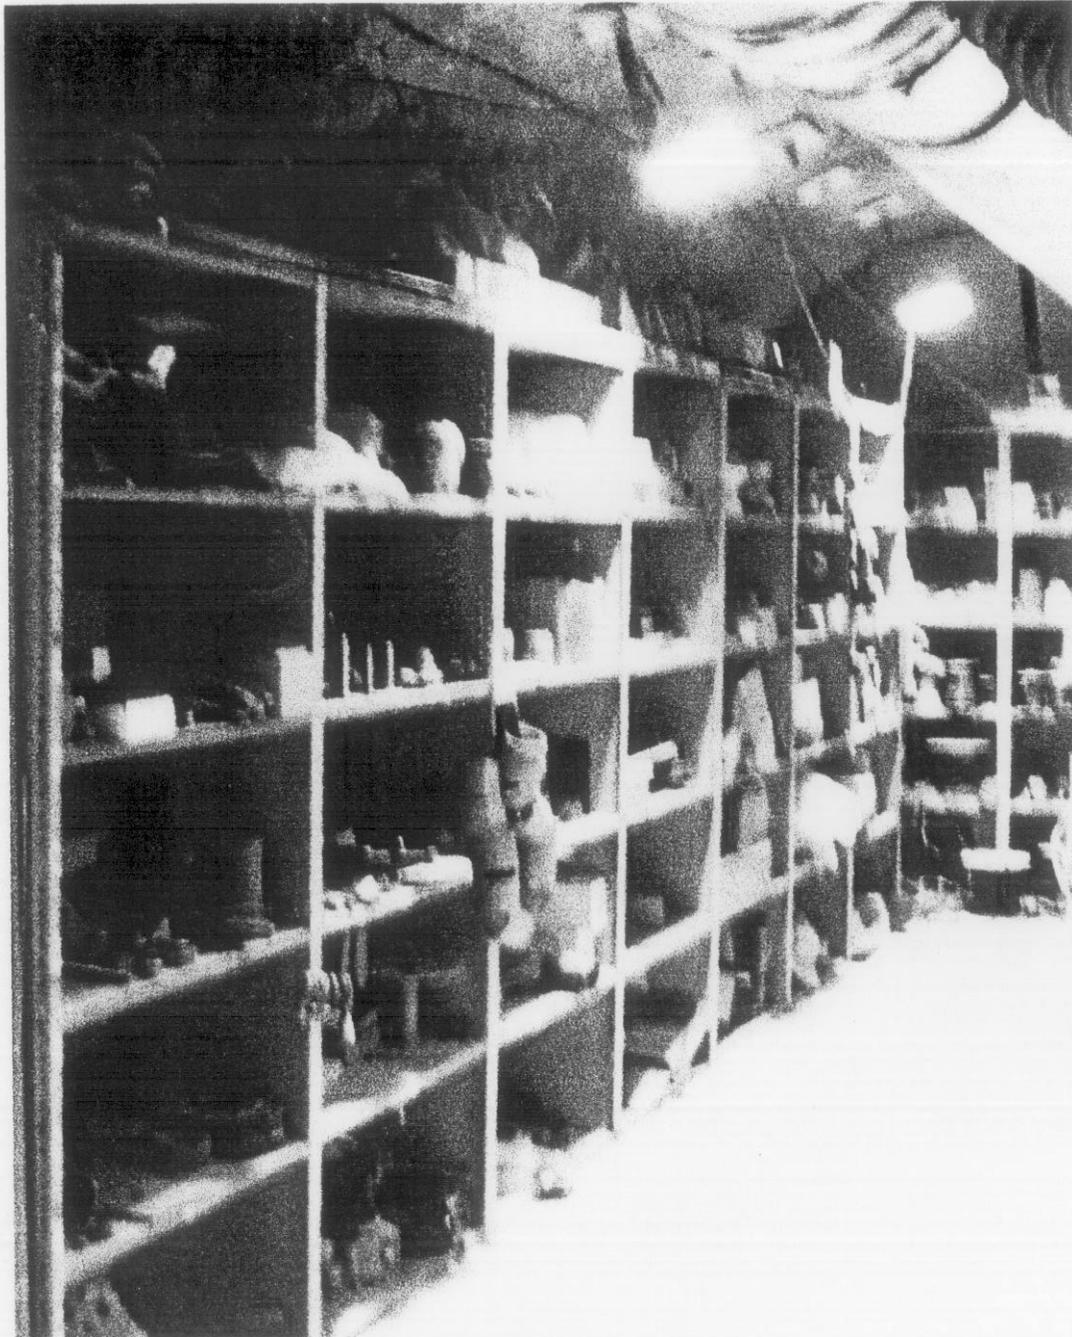
**Figure 29:** Storage racks do not have any safety mechanism to hold the contents in place.
