The Cleaning of Aluminum Frame Assembly Units

T.H. Shen

May 16, 2001

Lawrence
Livermore
National
Laboratory

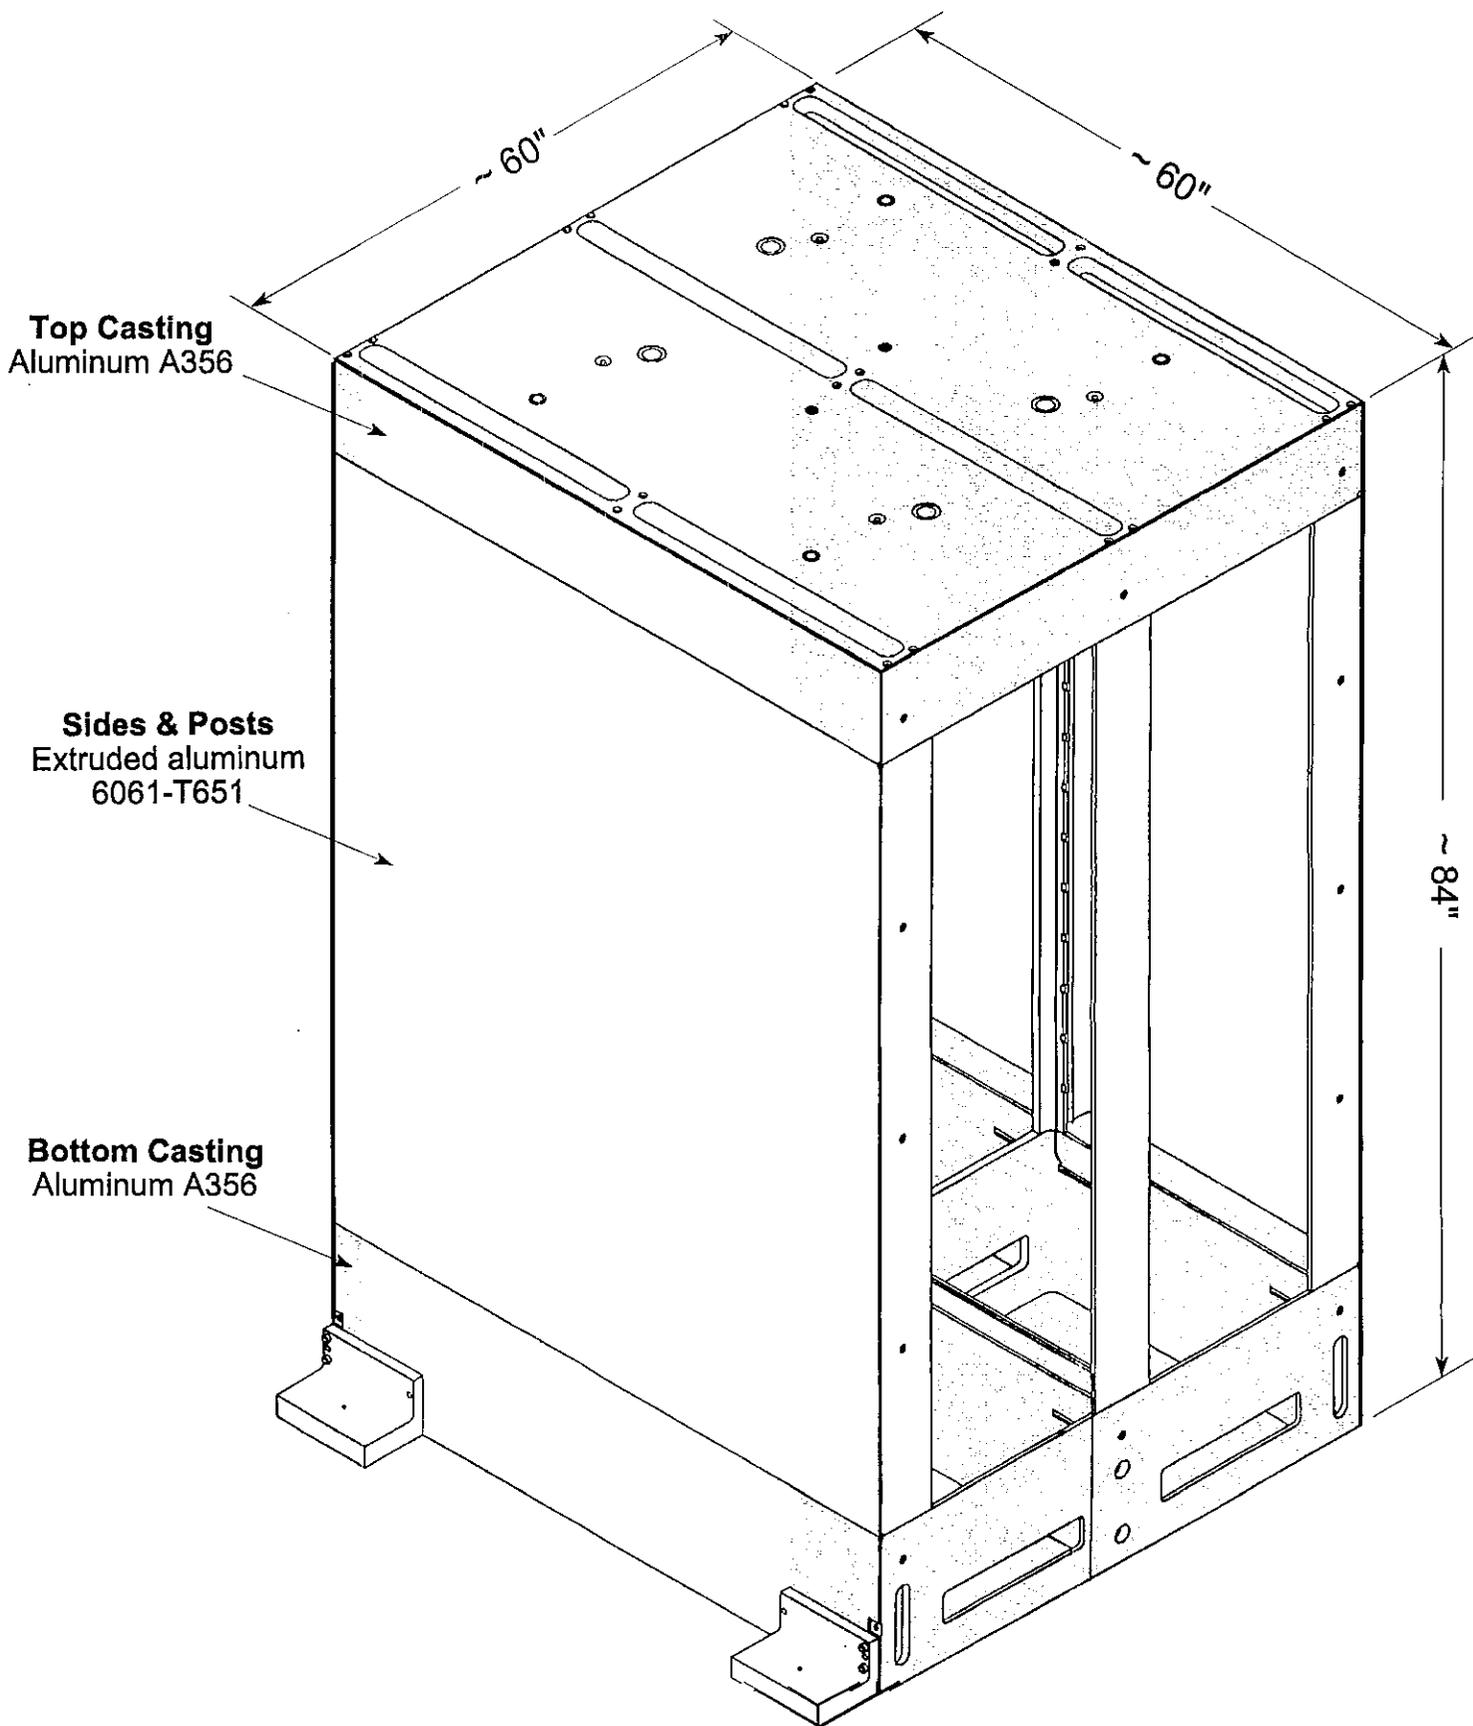
Figure 1 A frame assembly unit (FAU) in the NIF Amplifier Buses.

Nature of the smut Figure 1 shows the configuration of a FAU for the NIF amplifier. The top and bottom are made of cast aluminum alloy A356 and the sides and posts are fabricated from extruded aluminum alloy 6061-T651. Table I lists the nominal compositions of these two aluminum alloys.

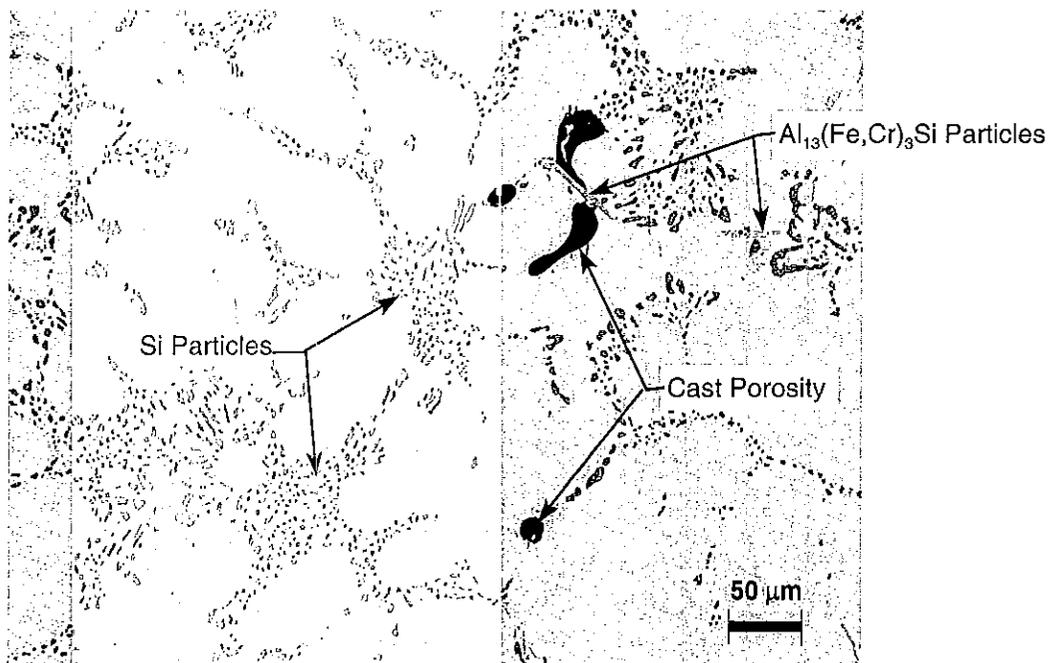
Figure 2 Typical microstructures of aluminum alloys A356 and 6061.

Figure 2 shows the typical microstructures of these two alloys. The $Al_{13}(Fe,Cr)_3Si$ (often referred to as the α -eutectic) are the typical second phase particles in all aluminum alloys formed by impurity elements such as Fe, Mn, Cr, Si, etc. In addition to the α -eutectic particles, the cast A356 alloy also contains a larger amount of pure Si particles and some cast porosity.

All these results are consistent with our understanding of the difference between these two alloys in the second phase particles as shown in Figure 2. Furthermore, these results do not match the signature of the common "dirt", which is heavily composed of calcium-aluminosilicates⁴. Hence we concluded early in the investigation that the "dirt" that might have penetrated the wrappings was not the cause of the problem. Since the majority of the smut came from the aluminum alloy itself and not from the contamination during the transportation and storage of the precision-

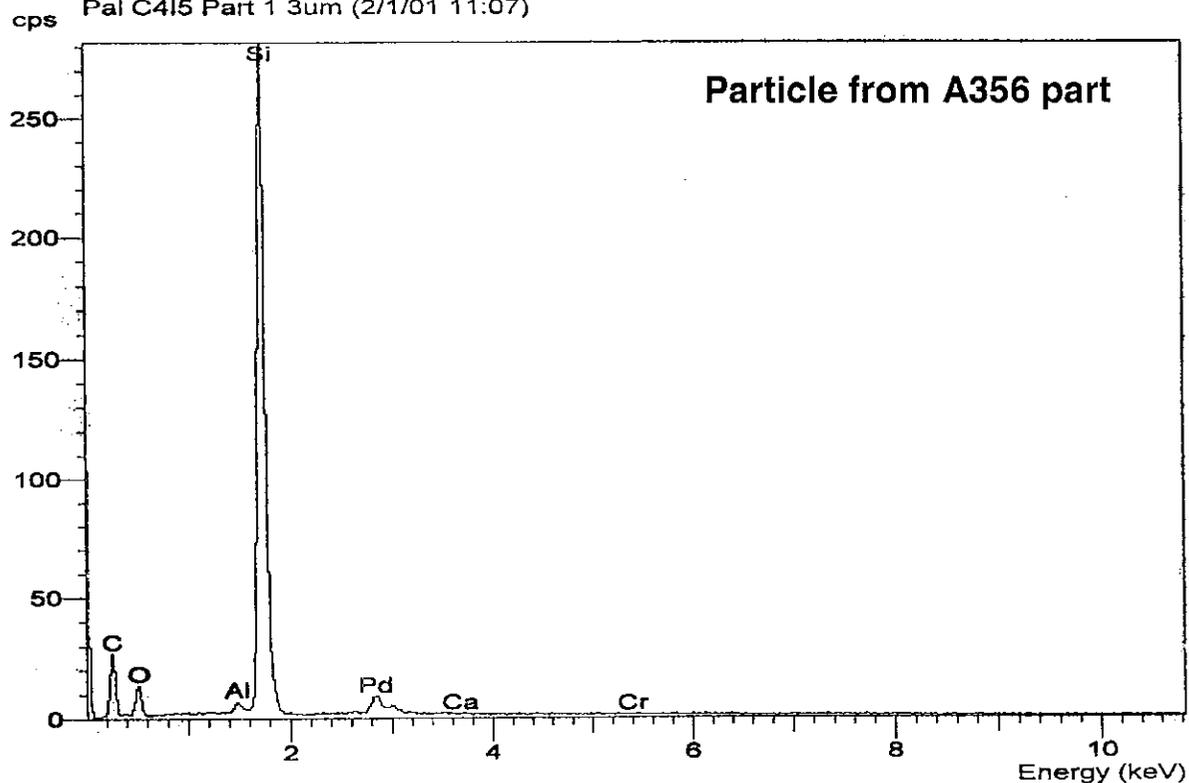
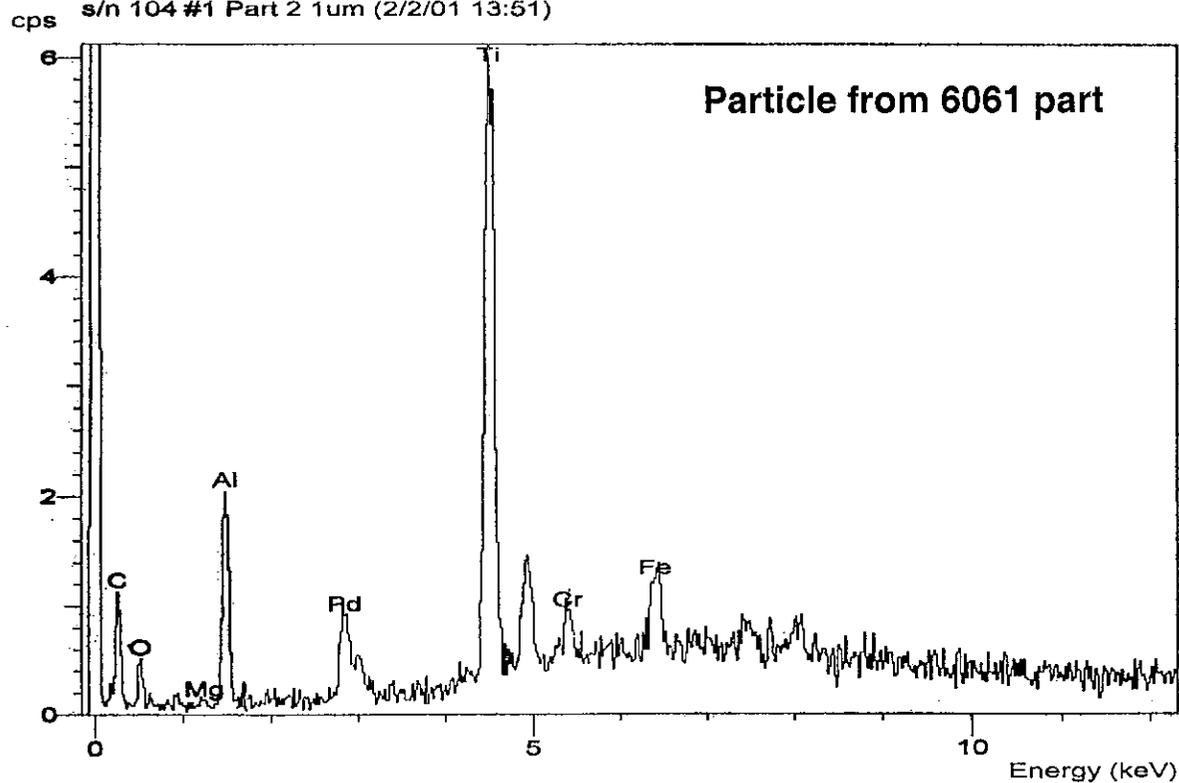
Figure 3 Typical SEM-EDXS of particles in the swipe paper obtained from A356 and 6061 parts.

Figure 3 shows a typical EDXS result of the particles in the swipe obtained from the A356 and 6061 parts. A detailed listing of these results compiled by Phil Miller is provided in the Appendix A-2. A swipe sample to gather a large amount of smut from an A356 part was also analyzed by Cheng Saw using x-ray diffraction(XRD). The results of the SEM/EDXS and XRD analyses are summarized as follows:

- 1) More than half of the particles analyzed in the A356 swipe are Si particles and the rest of the particles contain Ca, O and Cl.
- 2) The XRD result³ confirmed the EDXS/SEM analysis that the Si peaks in the EDXS are indeed caused by the elemental silicon.
- 3) The majority of the particles taken from alloy 6061 swipe contain very little Si, but rather other elements such as Fe, Cr, Ti, Al and Mg.

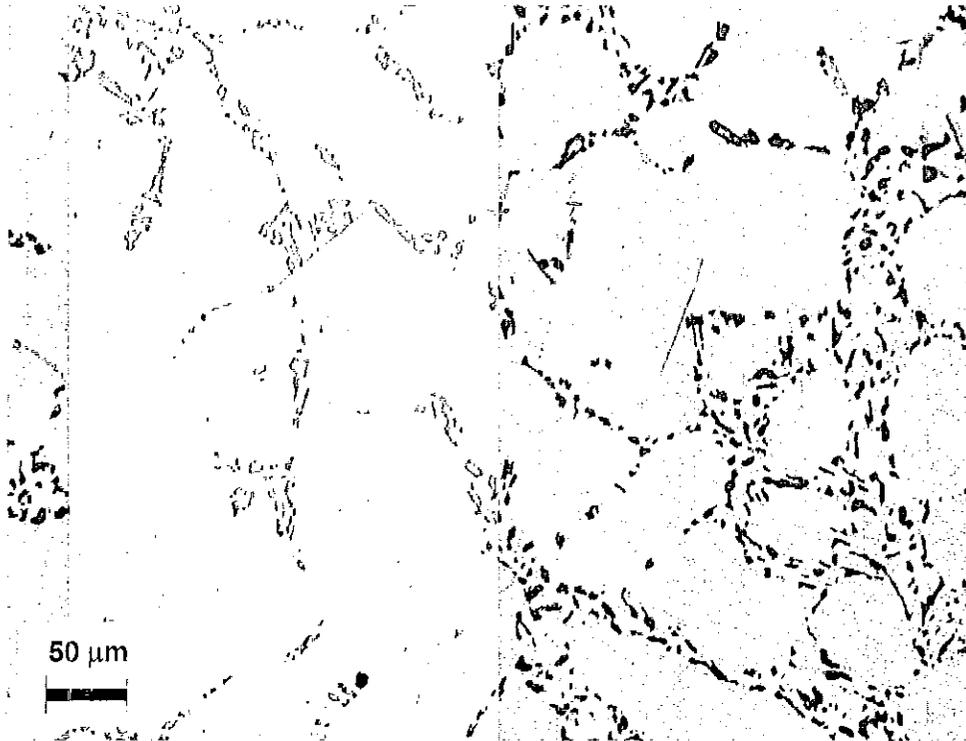
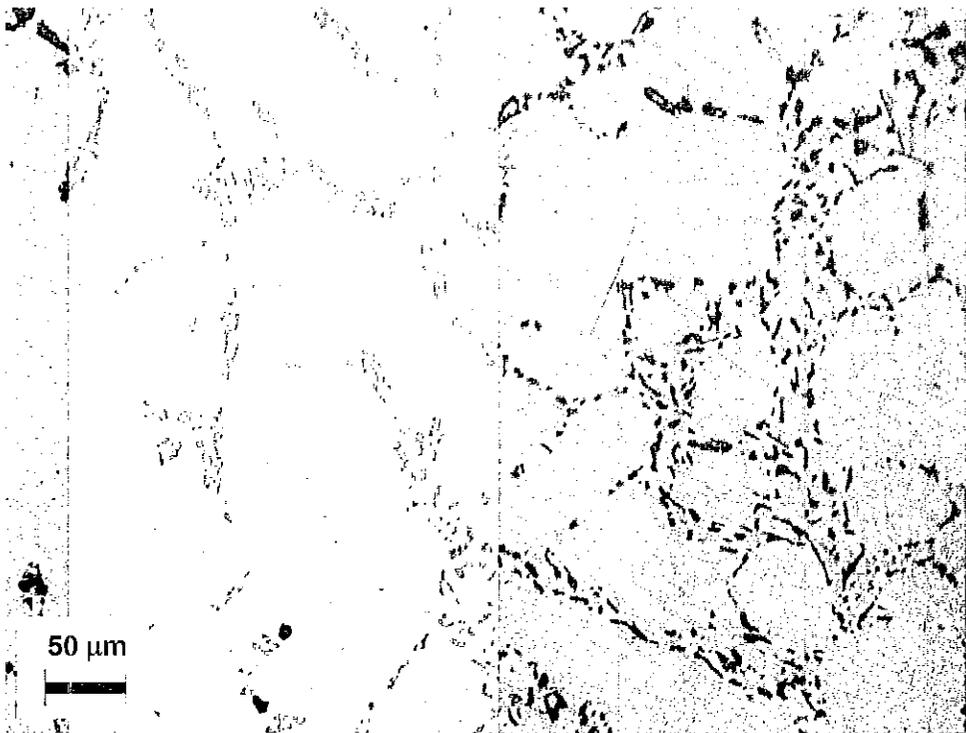
Figure 6 The combination of 3% Brulin at 130°F and the 2,500 psi high pressure spray in the precision cleaning procedure does not etch or attack the surface of an A356 alloy.

These results suggested that the precision cleaning removed the surface contaminants quite effectively. **Figure 6** shows a mirror-polished A356 sample that was precision-cleaned with 3% Brulin. Precision cleaning didn't show any signs of etching on the sample surface. However, the precision cleaning could create extra deposits if the cleaning/rinse steps were not applied properly. **Figure 7** shows the extra deposits on a precision cleaned surface on a mirror-polished A356 sample. These surface deposits were analyzed by EDXS in SEM. **Figure 8** shows that these deposits, **Particles A, B and F**, contain O, Na, P, S and K. Although the formulation of the Brulin is not available, these deposits are likely to be the residual Brulin detergent. In discussing this result with AstroPak, their experience showed that if the Brulin solution was left dried before the DI water rinse, the Brulin would stay on the surface and could not be easily removed by the subsequent Brulin spray/DI water rinse process.

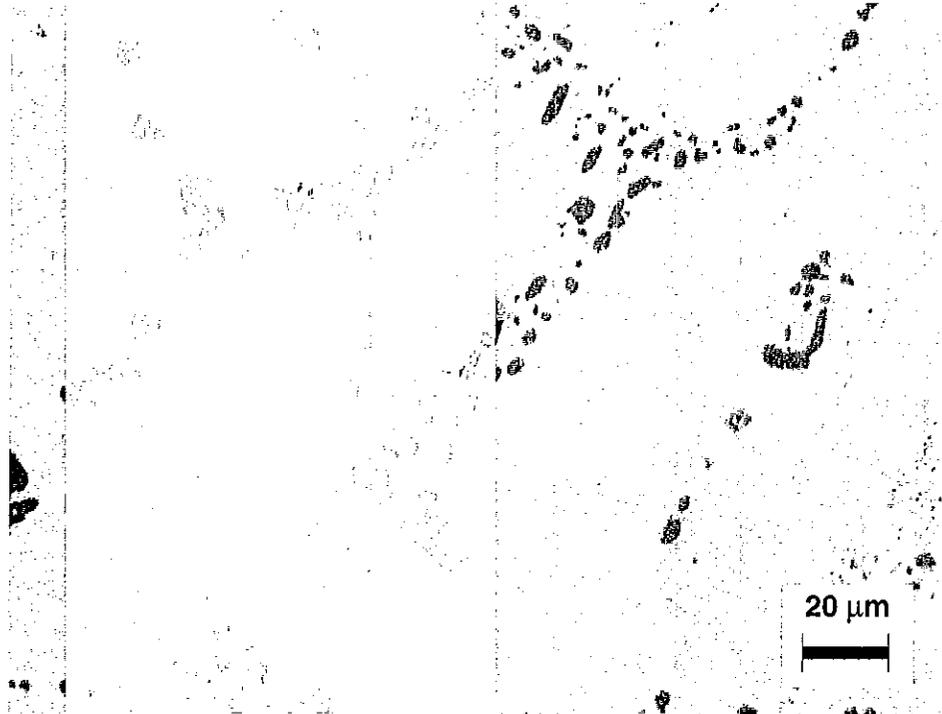
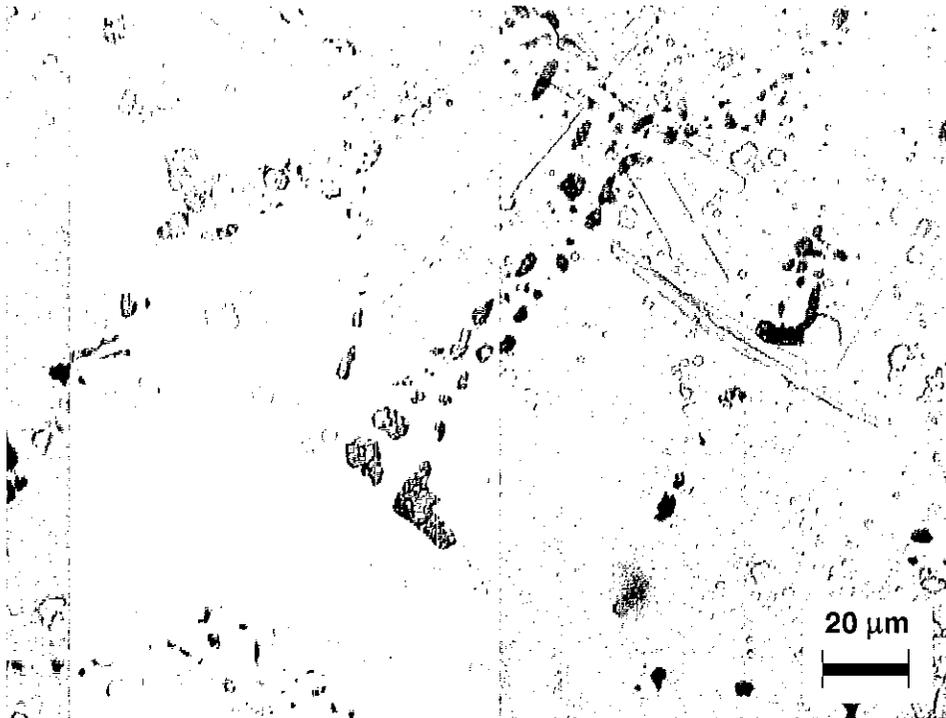
Figure 7 Extra deposits can be created by the precision cleaning process if the Bruin clean/rinse steps are not applied properly.

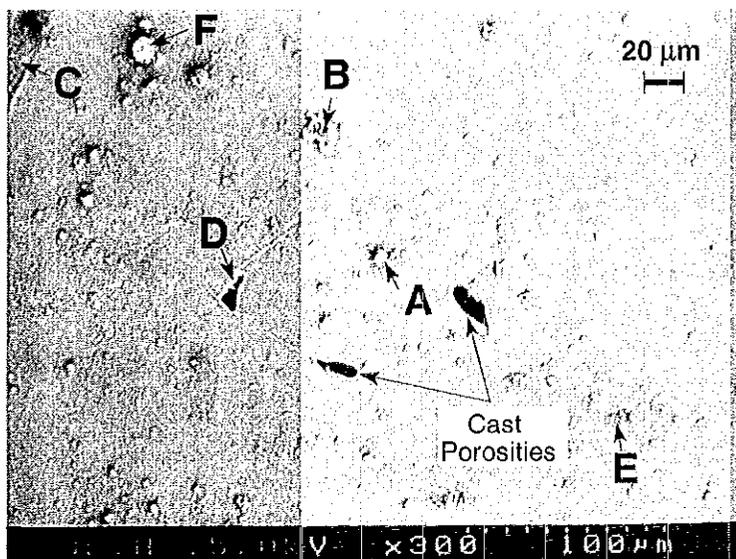
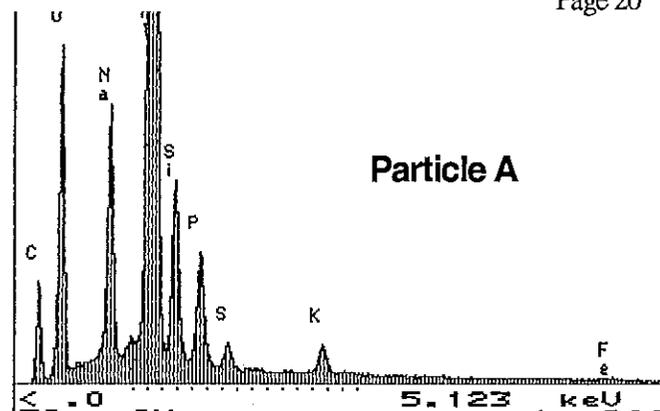
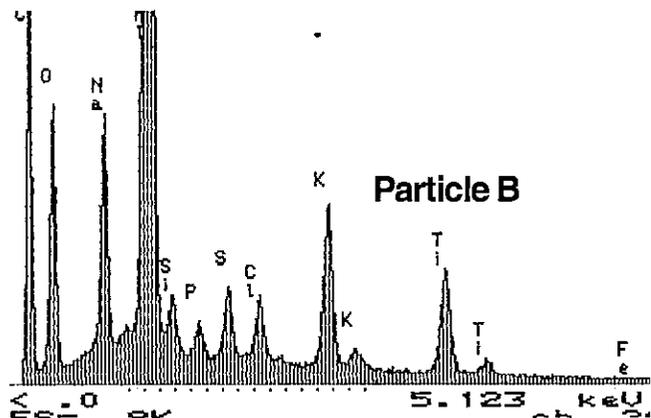
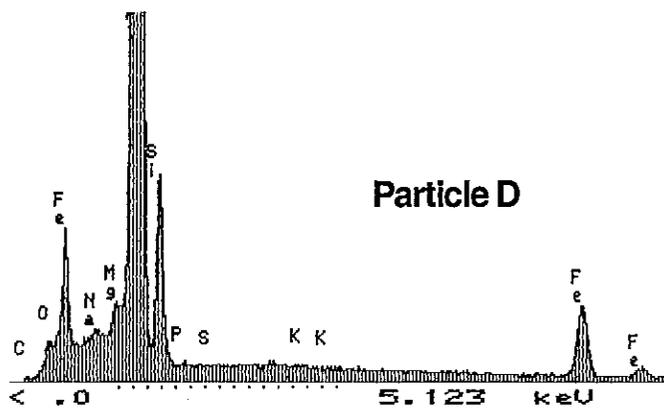
Figure 8 SEM/EDXS analyses of the debris left on the surface after the precision cleaning.

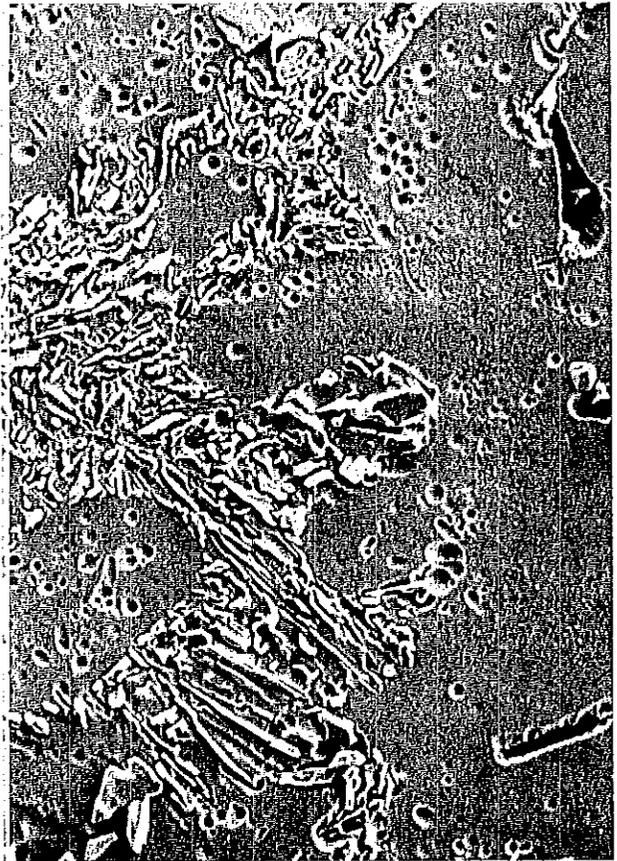
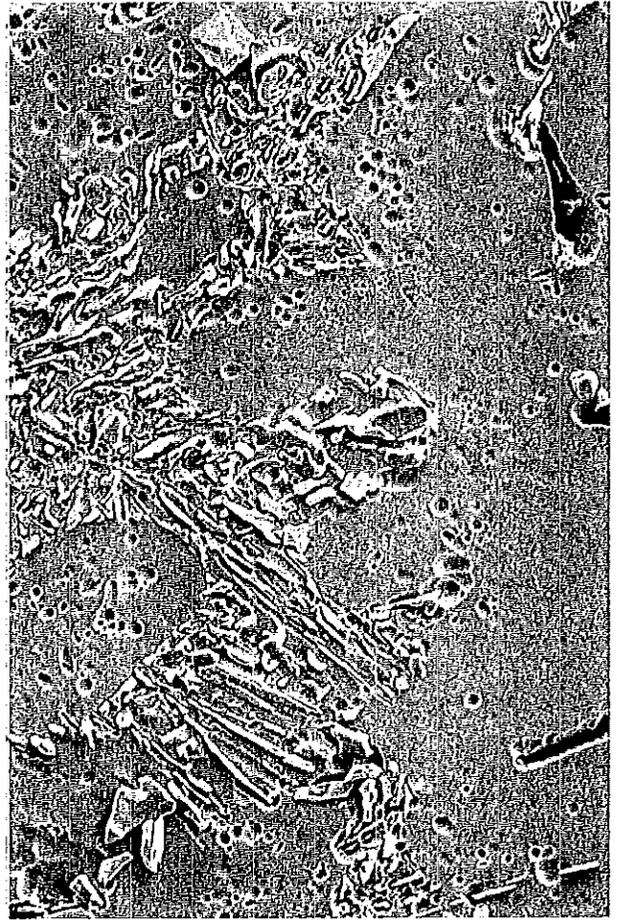
Figure 9 Effects of various cleaning steps on the morphology of a mirror-polished surface of a cast aluminum alloy A356.

Acid-bath Cleaning **Figure 9** shows the effects of **Acid A** and precision cleaning on a mirror-polished surface of an A356 alloy. The **Acid A** substantially etched the aluminum matrix and the α -eutectic particles, and left the Si particles protruding out of the surface. This can be seen by comparing **Figures 9a to 9b**. The depth of the etching was estimated optically to be around 13 μm . By carefully comparing the same Si particles before and after the acid cleaning, no evidence suggests that the Si particles were attacked by the **Acid A**. The precision cleaning after the acid-bath cleaning removed some of the protruding Si particles as shown in **Figures 9c**. The filter paper swipe did not noticeably change the morphology of Si particles as shown in **Figure 9d**.

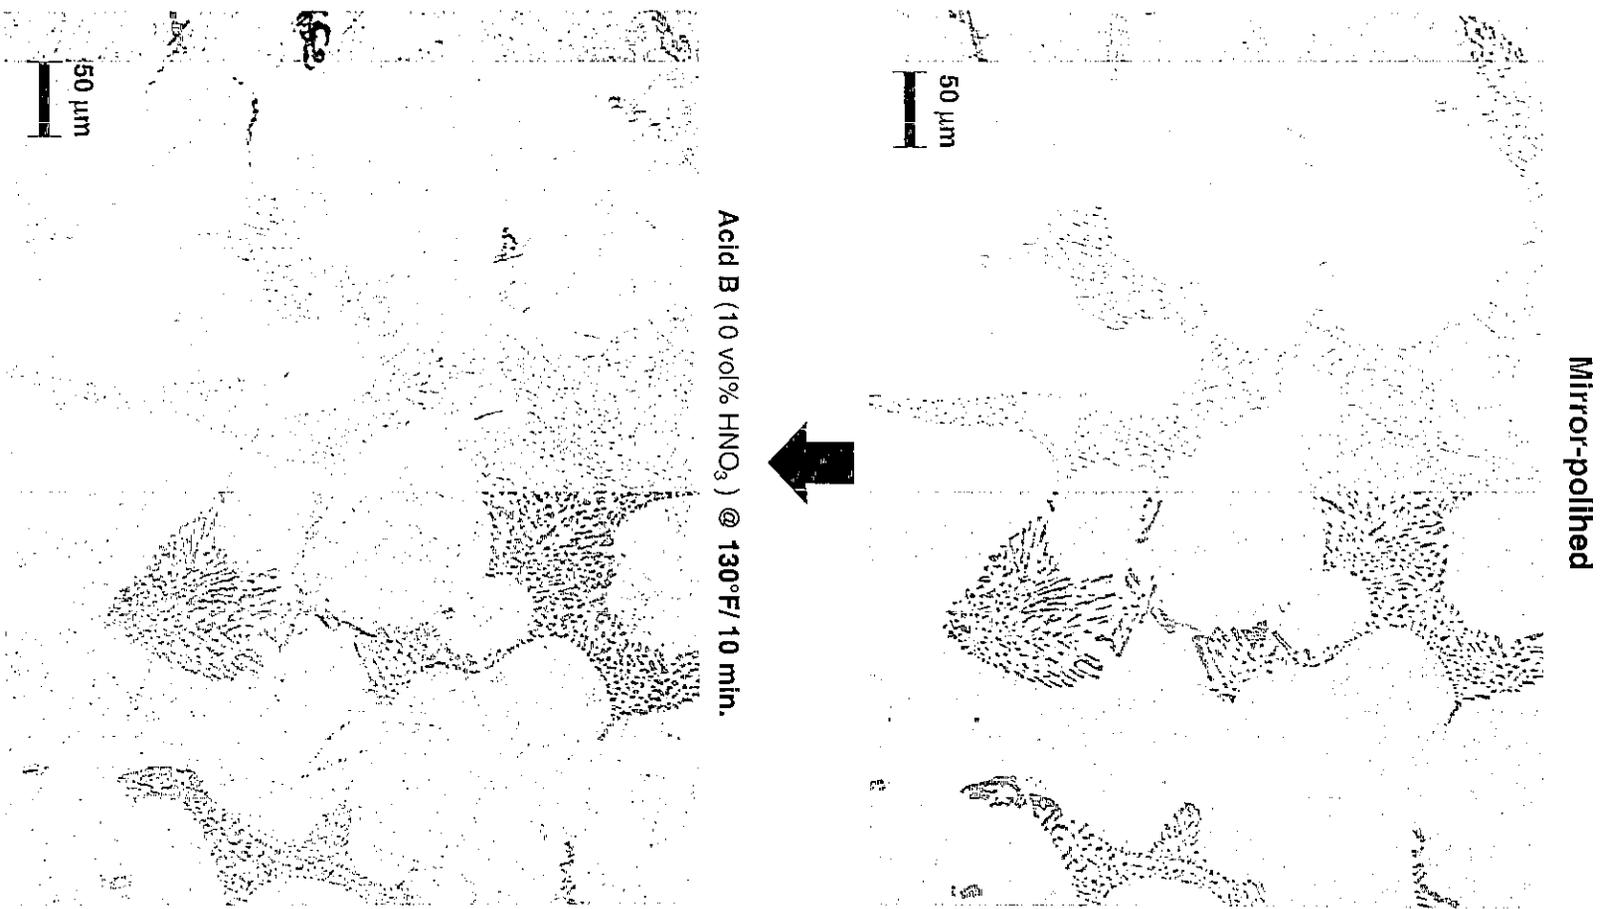
Figure 10 The Acid B showed only a mirror etching of a mirror-polished surface of an A356 alloy.

The **Acid B**, on the other hand, showed only a minor etching of the aluminum surface as shown in **Figure 10**. However, the **Acid B** did aggressively attack the α -eutectic particles as shown in **Figure 11**.

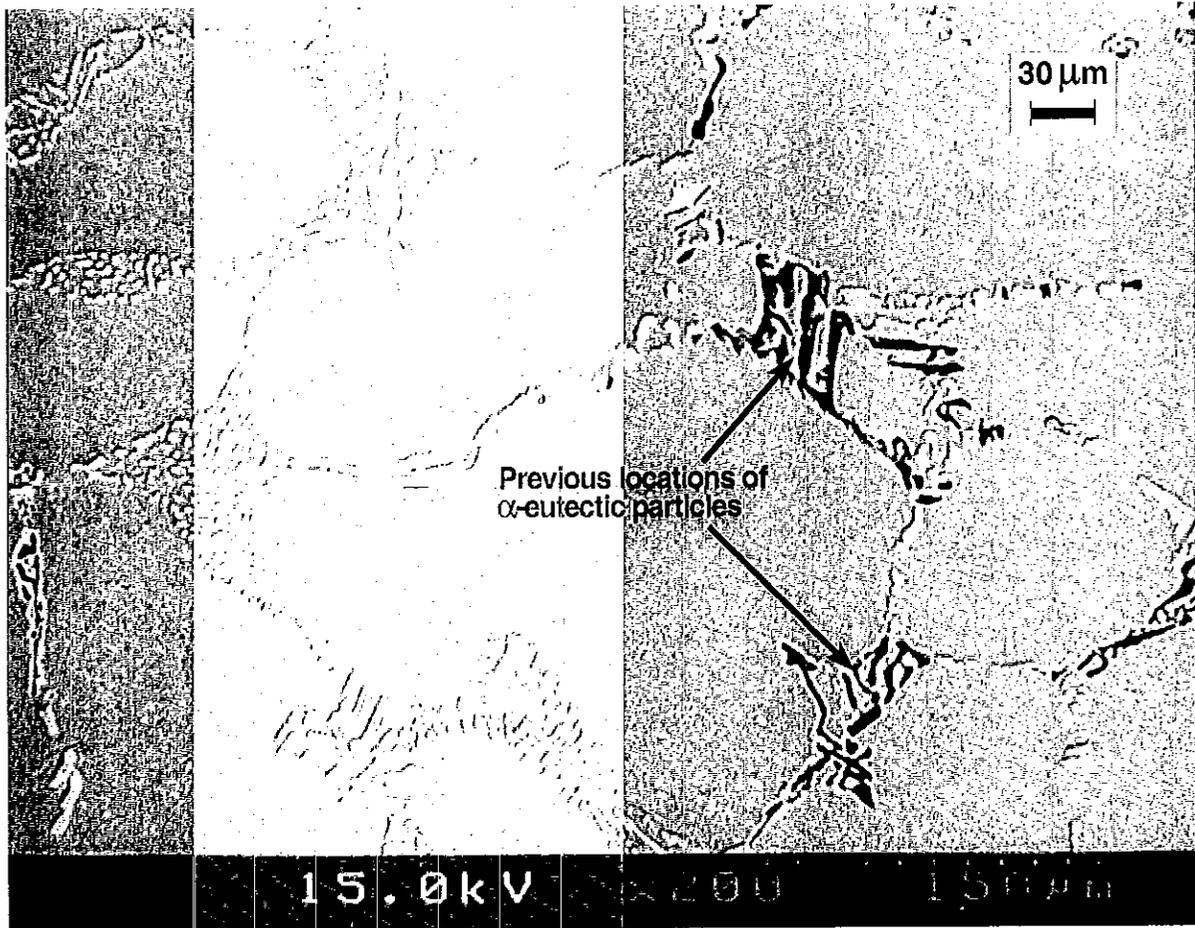
Figure 11 The Acid B etched the α -eutectic particles and left behind deep pits.

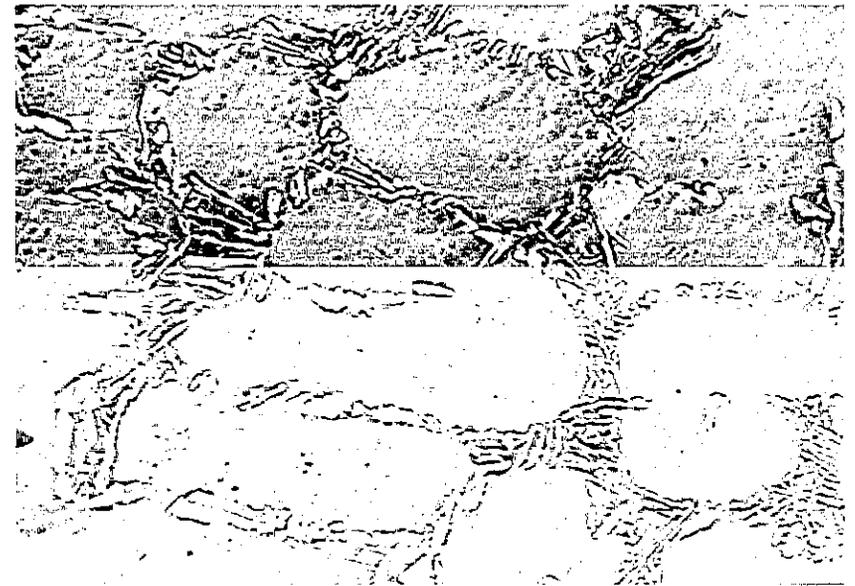
Figure 12 Effects of various cleaning steps on the morphology of an as-machined surface of a cast aluminum alloy A356.

Figure 12 shows the effects of **Acid A** and precision cleaning on an as-machined surface of an A356 alloy. These surfaces are more representative of the surfaces of the FAU parts after the acid-bath cleaning in GTC. The **Acid A** aggressively attacked the as-machined surfaces and left the morphology with no resemblance of the original surface as shown in **Figures 12a and 12b**. The precision cleaning seems to remove more Si particles compared to that of the mirror-polished sample. This was likely caused by the cracking of the Si particles during the machining of the A356 sample as shown in **Figure 13**. Again, **Figure 14** shows that the **Acid B** only slightly etched the as-machined surface of an A356 sample.

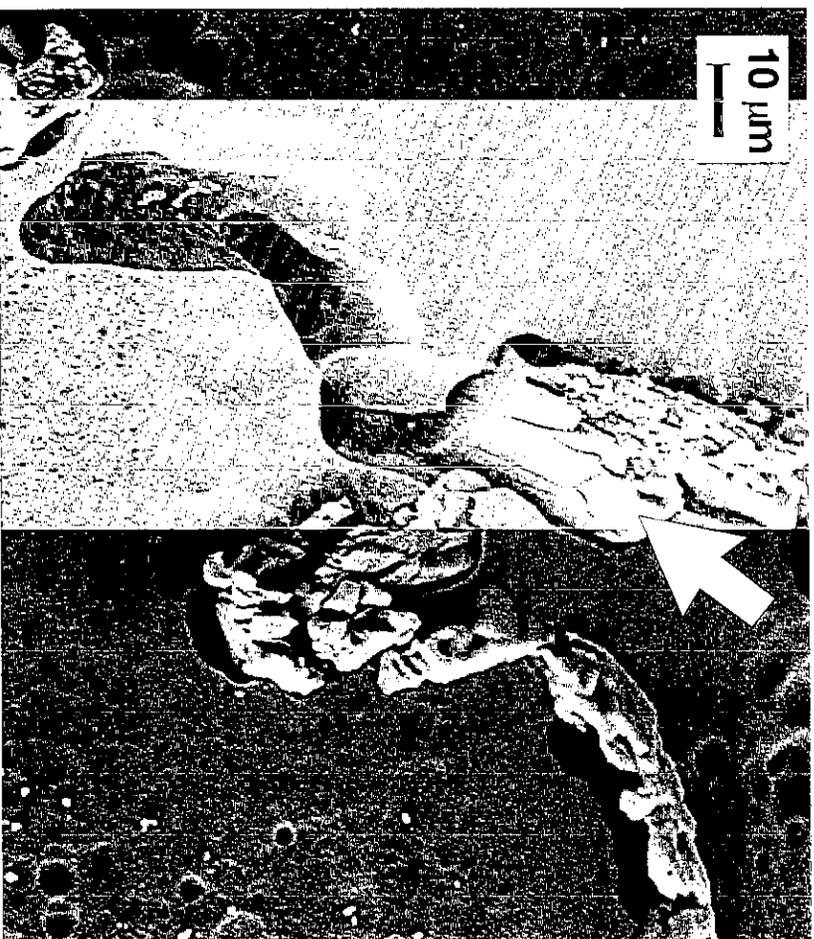
Figure 13 After the **Acid A** cleaning of an as-machined surface, the Si particle protruding out of the surface showed sign of cracking.

an A356 alloy, the surfaces were left behind with many protruded Si particles. These Si particles were very brittle and many of them have already shown signs of cracking as shown in **Figure 13**. It would be very easy to dislodge and/or break off these particles during the precision cleaning in AstroPak or during the filter swipe. This explains why the **Acid A** cleaned aluminum parts have very high swipe readings before the precision cleaning.

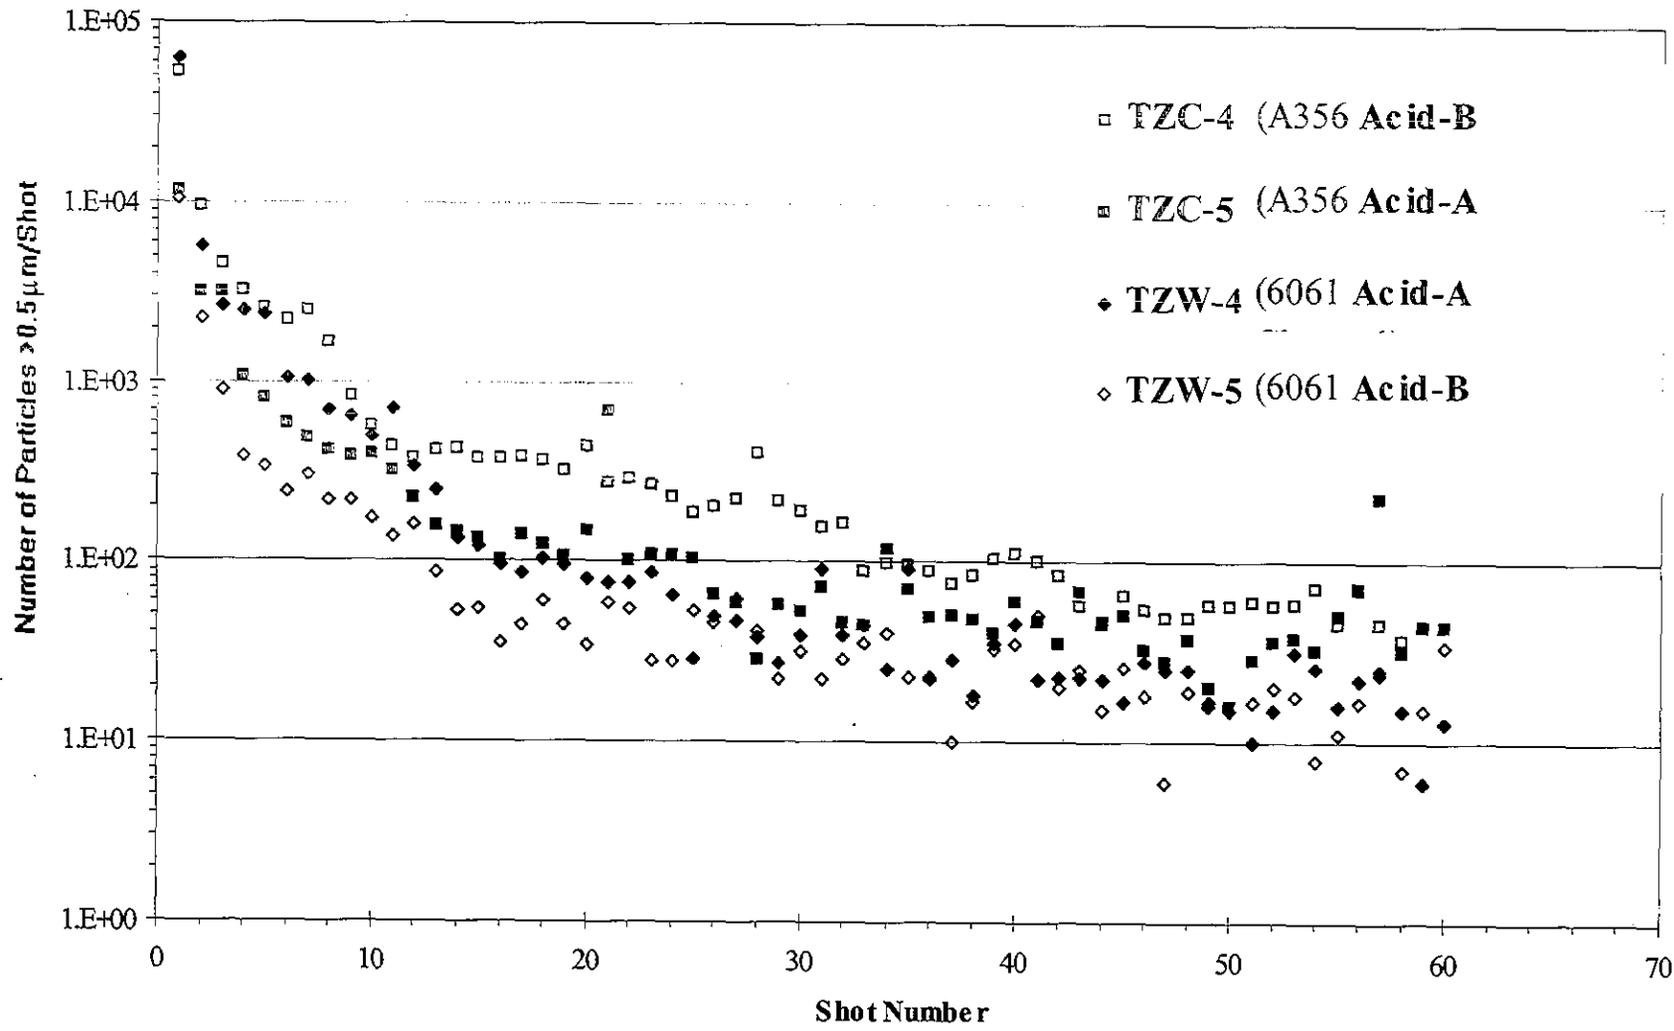
Figure 15 The results of aerosol testing of Acid-A and Acid-B cleaned A356 and 6061 alloys.

Figure 15 shows the results of the aerosol testing. All four panels passed the specification of less than 100 particles($>0.5 \mu\text{m}$)/ft³ after 60 flash lamp shots. The A356 generated a higher level of aerosol compared to that of the 6061 alloy. After 55 shots, there was no significant difference in the aerosol level between the **Acid A** versus the **Acid B** cleaned panels. Although prior to that, it appears that the **Acid A** cleaned parts have a somewhat lower rate of aerosol formation.

Previous NIF experiences¹³ suggest that the addition of dichromate may reduce the aerosol level during the frame testing. The current aerosol testing result, as shown in **Figure 15**, suggests that the acid without the addition of dichromate and HF can also achieve an acceptable aerosol level. However, the current GTC acid formulation has performed quite well from the aerosol point of view. The cost associated with the GTC acid formulation is relatively small compared to the potential negative effects of changing the acid bath to straight 10 vol% HNO₃. Thus, there is no pressing need to change the acid formulation in GTC as long as we can ensure a thorough precision cleaning in AstroPak using the **Revision D** procedure.

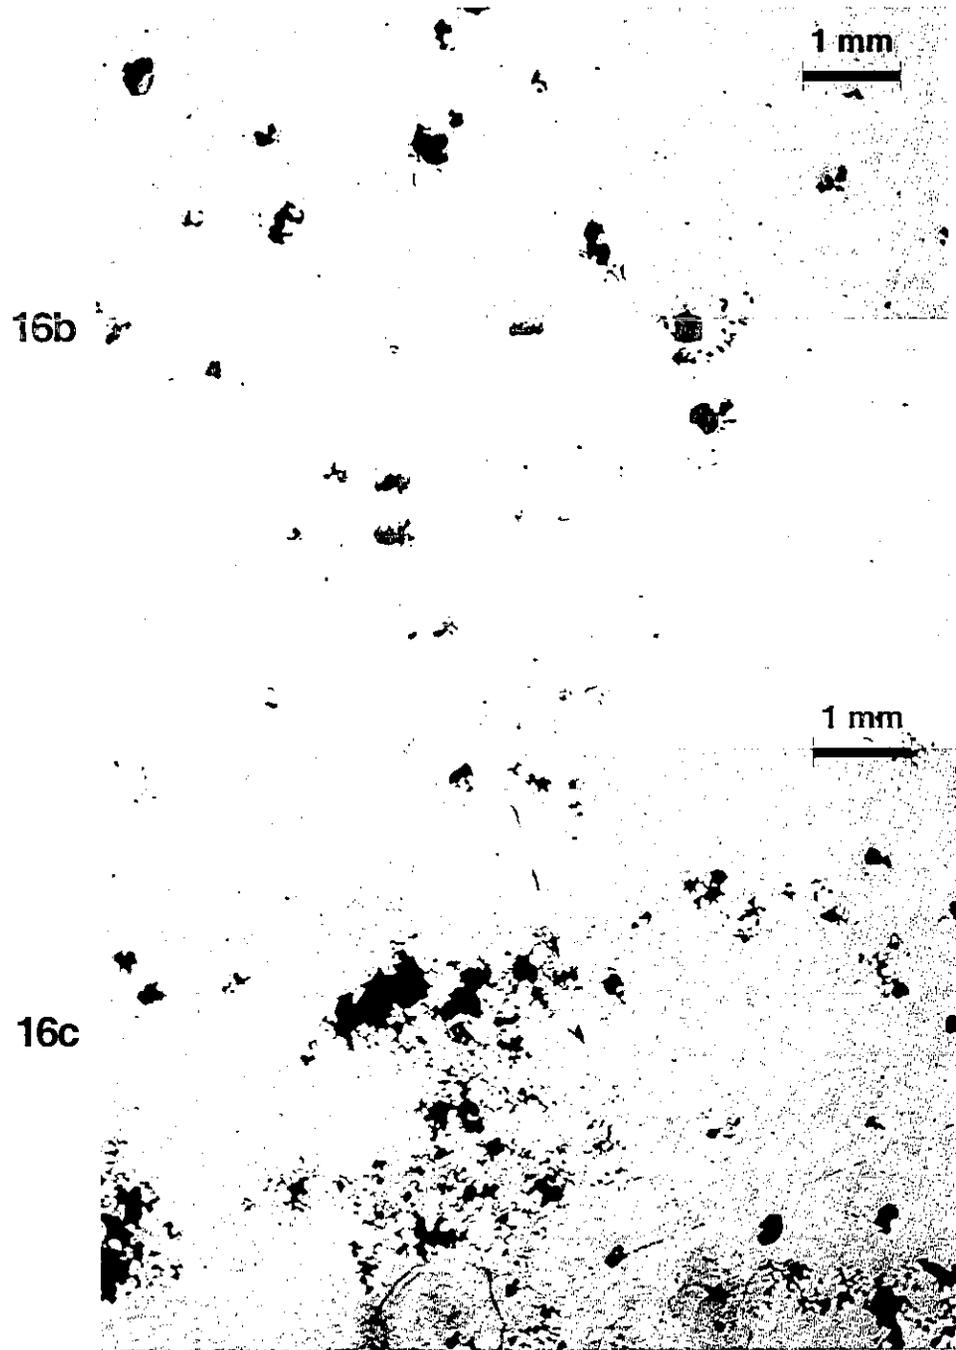
Area Density of Porosity
= 186 per in²

Figure 16 Typical distribution of porosity in cast aluminum alloy A356 of a FAU part.

During the course of the investigation, six A356 2½" × 2½" coupons were mirror-polished in preparation for an experiment. **Figure 16** shows that the cast aluminum alloy A356 has extensive cast porosity in the microstructure. These cast porosities could not be seen easily in the as-machined condition but readily revealed in the mirror-polished condition as shown in **Figure 16**. The amount of porosity varies and depends upon the location in the plate. Based on measurement from a 25 in² area, the area density of the porosity is 185 ±15 per in² with an area ratio of 1.7%. The size of these porosities can be as large as 1 mm as shown in **Figures 16b** and **16c**. Some of these porosities are interconnected underneath the surface and extend all the way through the thickness of the sample (~ ¼").

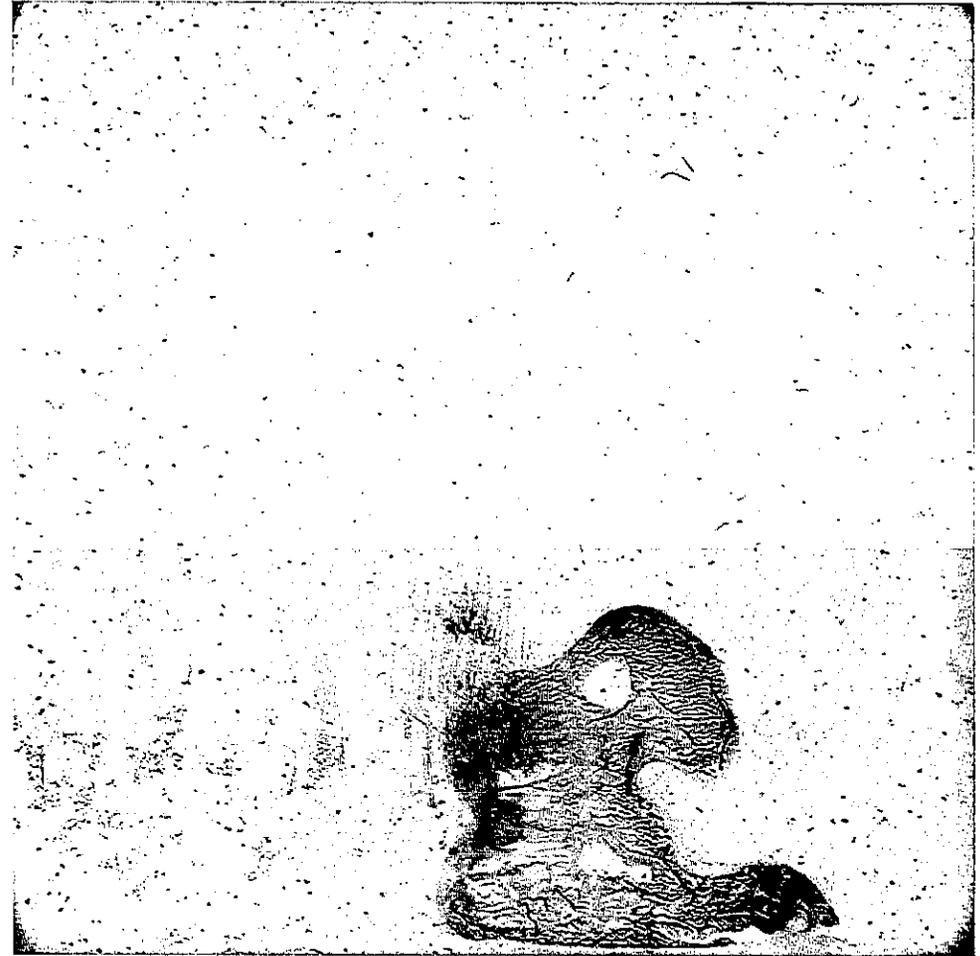
Figure 17 The porosities in the sample trapped water which later leached out to the surface during a 24-hour drying period. The staining of the surface is quite evident from the two samples above.

After leaving these six mirror-polished coupons at room temperature for 24 hours, two out of the six coupons developed brownish stains as shown in **Figure 17**. The locations of these stains were associated with the areas where large (>1 mm) and deep porosities are located. The back-side (as-machined surface) of these two 2½" × 2½" coupons also contained many large and deep porosities. Again, stains also developed on the back-side but were less noticeable due to the rough machined surfaces. **Figure 18** shows the EDXS analysis of the stain around a cast porosity. The result suggested that aluminum hydroxides may have formed in **Areas 2** and **3** as water was seeping out from the porosity during the air-drying period.

This scenario might have occurred in the FAUs if the units were not properly rinsed and dried after the various cleaning processes. The stains might develop in the area of the part surface containing large cast porosity. To minimize the stain caused by the cast porosity, a cleaned surface should be dried with blowing hot air (< 160°F) to drive out all the moisture trapped inside the porosity.

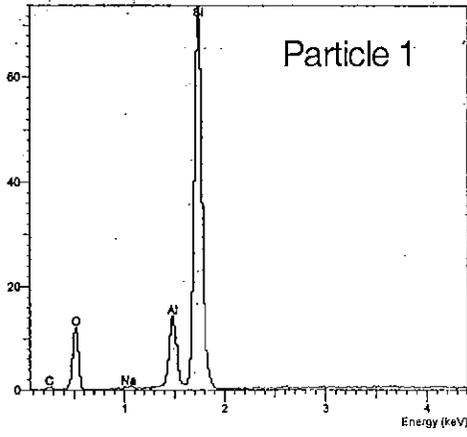
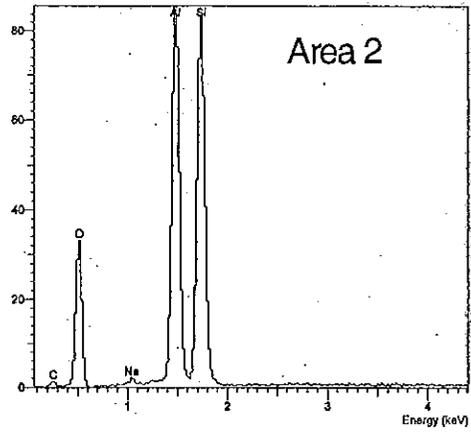
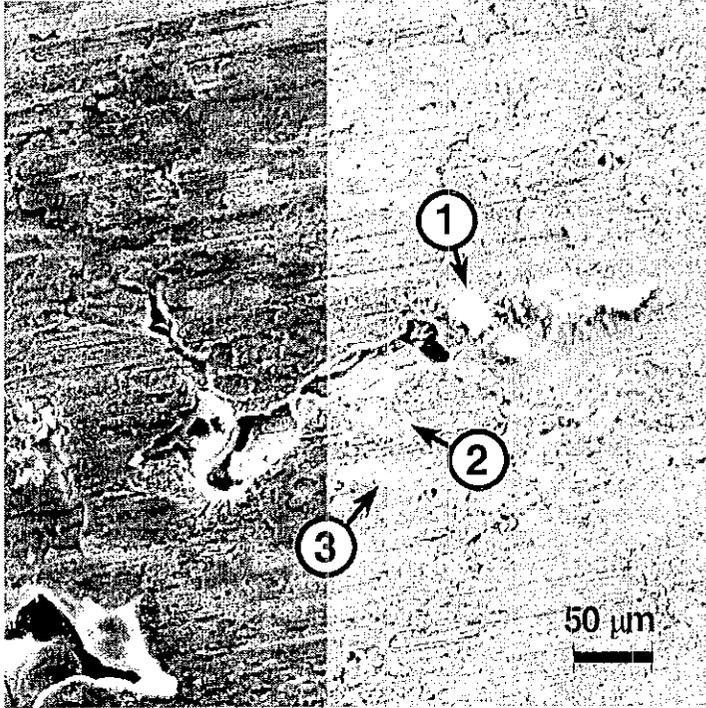
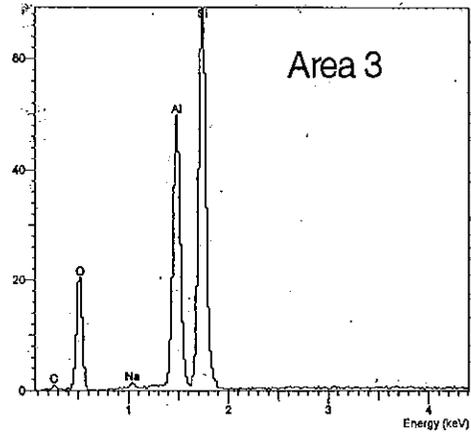
Figure 18 Areas around a cast porosity of an alloy A356 showing the formation of aluminum hydroxide.

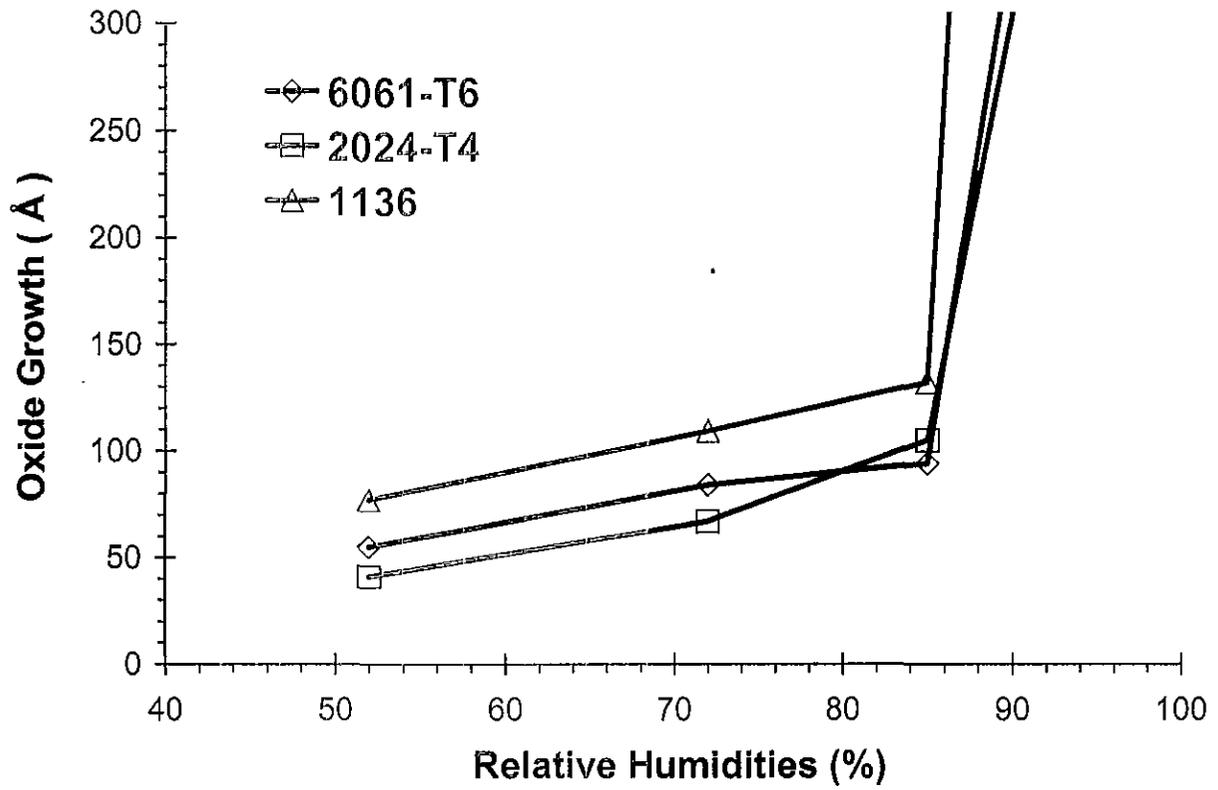
Figure 19 Oxide growth rate of aluminum alloys exposed in air for five years.

The clean room experiment has ruled out the dust contamination as the cause. The very slow oxide growth rate² as shown in **Figure 19**, at relative humidity less than 85%, eliminated the oxide growth as a possibility. Thus far, the reduction in electrostatic forces has yet to be proven.
