# Guided Wave Acoustic Monitoring of Corrosion in Recovery Boiler Tubing

*D.J. Chinn, M.J. Quarry*

This article was submitted to  
TAPPI Spring Technical Conference, Atlanta, GA, May 3-5, 2004

**February 19, 2004**

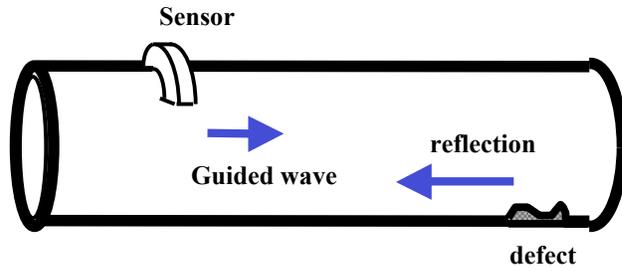
Figure 1. Guided wave testing on tubes uses a sensor to detect defects anywhere on the tube. Acoustic energy spreads from the probe to fill the entire cross-section and reflect from defects on the coldside or fireside.

Guided acoustic waves are launched from a single position and propagate along the axis of the tube for long distances. Waves are reflected where damage, such as cracks or corrosion, occur. Guided waves fill the entire cross-section of the tube with acoustic energy, so flaws located on the coldside, fireside, inner diameter or outer diameter can be detected. Figure 1 shows the concept of guided wave testing to detect defects on boiler tubing. Many guided acoustic wave modes may propagate in a tube. Each mode has unique characteristics for wave speed, distribution of energy across the thickness, and sensitivity to loading conditions. A successful technique requires that the proper modes be selectively excited. In practice, a single mode must be excited because multiple modes result in several echoes arriving at different times from the same flaw thereby causing difficulty in interpreting data. For boiler tubes, the mode must propagate with minimal sensitivity to water loading conditions and maximum sensitivity to flaws. To selectively excite modes, sensors are designed to propagate waves at the appropriate frequencies and with proper phase characteristics to control the mode generated in the tube.

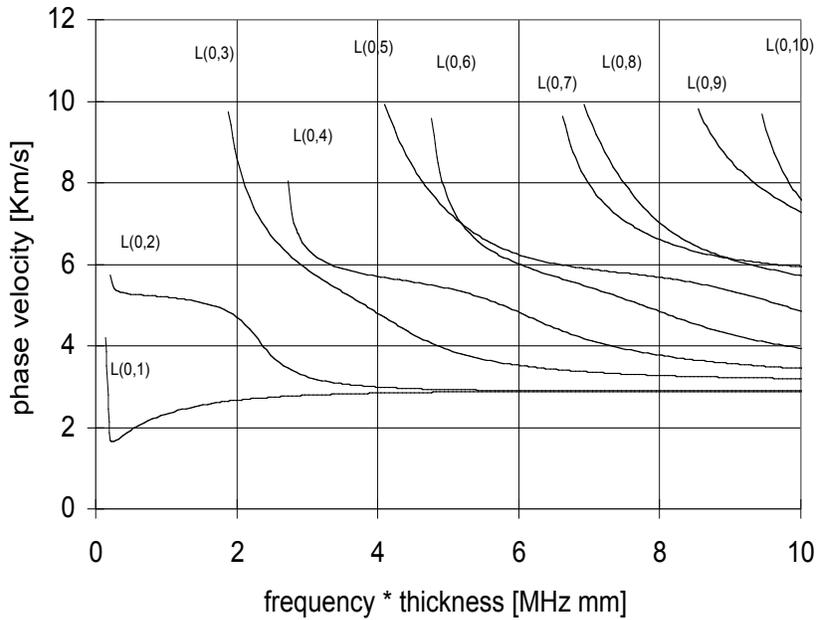
Figure 2A. The first 10 axisymmetric guided wave modes for a 3” O.D. carbon steel tube with a thickness of 0.210” are described by phase velocity dispersion curves. Phase velocity is important for sensor design.

Numerous guided acoustic wave modes can be excited in the tube. All possible modes of propagation are represented in phase and group velocity dispersion curves. For a tube, the curves are calculated by solving eigenvalues of the wave equation with boundary conditions of free surfaces on the outer and inner diameter of the tubes. The dispersion curves of the first 10 axisymmetric modes of propagation for a 3" outer diameter carbon steel tube with a thickness of 0.210" are shown in Figure 2. Phase velocity (Figure 2A), is the speed of the phase of the guided wave. Group velocity (Figure 2B), different from the phase velocity in a guided wave, describes the speed at which the guided wave "packet" propagates. Phase velocity is important in the design of a guided wave sensor while group velocity is used to identify and locate a defect.

where  $\theta$  is the incident angle from the wedge and  $V_{pl}$  is the longitudinal wave speed in the Lucite wedge. The range of excitation of the wedge is a constant phase velocity at any frequency. For example the wedge in Figure 3 excites all modes in Figure 2A where  $V_{ph} = 3.1$  km/s. The wedge determines the phase velocity (vertical axis) of the excited modes.

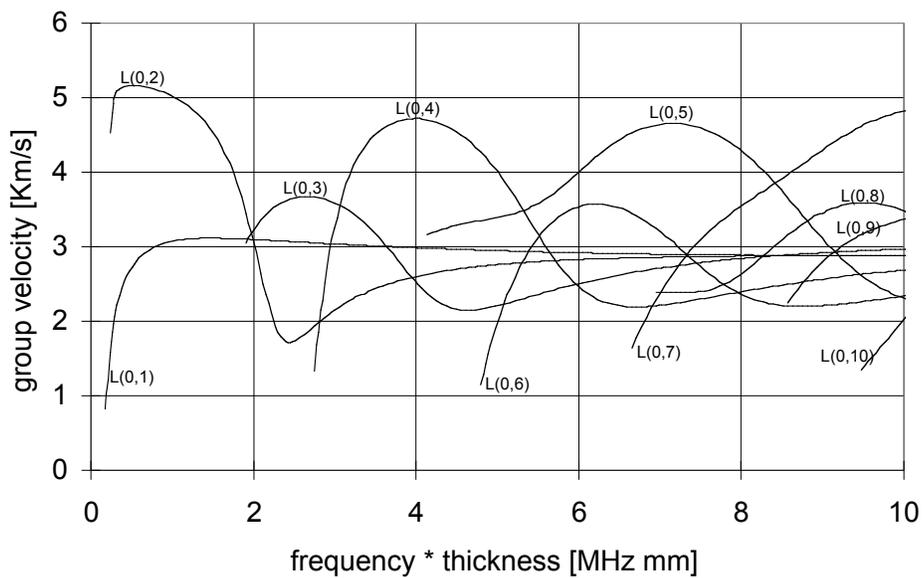
Figure 2B. Group velocity dispersion curves for the first 10 axisymmetric modes in Figure 2A show the velocity of the wave “packet”. Group velocity is used to locate flaws.

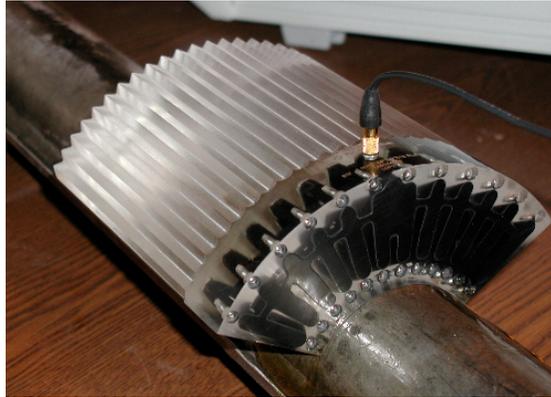
Figure 3. A piezoelectric array sensor for exciting and receiving guided waves in recovery boiler tubing contacts an accessible area of the tube.

The piezoelectric sensor that was designed for membraned boiler tubing is shown in Figure 3. The sensor consists of an array of 12 piezoelectric elements mounted on a solid lucite wedge that covers 120° of a 3" diameter tube. The sensor controls the phase velocity by generating a narrow band of phase velocities around a nominal value obtained from Snell's Law. Possible excitation of guided waves can be determined from Snell's Law assuming the refracted angle is 90° (i.e. propagation is in the direction of the axis of the tube). Therefore, the sensors excite guided waves with a phase velocity  $V_{ph}$  given by

Experimental tests were conducted on a variety of samples with both simulated flaws as well as real defects. In these tests, the piezoelectric array sensor in Figure 3 both sends and receives the guided waves and detects defects in reflection mode. A tone burst generator, capable of sweeping through frequencies to 5 MHz, is used to excite the sensor. Gel couplant is used between the sensor and tube.

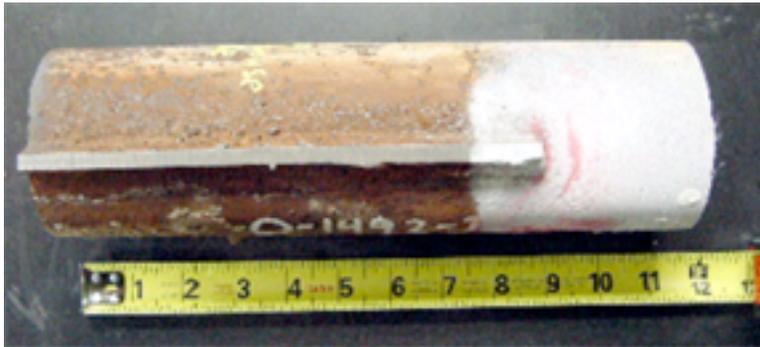
Figure 4. Removed from service because of a crack (indicated by a dye penetrant) located just beyond the membrane, this boiler tube section was welded between two 10 ft. lengths of tube to test guided wave detection.

Figure 4 shows a section of boiler tube that was pulled out of service due to circumferential cracking. The crack in Figure 4, located at approximately 9" according to the scale, is highlighted by dye penetrant. X-ray computed tomography (CT) was performed on this section to obtain an image of the crack. Circumferential X-ray CT slices of the inner and outer diameter in Figure 5 show that the crack initiated on the I.D. and grew to the O.D. To test guided wave detection on this type of crack, the 12" section of tube was then welded between two - 10' lengths of tubes according to industry welding guidelines.

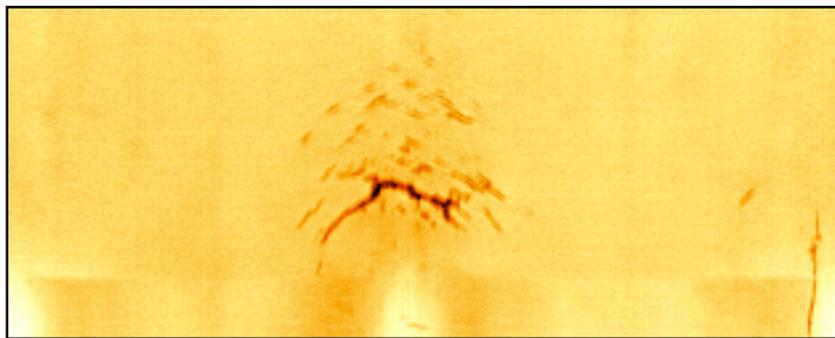
Figure 5A. X-ray CT image of the inner diameter of the circumferential crack specimen shows crack initiations.

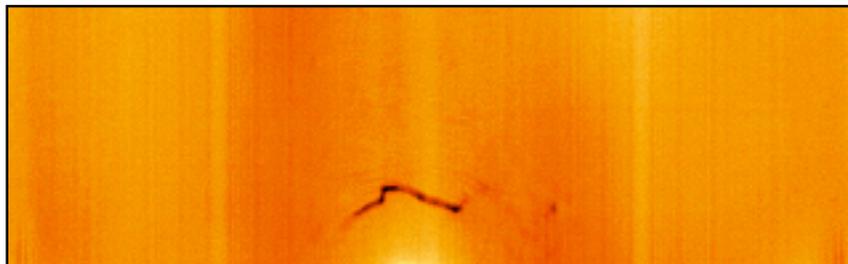
Figure 5B. X-ray CT image of the outer diameter of the circumferential crack specimen shows less crack initiation sites than the inner diameter.

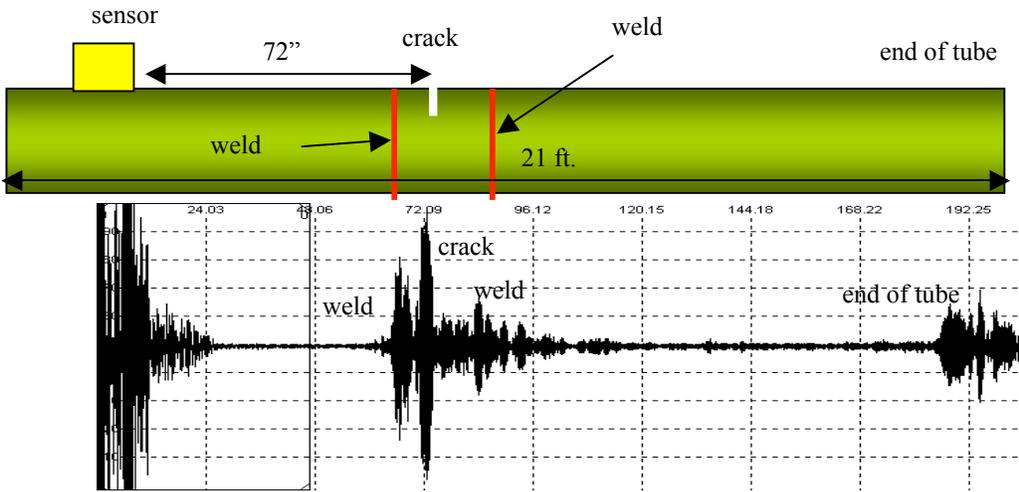
Figure 6. A sample RF waveform shows detection of a crack at 72" and the end of the tube at 16.5 ft.

A guided wave signal detecting the crack is shown in Figure 6. The tone burst excitation frequency was tuned to 510 kHz to maximize the reflection from the crack. Reflections from the welds also appear before and after the crack reflection. A reflection from the end of the tube, 16.5 ft. away, also appears in the signal. The results demonstrate long-distance detection of a real circumferential crack by the guided wave technique.

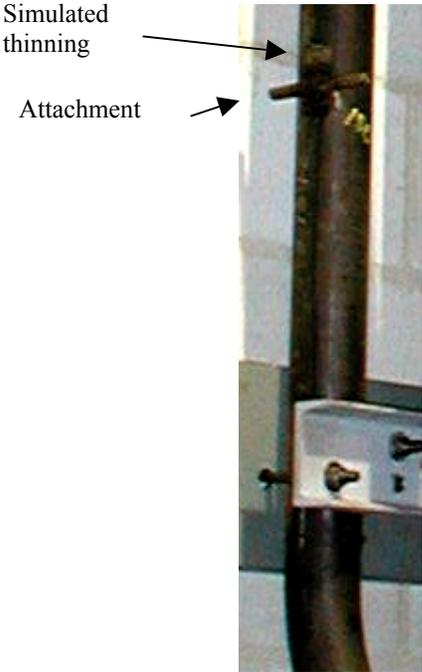
Figure 7. A 1" x 1" area of simulated thinning is located near a welded attachment.

Another test was performed on a mockup set of tubes to show the ability to resolve flaws in the vicinity of attachments. Thinning was simulated near an attachment by machining a 1" x 1" area to a depth of 0.066", or 30% of the thickness, into a tube near an attachment. The welded attachment area is shown in Figure 7.

The tube in Figure 7 was tested using the guided wave technique with the sensor approximately 40" from the thinning and attachment. The simulated thinning was easily detected in reflection mode as shown in the guided wave signal in Figure 8. Detection of the thinning was verified by group velocity calculations of the mode as well as damping the signal on the tube around the thinning.

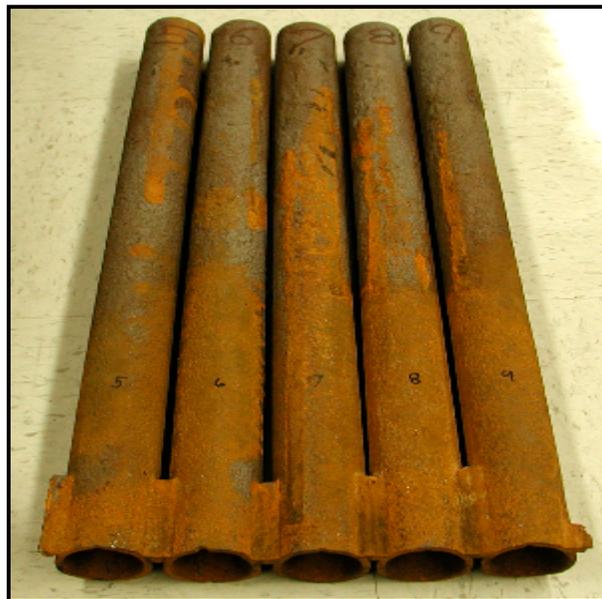
Figure 9. A panel of tangential tubes with suspected stress-assisted corrosion was tested with guided waves.

Tests were performed on panels of tubes having areas suspected of having stress-assisted corrosion (SAC). The panels, as shown in Figure 9, were tangent tubes, 24" in length, 2" in diameter and 0.170" thick. The panels were removed from the sidewall of the boiler above the secondary airports and below the nose arch. Radiographs were taken of the panels to identify tubes with SAC. The depth of the SAC was roughly estimated at about 20% through-wall. The SAC had several orientations. A typical radiograph of the SAC area of a tube is shown in Figure 10.

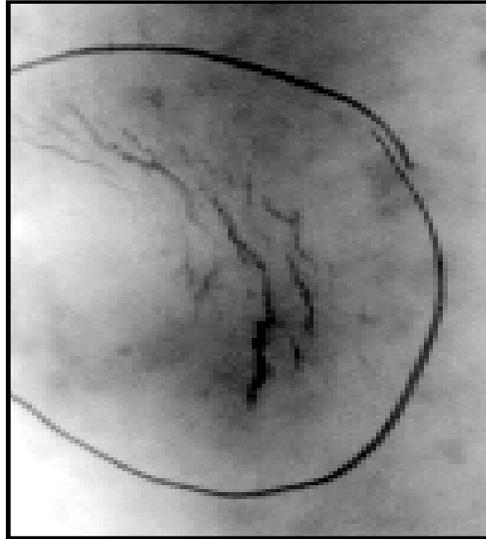
Figure 10. A radiograph of a tangent tube shows stress-assisted corrosion.

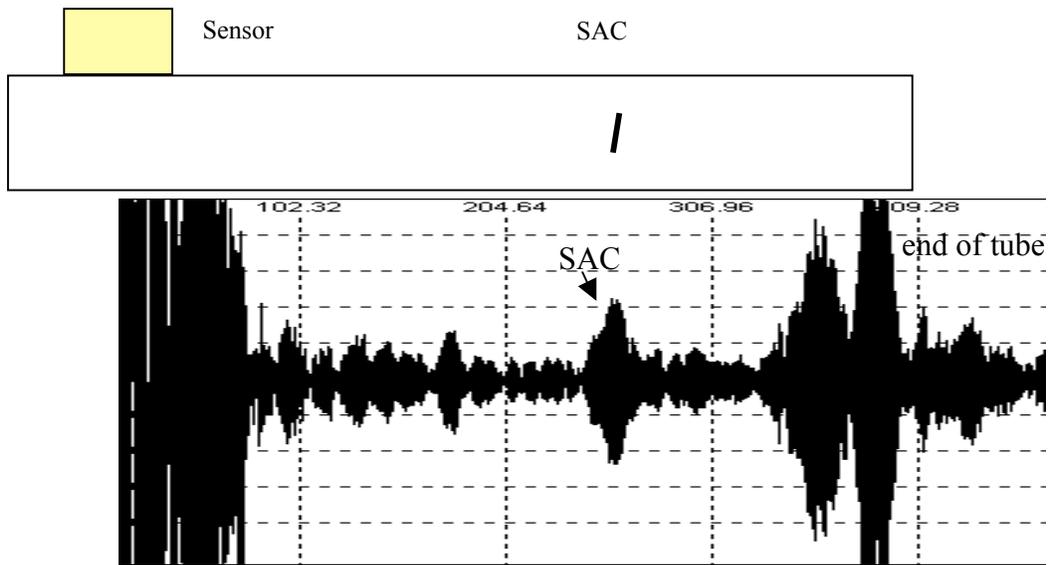
Figure 11A. A sample waveform shows the detection of SAC in a tangent tube.

After cleaning guided wave testing was performed on the samples. A typical signal in Figure 11A shows detection of SAC by guided waves. Despite the rough surfaces, the SAC was still detectable. Figure 11B shows the guided wave signal from a tube that was radiographically found to have no cracks. The tangent tubes demonstrate why extremely low detection sensitivity is not desirable in this application. Sensitivities to wall thinning and other flaws that are much below 10% through-wall would result in the detection of numerous features that are of little interest, e.g. surface roughness, scratches, and general wear. A successful guided wave technique should effectively filter out features that are not of interest. The tangent tubes were rejected for cracking, not for thinning. For these tubes, the technique must detect cracking or deep areas of thinning while not detecting the thousands of small features on the surface.

signal using an EMAT send/receive pair is shown in Figure 11C. The arrival time of the reflection from the SAC defect differs from the piezoelectric array transducer (Figure 11A) because a different mode with a different group velocity was excited by the EMAT. Although the EMAT sensor is flat and was not optimized for curved surfaces, detection of SAC shows the potential of using EMAT sensors on rough tube surfaces.

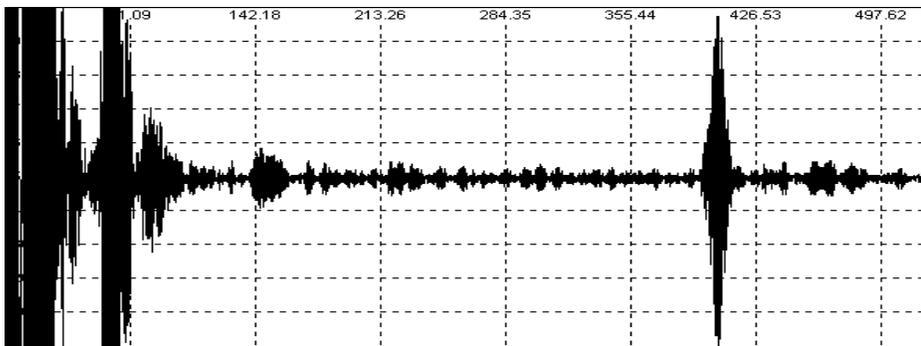
Figure 11B. A sample waveform in a tangent tube with no indication of flaws.

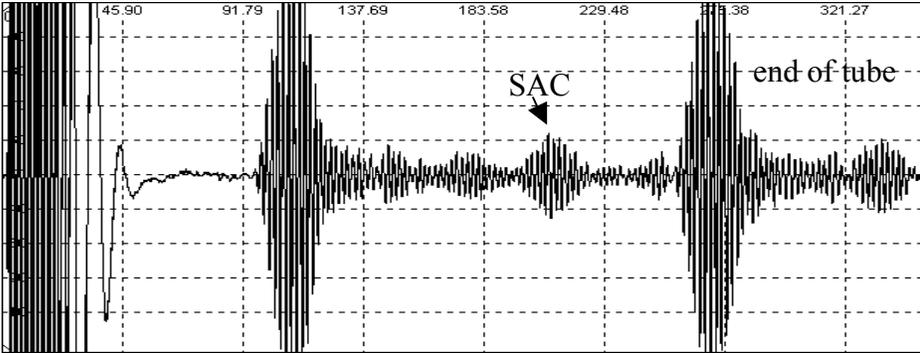
Figure 11C. A guided wave signal generated with EMAT sensors shows detection of SAC.

Aggressively cleaning tubes for inspection is time-consuming and at times impractical. Electromagnetic acoustic transducers (EMAT), sensors that modulate a magnetic field to create an acoustic wave, are known to perform well on rough surfaces. For comparison, the tangent tube with SAC was tested using a flat EMAT. The guided wave
