UCRL-TR-217950

# **Aging and Phase Stability of Alloy 22 Welds**

## ***FY04 SUMMARY REPORT***

*Yucca Mountain Project  
Lawrence Livermore National Laboratory*

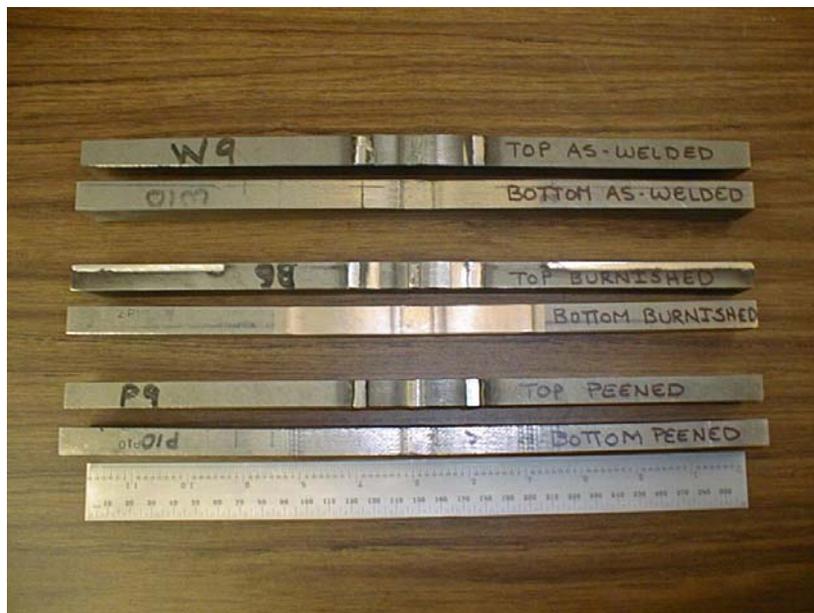
**Figure 1.2.1.** Top and bottom images of as-welded, burnished, and peened bars received for stress mitigation studies.

- Received 4 each (12 total) of as-welded, burnished, and peened bars as shown in Figure 1.2.1 (305 mm x 13 mm x 25 mm) in April 2004.

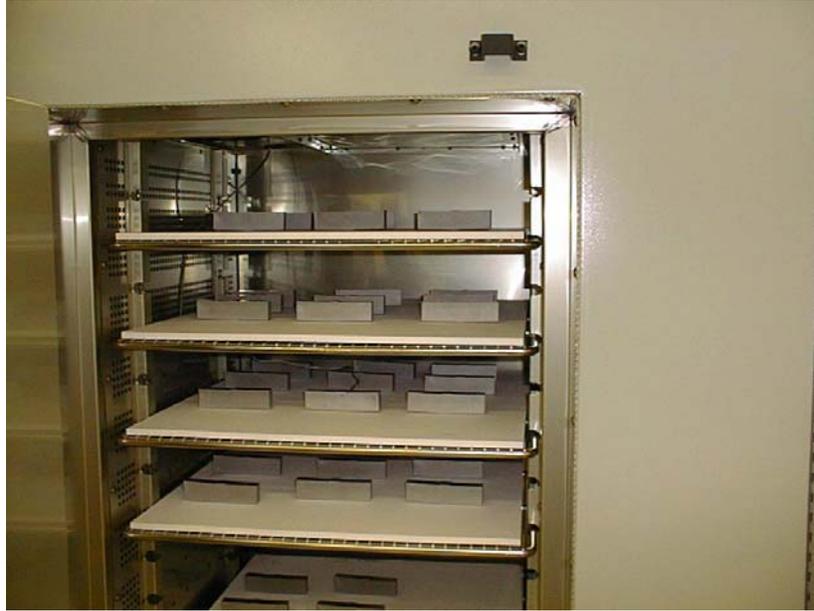
**Figure 4.2.2.** Inside View of Furnace with Samples for Aging.

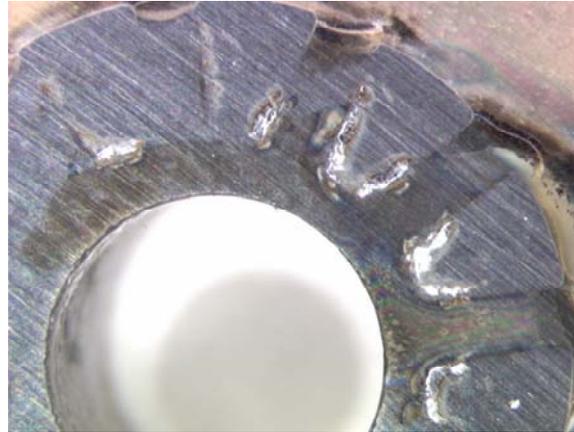
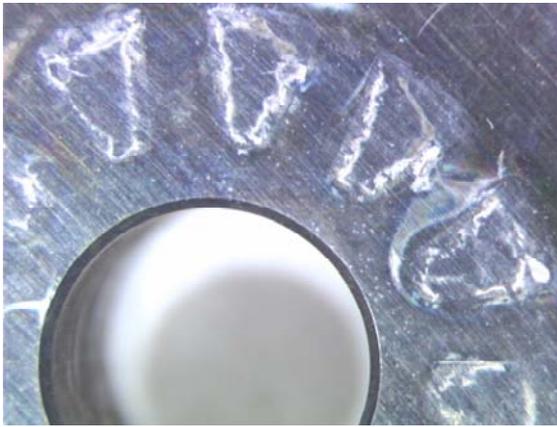
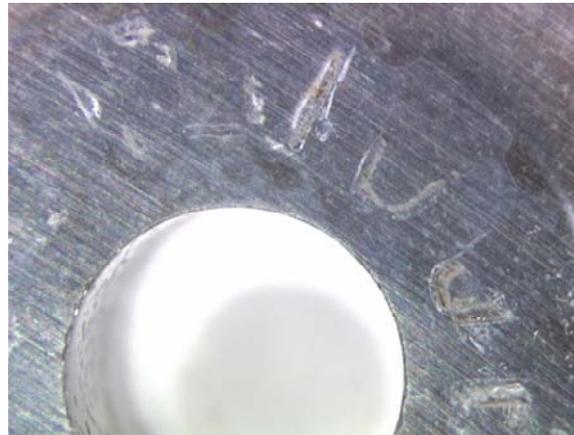
a) Specimen KE0413, non-annealed, tested in 1 M NaCl at 90°C.

b) Specimen KE0490, solution annealed at 1300°C for 20 minutes, tested in 1 M NaCl at 90°C

c) Specimen KE0416, non-annealed, tested in 6 m NaCl + 0.9 m KNO<sub>3</sub> at 100°C.

d) Specimen KE0493, solution annealed at 1300°C for 20 minutes, tested in 6 m NaCl + 0.9 m KNO<sub>3</sub> at 100°C.

**Figure 5.4.2.3.** Comparison of Welded Specimens in Non-Annealed vs. 1300°C Anneal conditions.

- Figures 5.4.2.1 and 5.4.2.2 show the cyclic polarization curves for the specimens tested in 1 M NaCl at 90°C and 6 m NaCl + 0.9 m KNO<sub>3</sub> at 100°C, respectively. Crevice corrosion was observed on all test specimens to some degree. In both environments, the amount of hysteresis decreases as annealing temperature increases, indicating higher resistance to localized corrosion for the specimens annealed at higher temperatures. This agrees well with post-test specimen observations (see Figure 5.4.2.3).

- In both environments, specimens show lower breakdown potentials ( $E_{20}$  and  $E_{crit}$ ) with increasing annealing temperatures. This indicates that with increasing annealing temperatures, resistance to crevice breakdown tends to decrease. Specimens annealed at 1300°C, showed a significantly lower breakdown potential. Despite the higher breakdown potentials, observations show lower total area of crevice corrosion for specimens annealed at higher temperatures (Figure 5.4.2.3).
