LAWRENCE
LIVERMORE
NATIONAL
LABORATORY

"When the Safety System Fails the Worker: Did We Do Our Job?...a Case Study"

July 12, 2006

“Exposure to Exhaust Gases,
Including Carbon Monoxide,
During Manlift Operations”

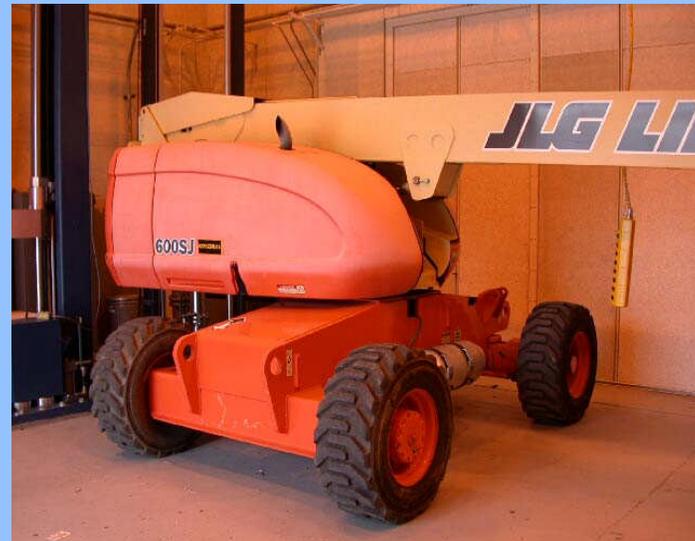
- FPOC and Task Lead agree a manlift is the most feasible way to reach the detectors
- Although several sizes are on site, the JLG 60 was the only one available at the time

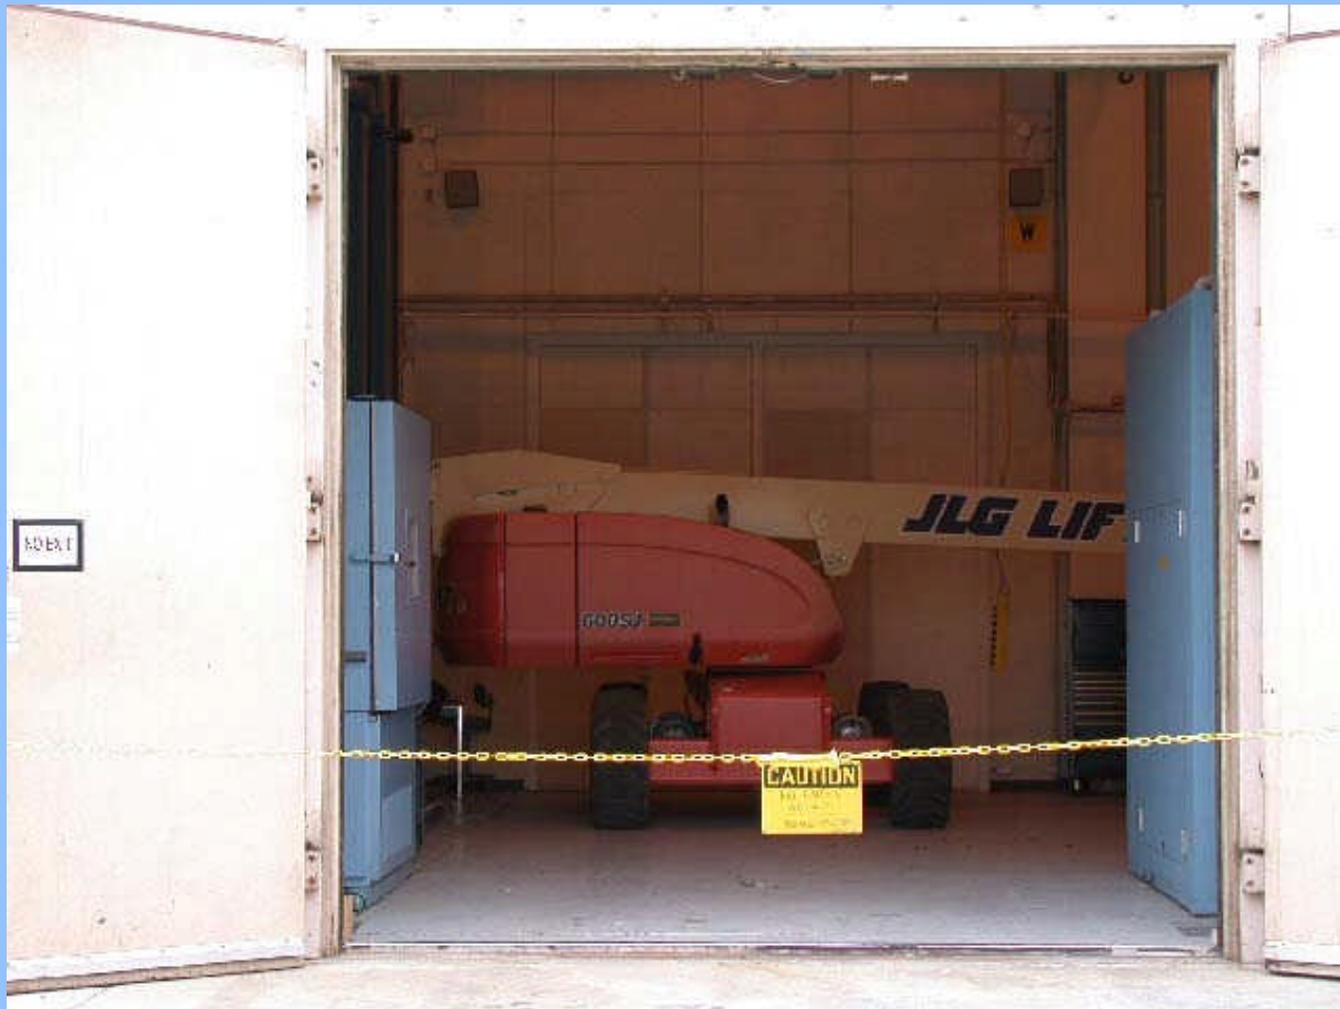
The operator was not able to maneuver the lift into the building - another operator in the area provided help

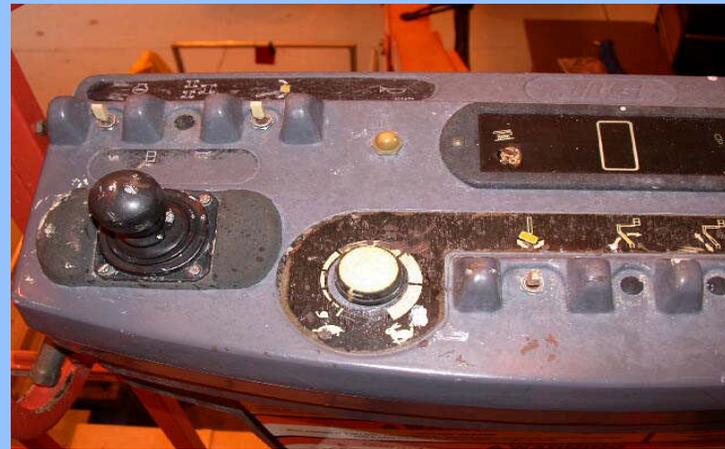
- Operator dons PPE
- FPOC leaves area to attend a meeting
- Operator experiences difficulty with equipment controls
- Operator requests help from second operator in the area
- Second operator returns and reviews controls

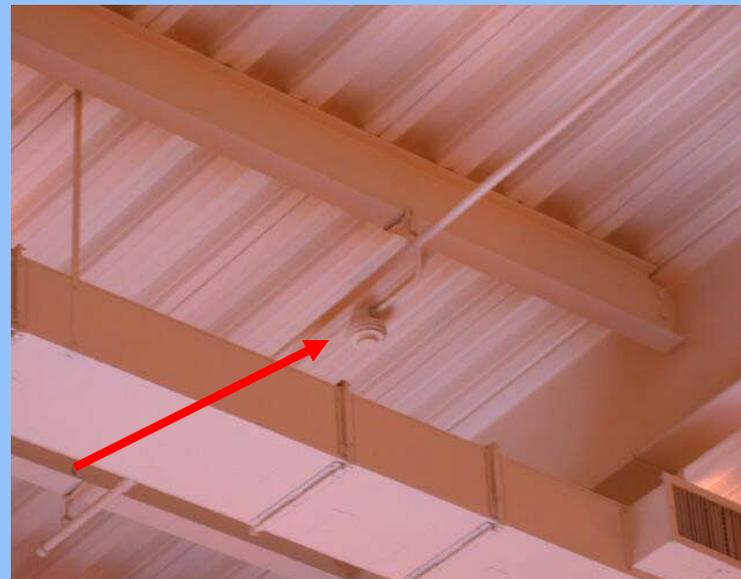
- ~ 30 minutes to complete Northwest detector
- Engine ran on propane continuously ~ 30 minutes due to frequent relocation of basket
- Operator begins to move to Southwest detector head

Location of detectors
made access difficult

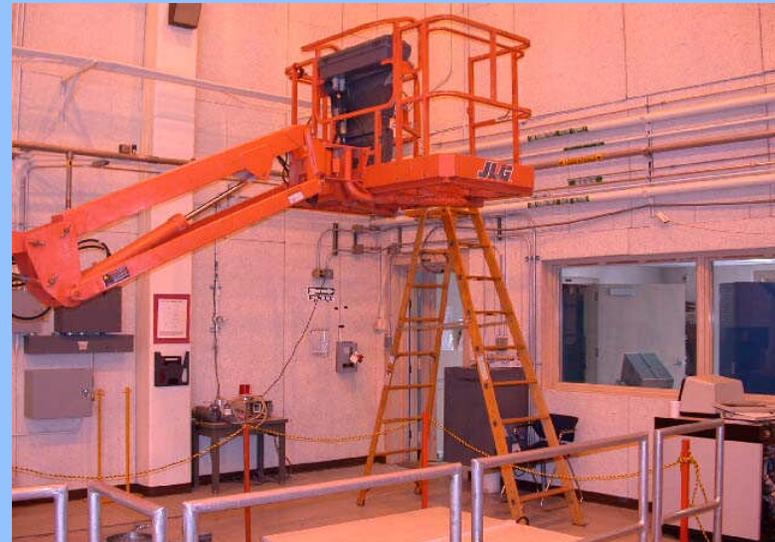
- Operator is sitting on floor of basket
- Basket is ~ 10 feet above floor over a pit
- Task Lead uses ladder to get drink to operator
- Recognizes operator is in trouble

Task Lead helps operator out of basket, down the ladder and into fresh air

- Vehicle was found to operating “rich” resulting in a higher level of CO being exhausted
- Fired Department recorded 854 ppm in the East Bay ~ 30 minutes after engine shut off
 - TWA = 50 ppm

- Site-wide policy for the use of internal combustion engines indoors
 - Include hazard assessment by ES&H Team
 - Portable CO monitors
- More rigorous requirements for operators to demonstrate their capability
- Posting of warning labels on internal combustion equipment to warn personnel about it's use indoors or in confined spaces
 - Fleet maintenance to check legibility of labels/stickers during PMs
- Site-wide emission standards for JLGs, Forklifts, Scissor Lifts and other internal combustion equipment
