# B365 High Efficiency Particulate Air Filter Emergency Replacement An Example of Team Work

# **B365 High Efficiency Particulate Air Filter Emergency Replacement**

An Example of Team Work

October 2, 2006

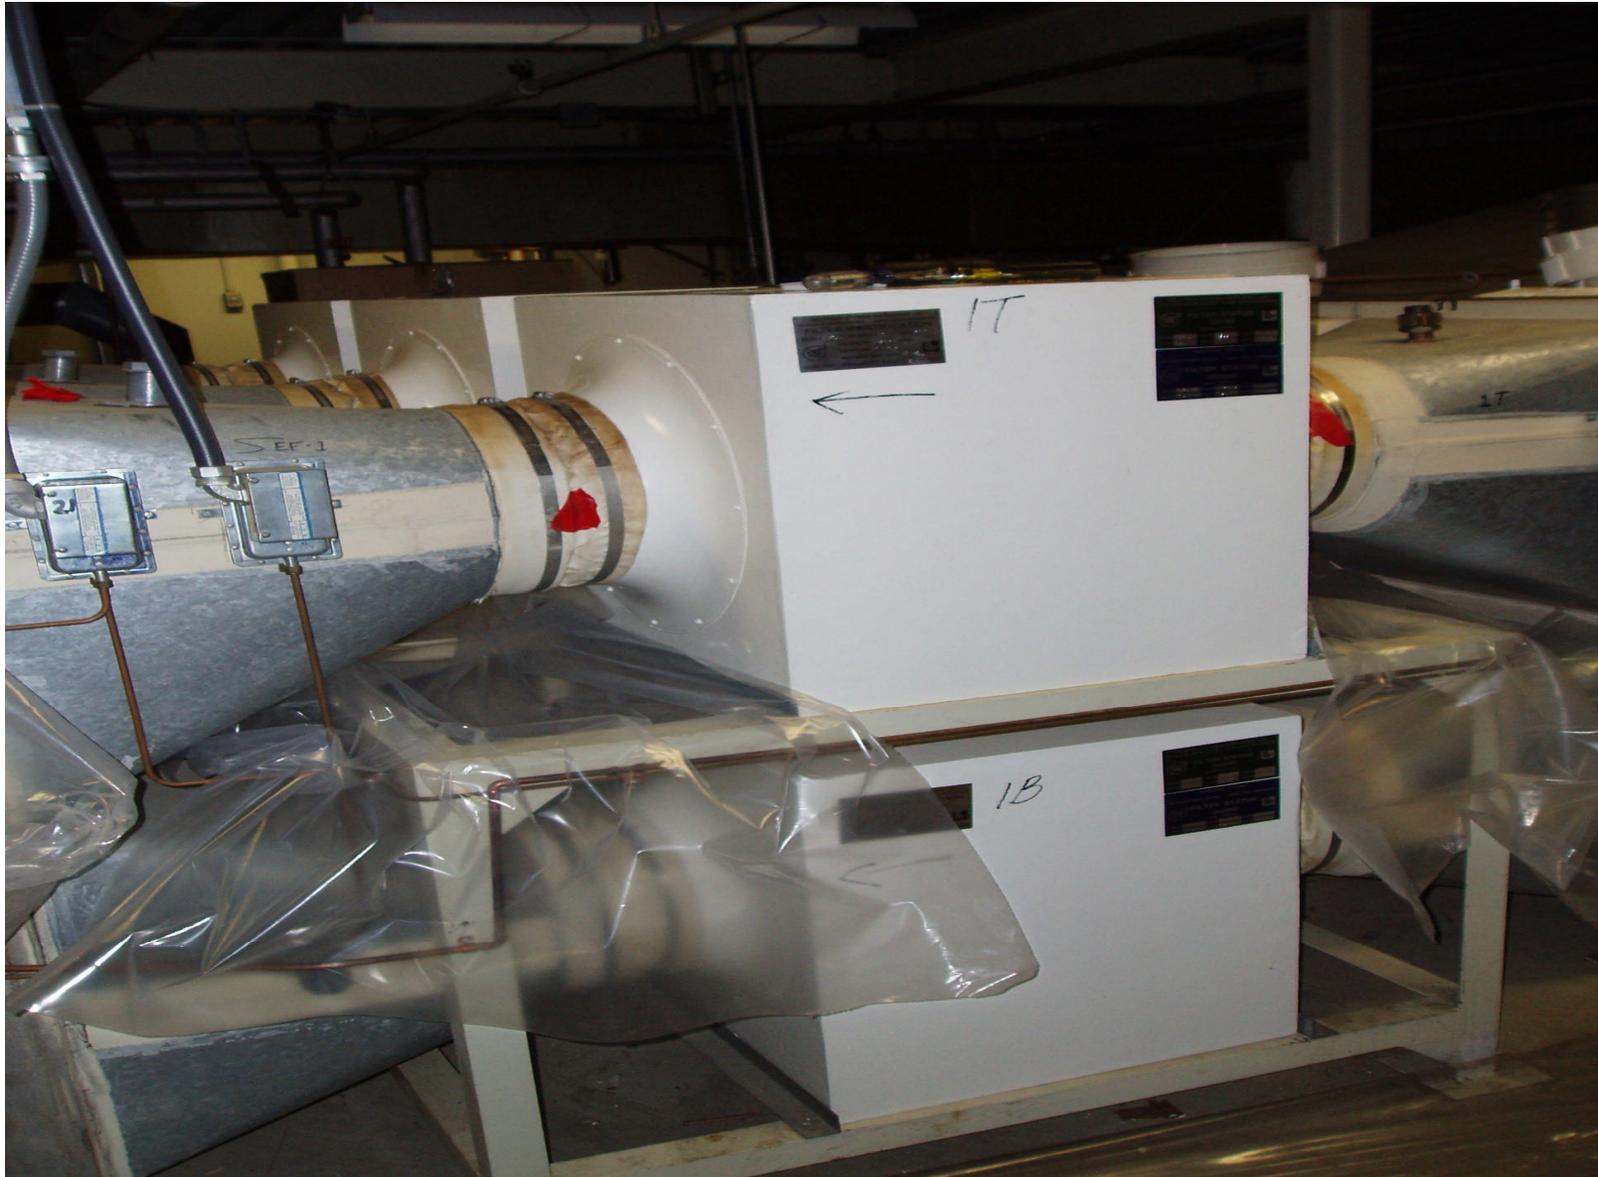
# Building HEPA Filter Exhaust System 6 Filters in Parallel

- Research building
- 1 carcinogen research laboratory and 7 Biological research laboratory.
- Building exhaust system is HEPA filtered through a bank of six filters in parallel.
- Exhaust HEPA filter system is required for work in B365.

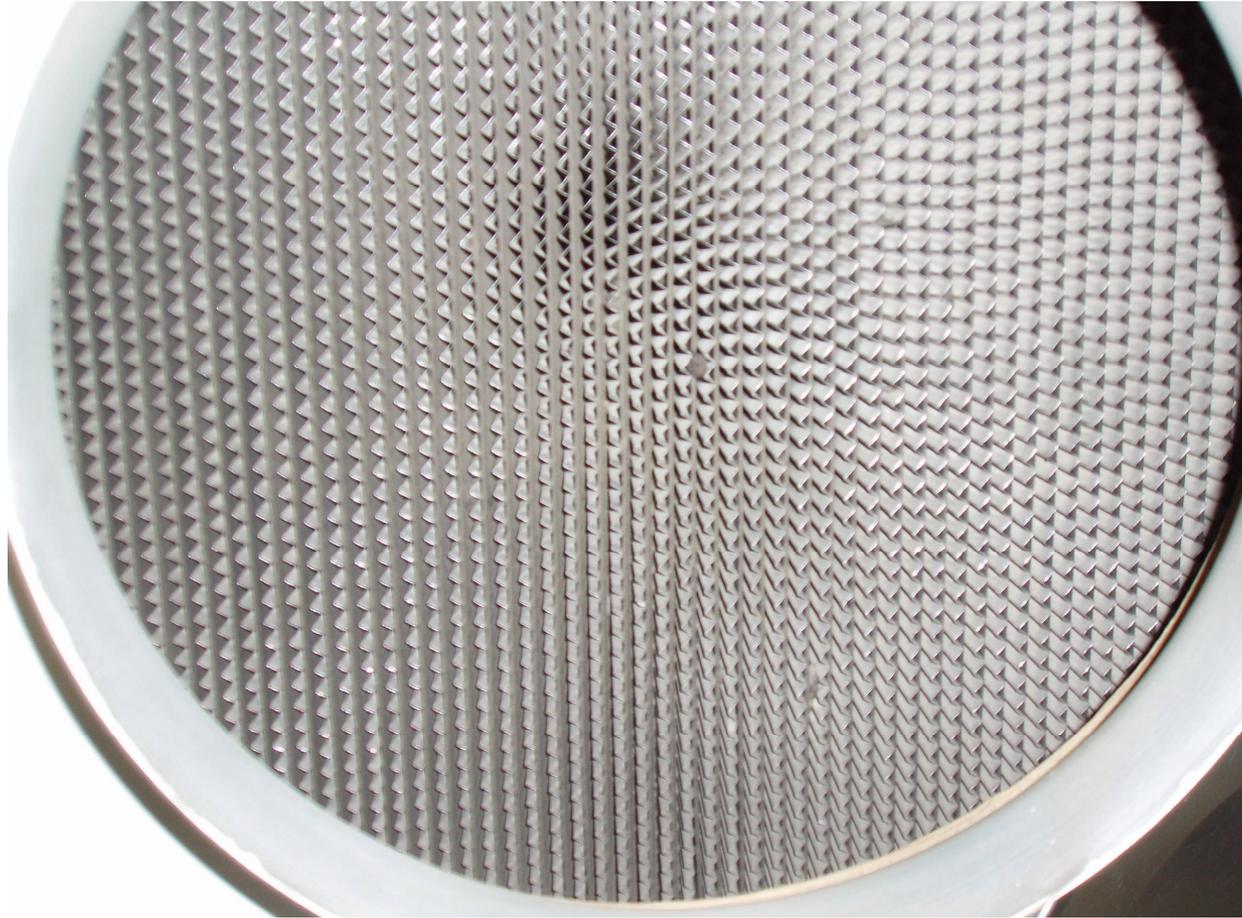
The belly of the monster...
