Cleanliness for the NIF 1w Laser Amplifiers

M. Spaeth, K. Manes, J. Honig

Fusion Science and Technology - An international research
journal of the American Nuclear Society

CLEANLINESS FOR THE NIF 1ω LASER AMPLIFIERS

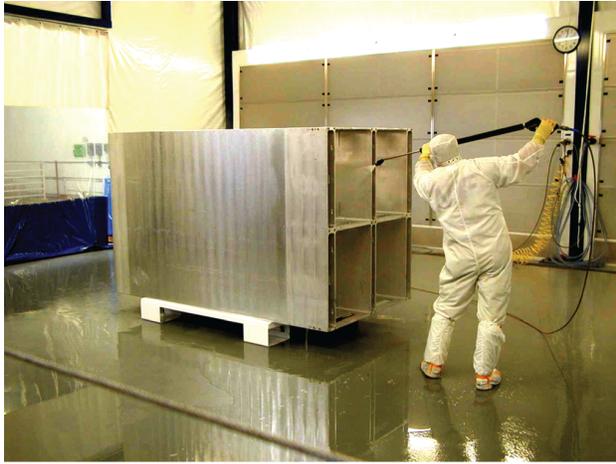
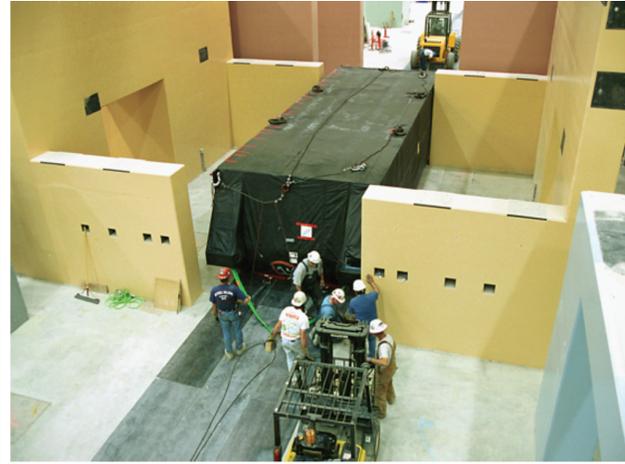
Fig. 7. (a) Hot high-pressure surfactant spray washing of a FAU (Frame Assembly Unit) in a temporary off-site cleaning facility operated by Astro Pak of Downey, CA. The clean FAU became the housing for the large amplifier slabs. (b) One of the triple-wrapped spatial-filter end vessels arriving in NIF after off-site high-pressure Brulin water/rinse cleaning.
