EUV Inspection of Defect-Repair Sites
& Status of the actinic inspection tool

A multilayer-coated blank with 14 repair sites

The repair sites were measured in five ways

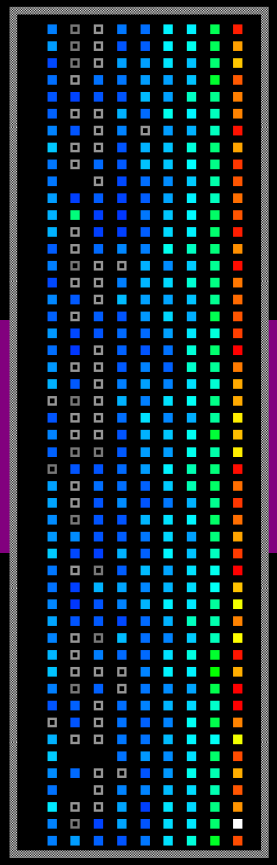
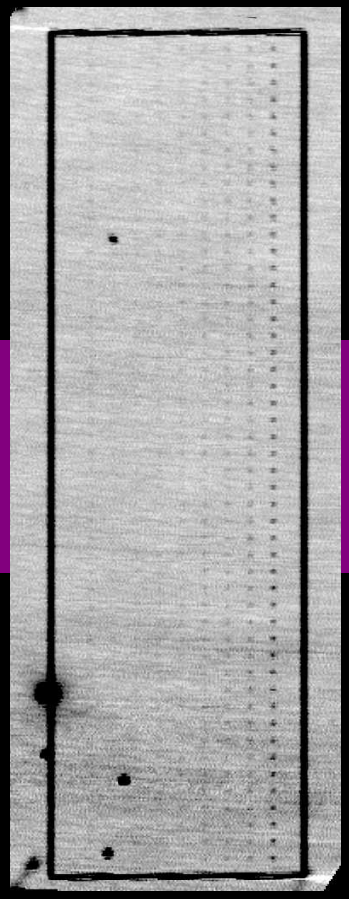
Bright-field revealed defects that do not scatter

Phase defects **scatter** well
→ *buried bumps and pits*

Surface particles and contamination **absorb light** and scatter poorly,
→ especially µm-scale defects

Actinic **DF only** could miss critical defects

BF only doesn't have enough sensitivity

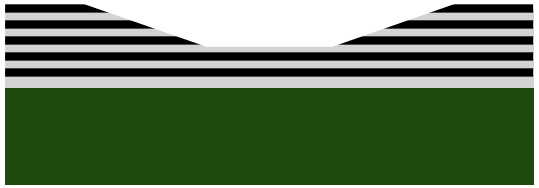
Group I
A,B,C,D,E

Sites were etched as ditches (pits) with shallow sidewall angles in the range of 2°–4°.

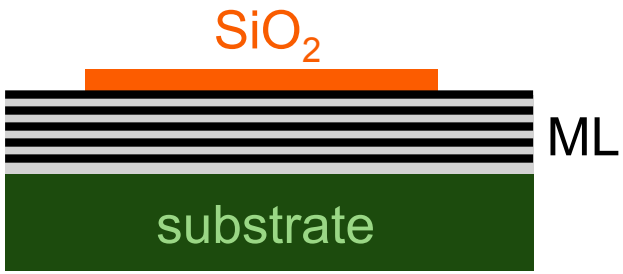
Group II
F,G,H,I,J

SiO_2 was deposited in different thicknesses: 1.5–12 nm

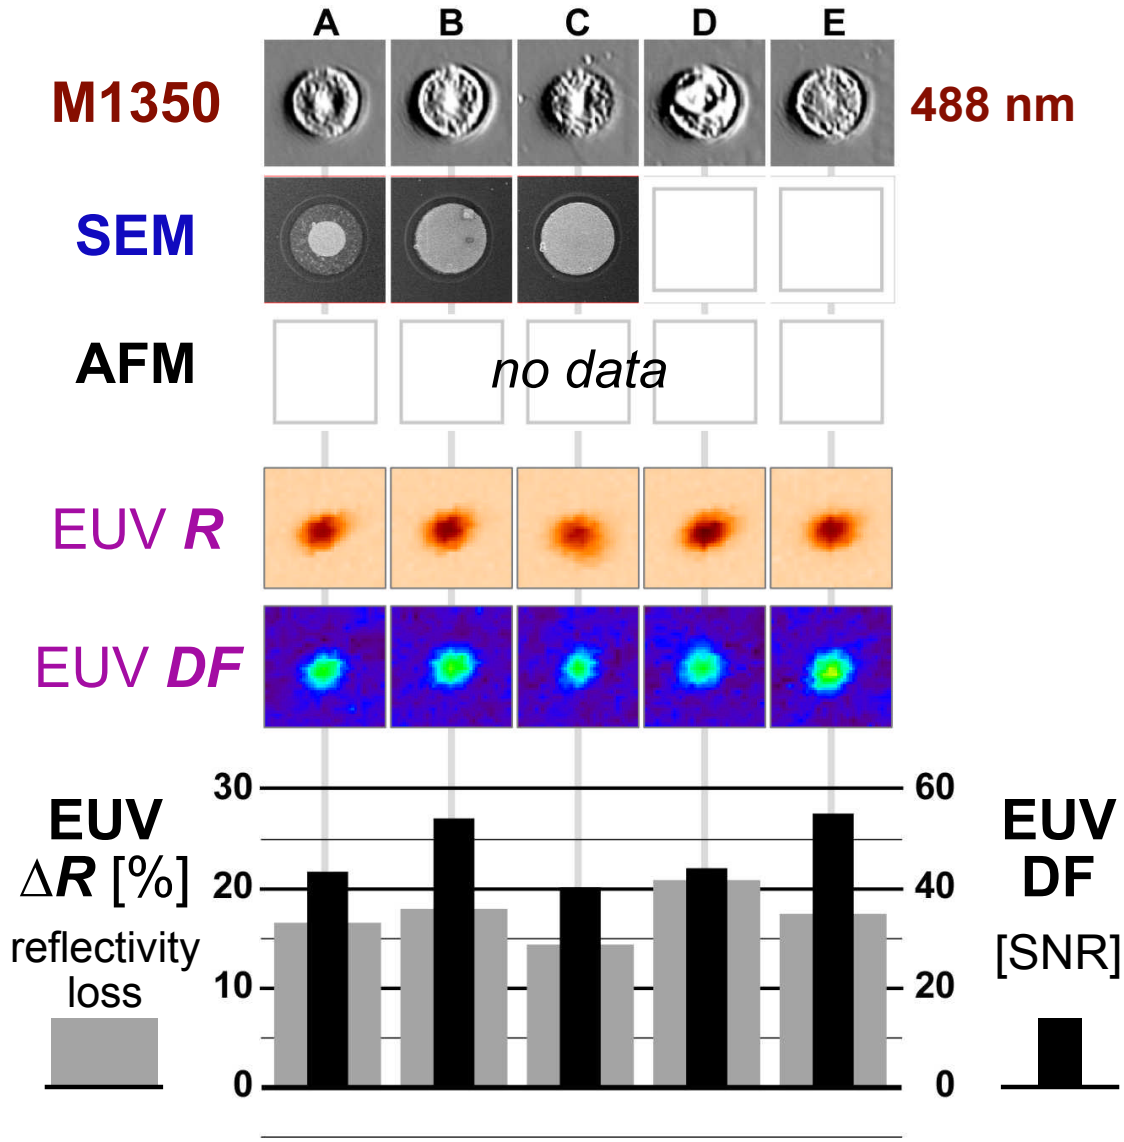
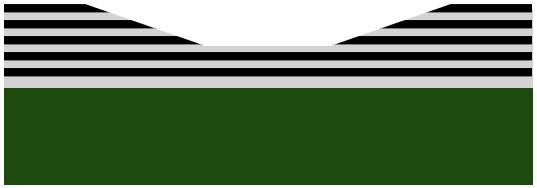
Measurements of Group I: *shallow ditches*

M1350:
→ High contrast

EUV:
→ Strong reflectivity loss
→ **Strong scattering**

sites dramatically
re-direct the beam

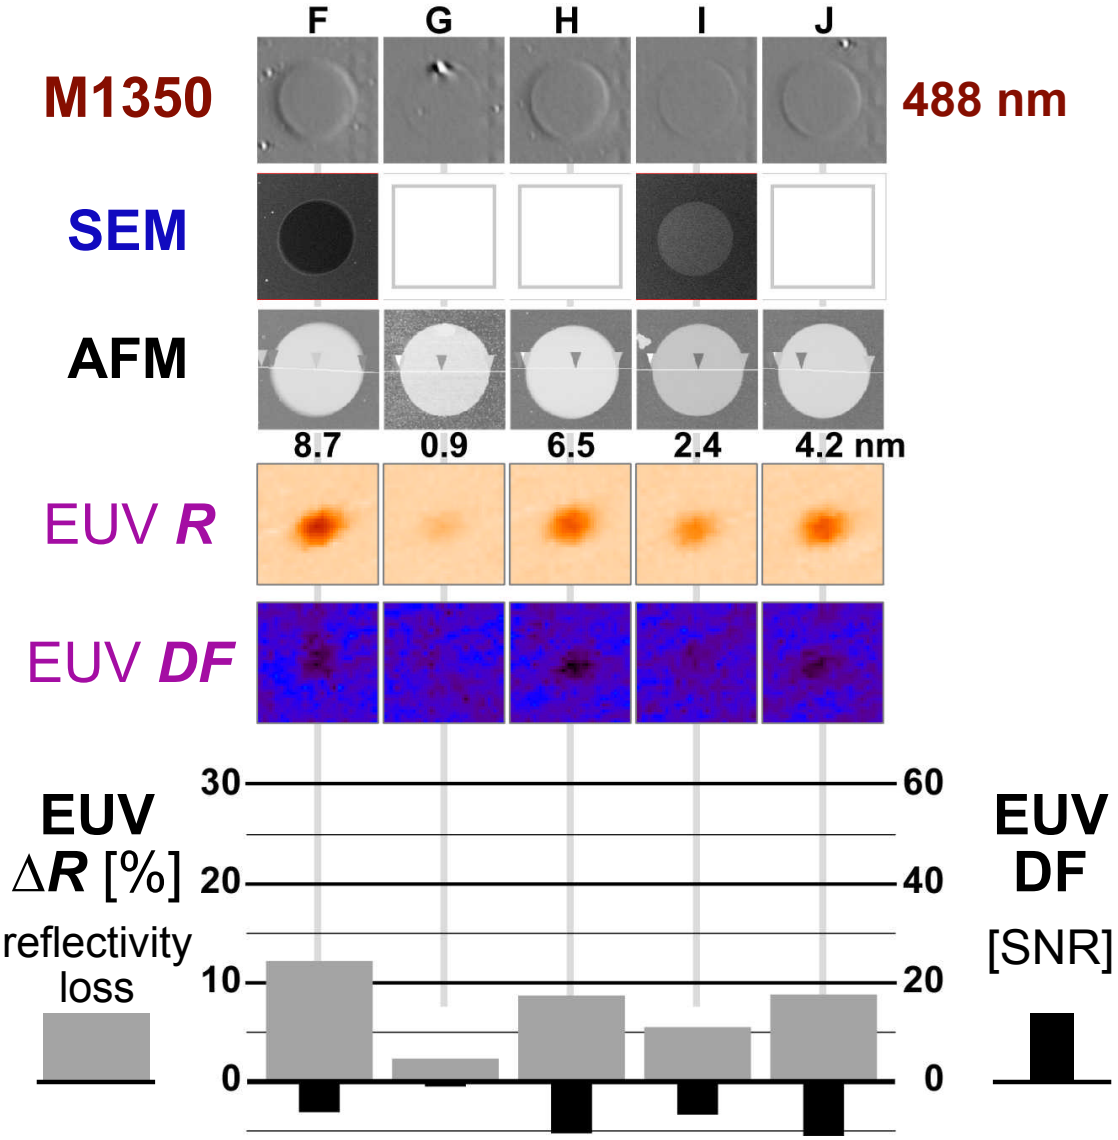
Measurements of Group II: *SiO_2 deposition*

M1350:
→ Low contrast

EUV:
→ Moderate reflectivity loss
→ **Suppressed scattering**

Absorption eliminates scattered light. Reflectivity drops with SiO_2 thickness.

$\Delta R \approx -1\%$ for 2 nm SiO_2

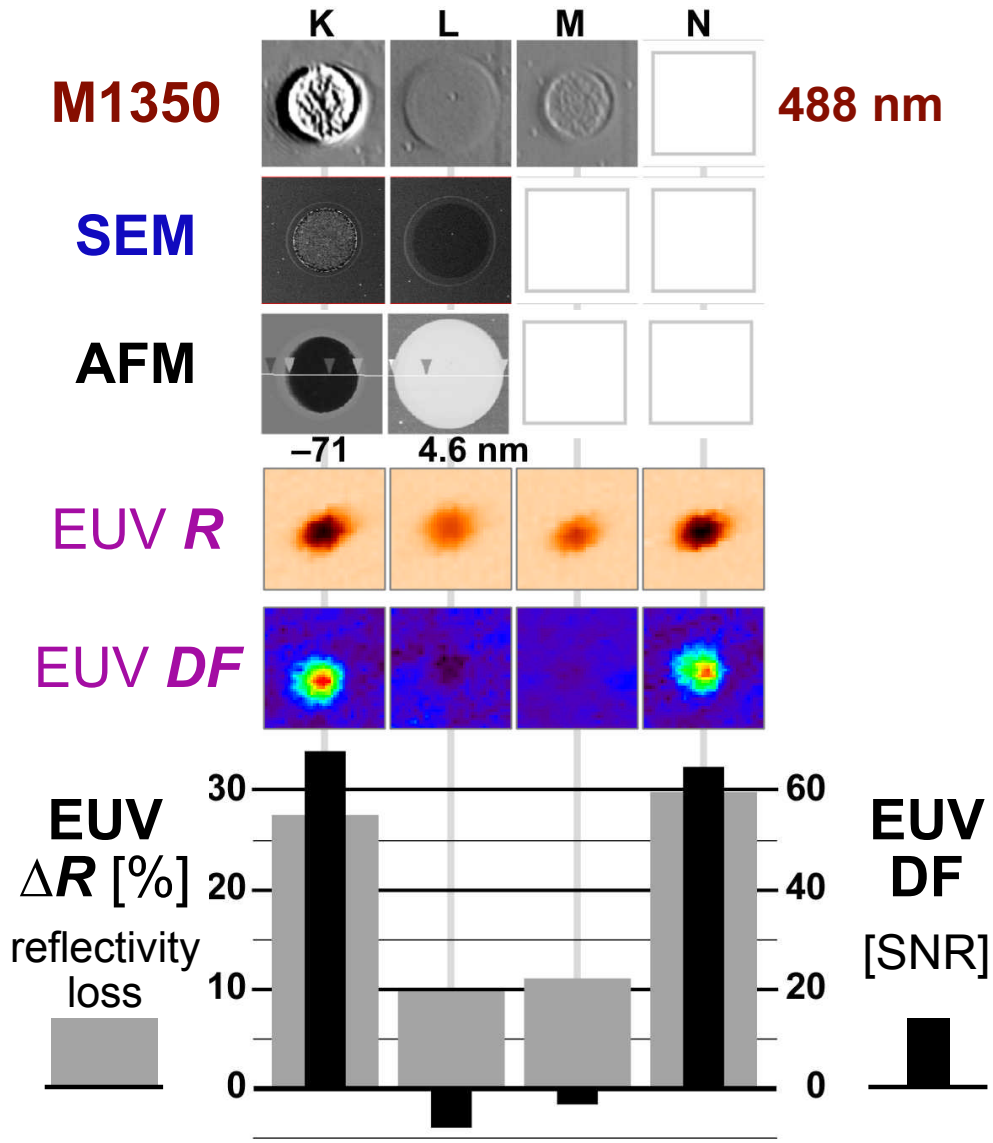
Measurements of Group III: *SiO_2 ditch protection*

M1350:
→ Mixed results

EUV:
→ Mixed results

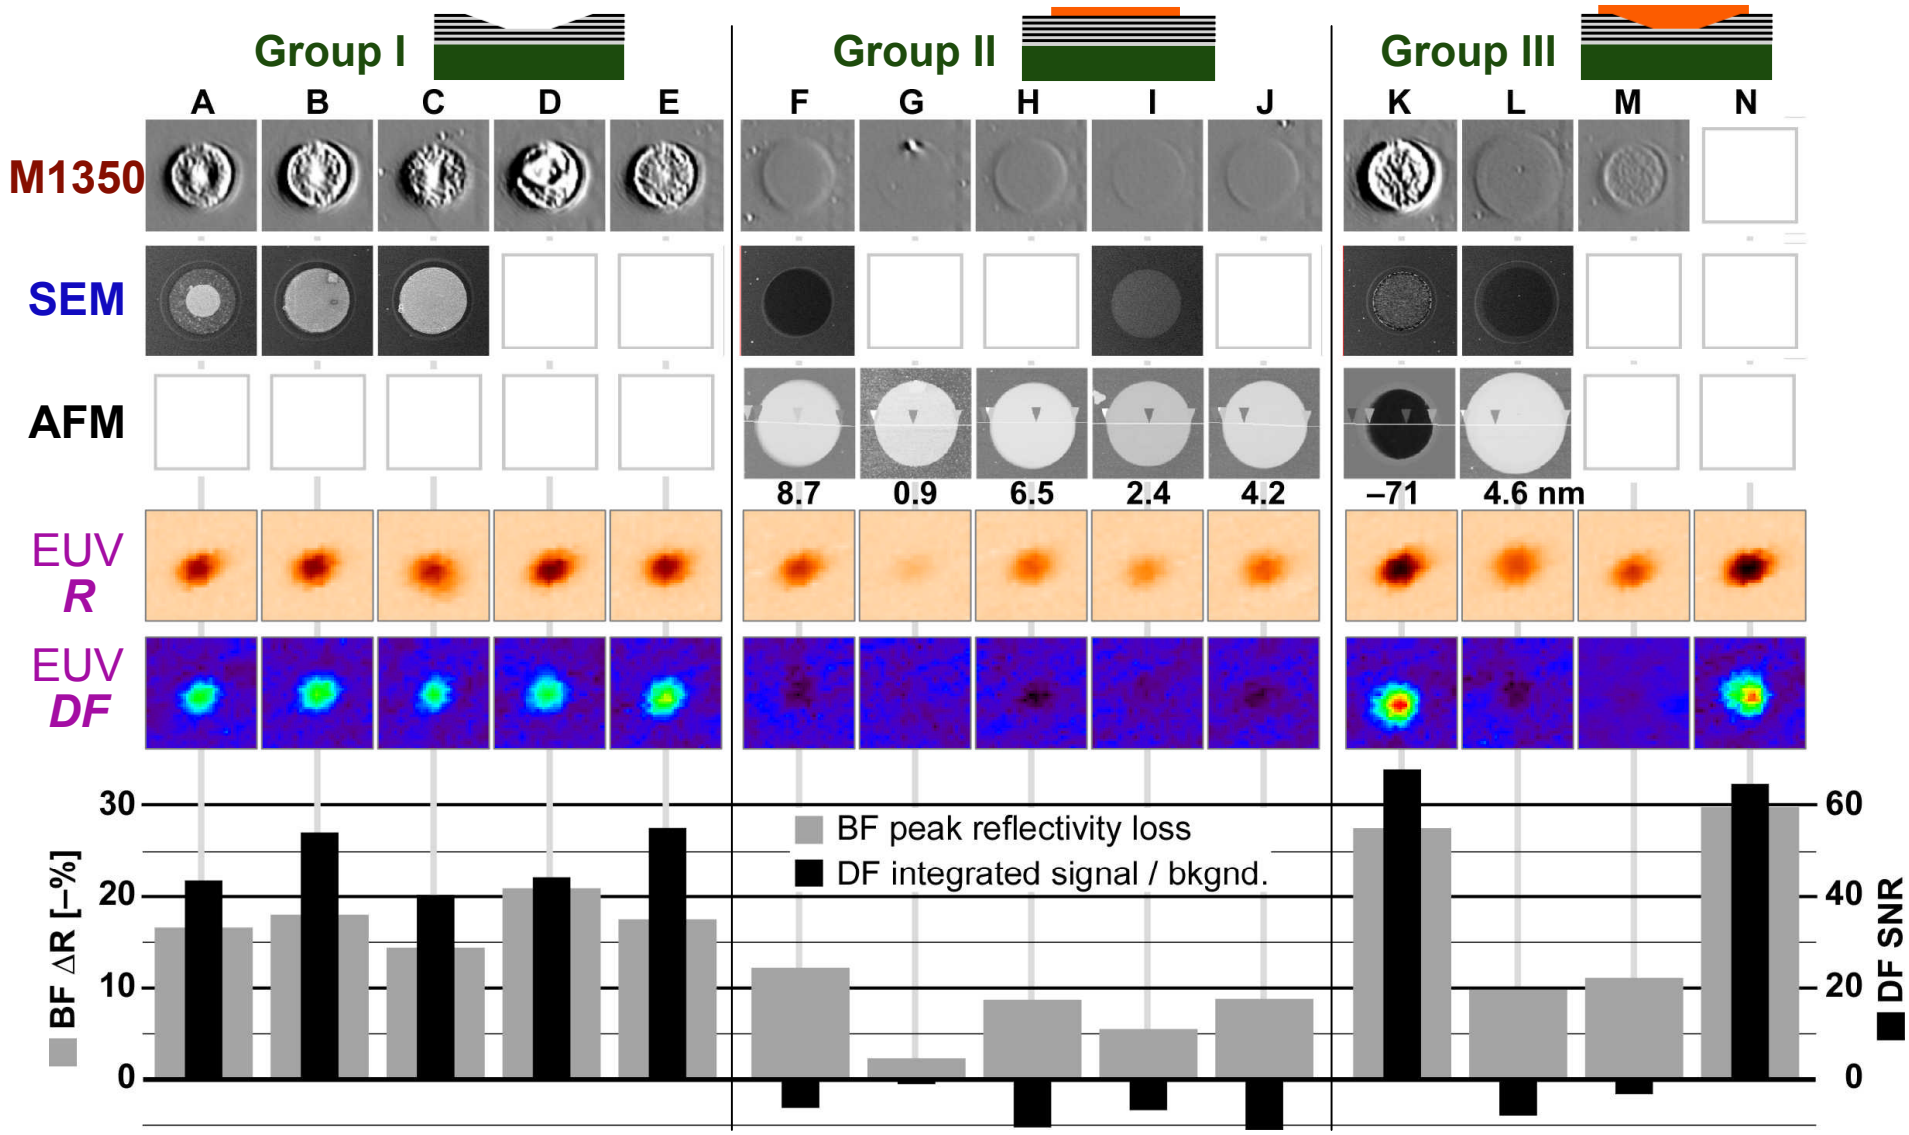
Some sites scatter strongly, others absorb light

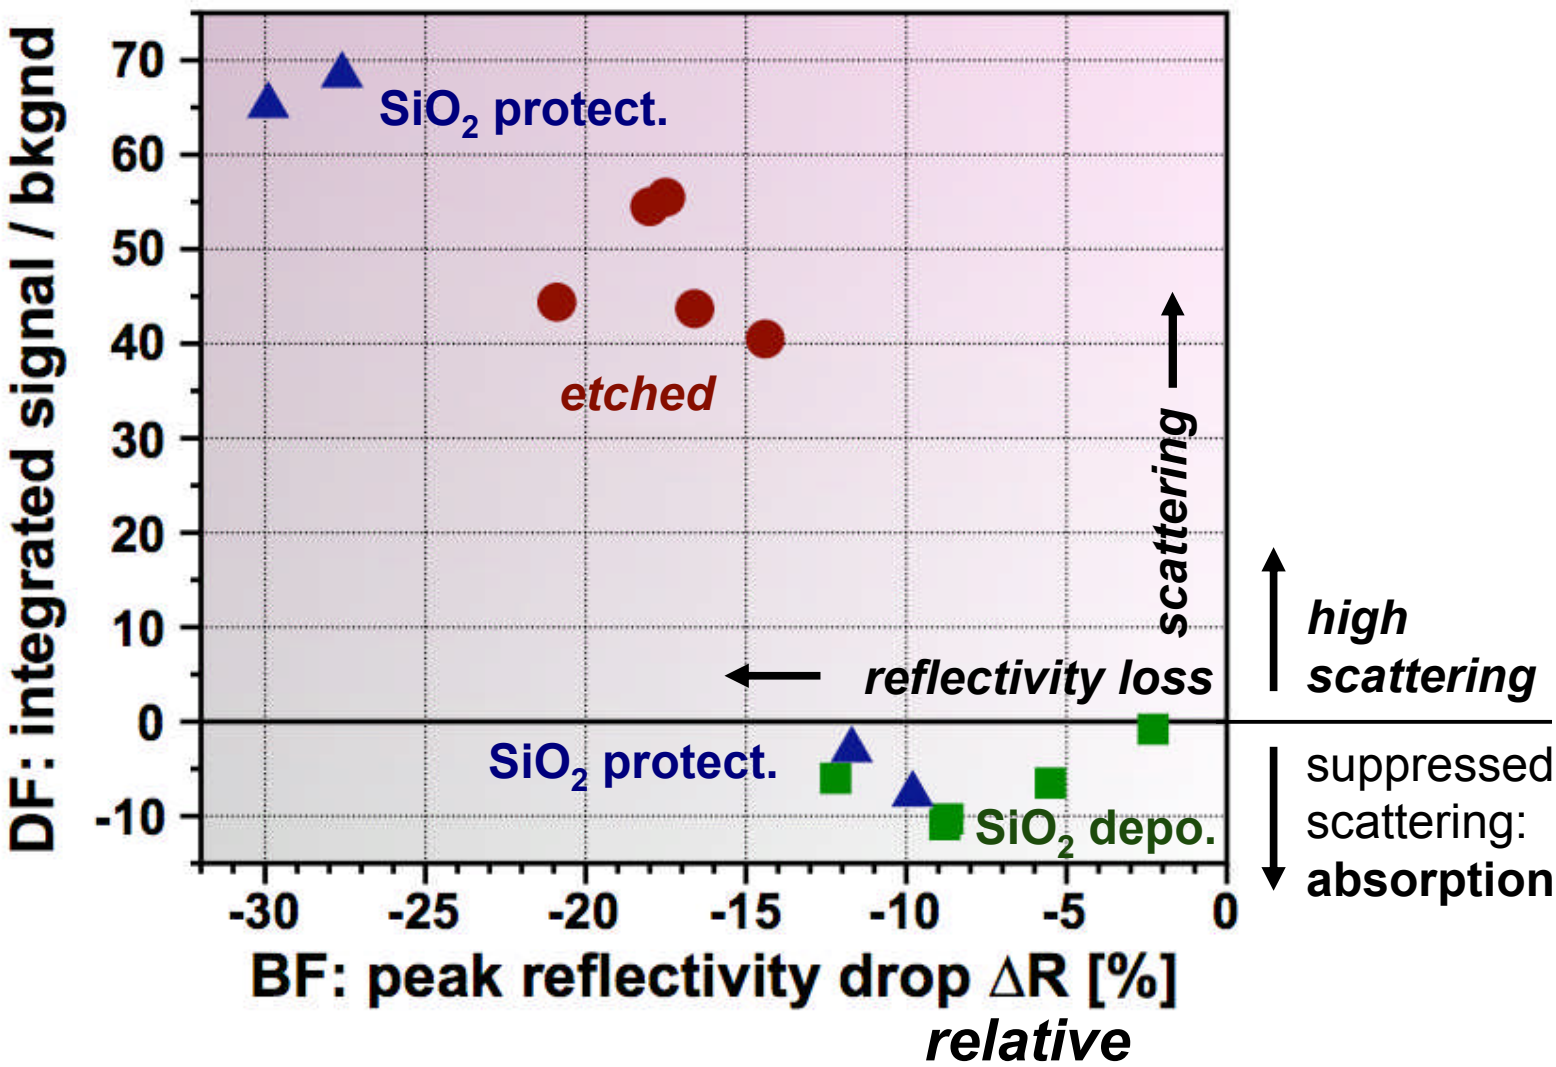
Actinic BF and DF correlation has no single trend

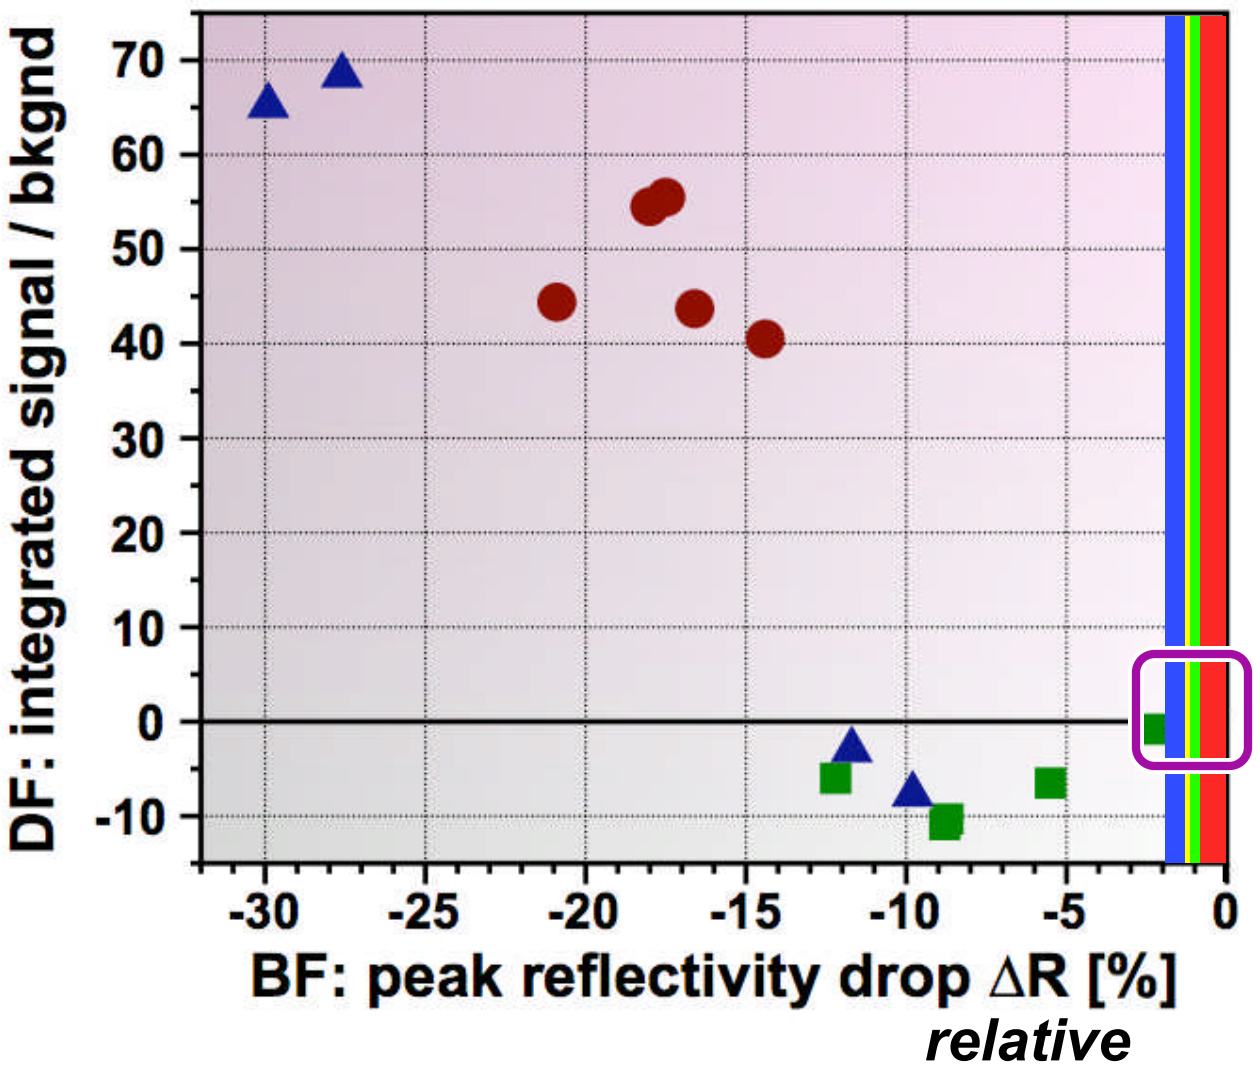
These sites are well beyond the SEMI P-38-1103 reflection uniformity standard

Perhaps the correlation here matters little since we are **so far beyond the allowed Δ*R***

Perhaps we should only consider *this* region

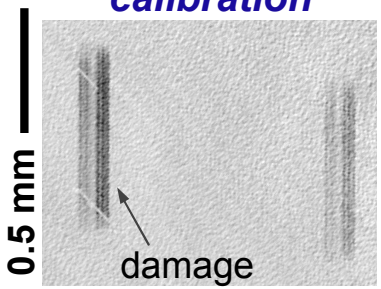
5 @ full power
ΔR_{max} = –5.4%

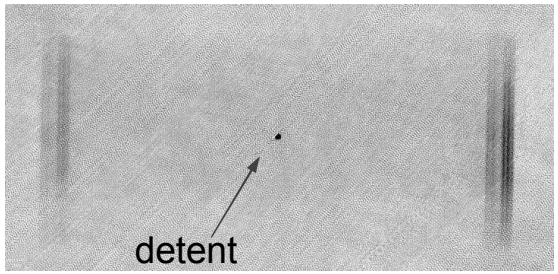
20 @ full power
ΔR_{max} = –2.1%

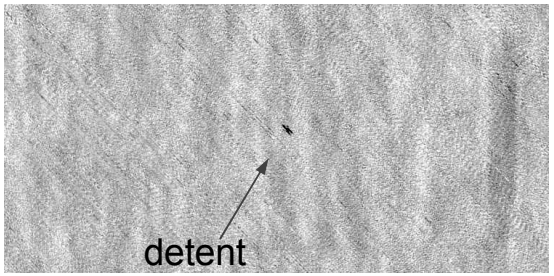
1 @ lower power
ΔR_{max} = –0.8%

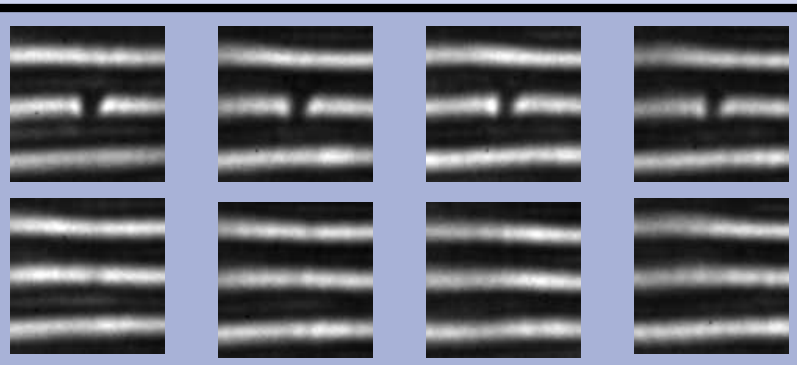
Defect repair studies

half-pitch: 450 nm (mask)
112.5 nm (wafer)
