Solid Collection Efforts: Ta Collimator Evaluation

J. M. Gostic

November 22, 2011

Ta collimator sets that were part of the gated x-ray detector diagnostic (GXD) at NIF were analyzed for debris distribution and damage in 2011. These disks (ranging in thickness from 250 to 750 μm) were fielded approximately 10 cm from target chamber center (TCC) on various symcap, THD and re-emit shots. The nose cone holder and forward Ta collimator (facing target chamber center, TCC) from all shots show evidence of surface melt. Non-destructive analysis techniques such as optical microscopy, surface profilometry, scanning electron microscopy (SEM), energy dispersive spectroscopy (EDS), and x-ray fluorescence (XRF) were used to determine debris composition and degree of deformation associated with each Ta disk. Molten debris from the stainless steel nose cone contaminated the surface of the collimators along with other debris associated with the target assembly (Al, Si, Cu, Au and In). Surface elemental analysis of the forward collimator Ta disks indicates that Au hohlraum debris is less concentrated on these samples versus those fielded 50 cm from TCC in the wedge range filter (WRF) assembly. It

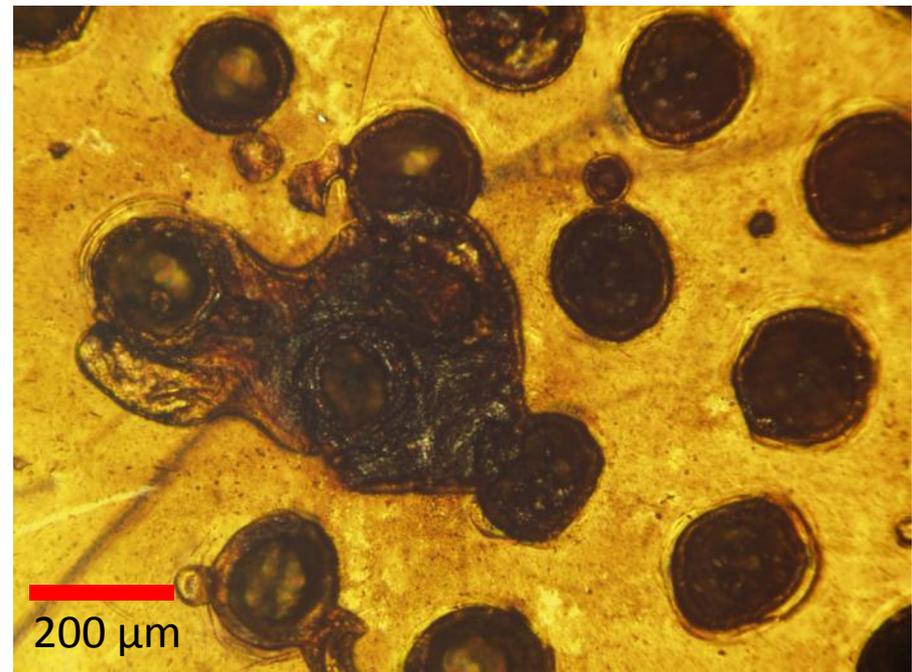
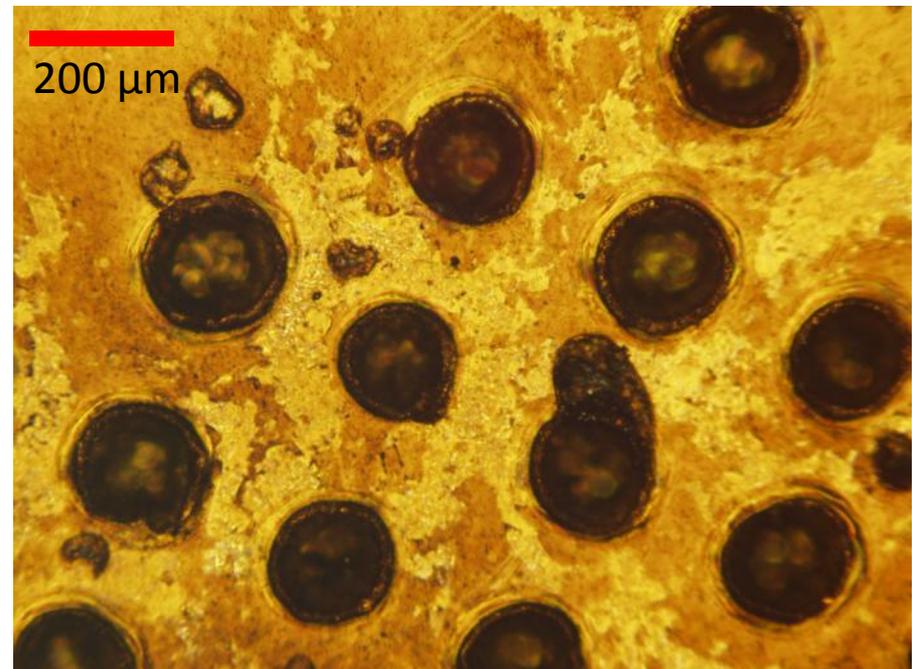
0-0, Kapton Disk 1 Surface Deformation

Surface penetration, back side crater formation

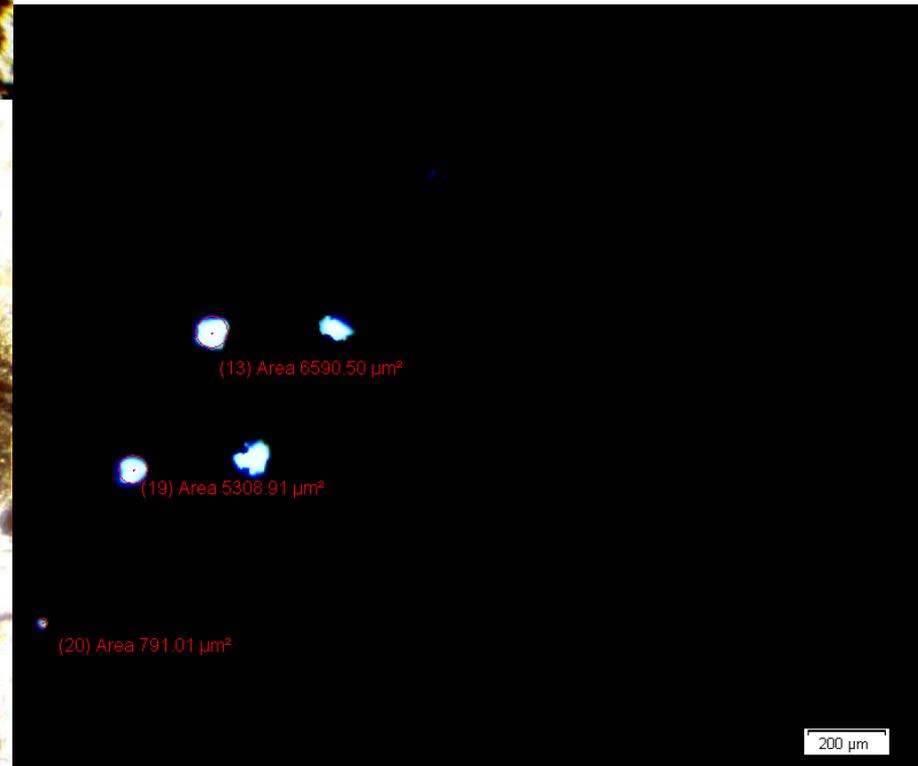
Disk 1, 0-0 (100 mm)

- High degree of surface melt
- Holes were covered by the melt and irregular in shape
- Area of holes ranged from 700 to 14,000 μm^2

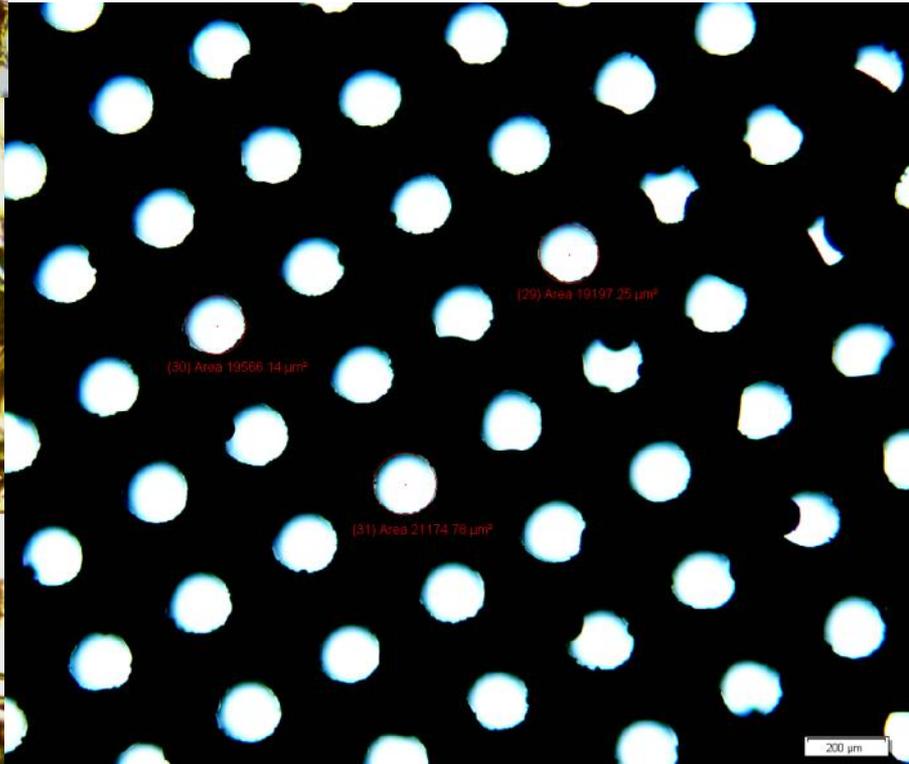
Disk 1, 0-315 (80 mm)

- High degree of surface melt, covered entire disk
- Most of the holes are still visible, some irregular holes in edge region
- Area of holes ranged from 19,200 to 24,500 μm^2

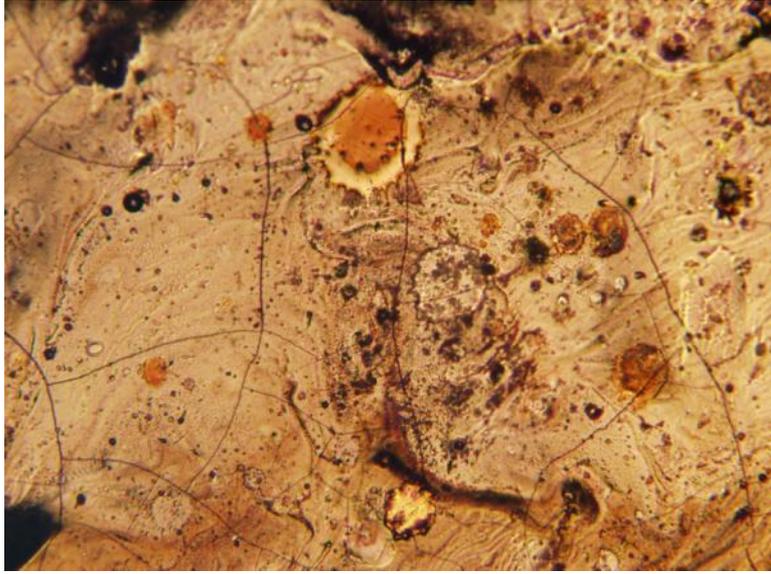
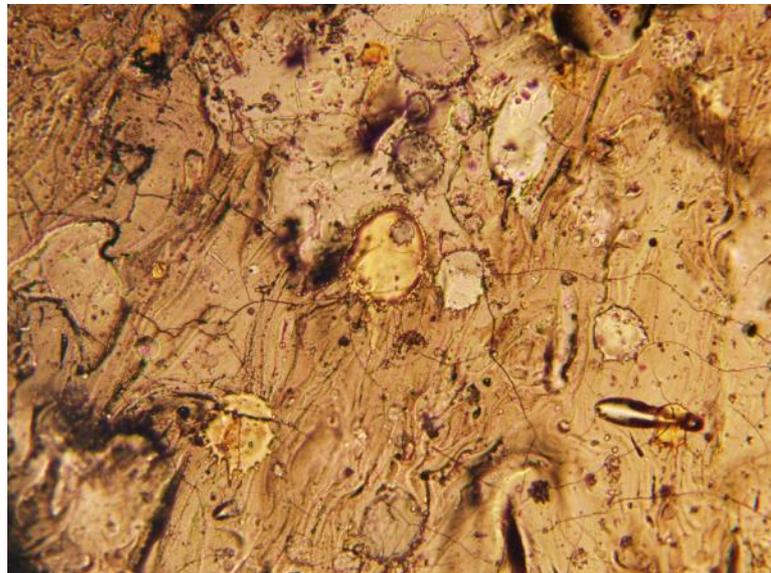
0-0 Disk 1 Serial Side -Debris

- Debris is scattered over the middle region of the disk (around collimator holes and melt)
- Diameter of splats $\leq 100 \mu\text{m}$

- Disk is Ta but there is a stainless steel (Cr, Fe, Ni) layer on top

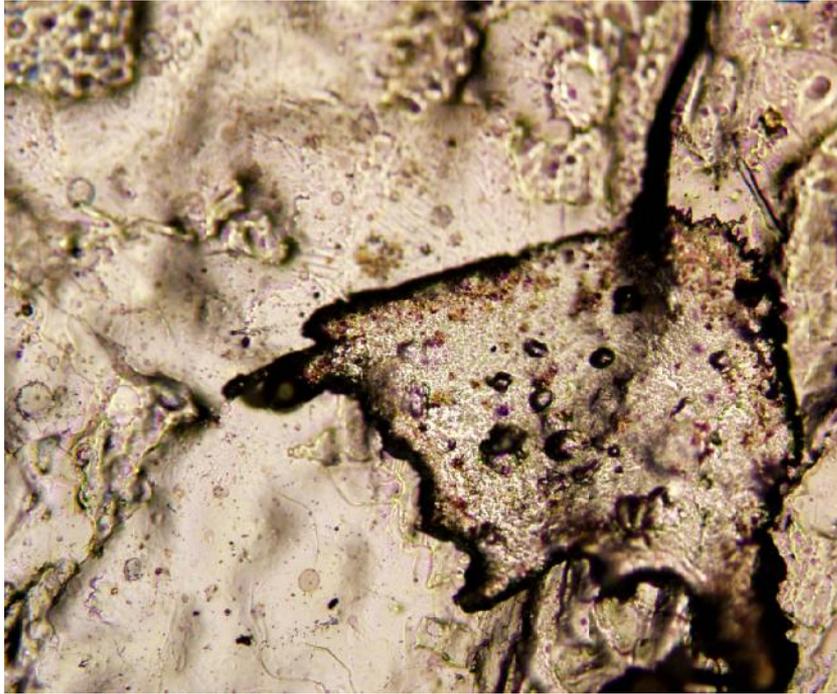
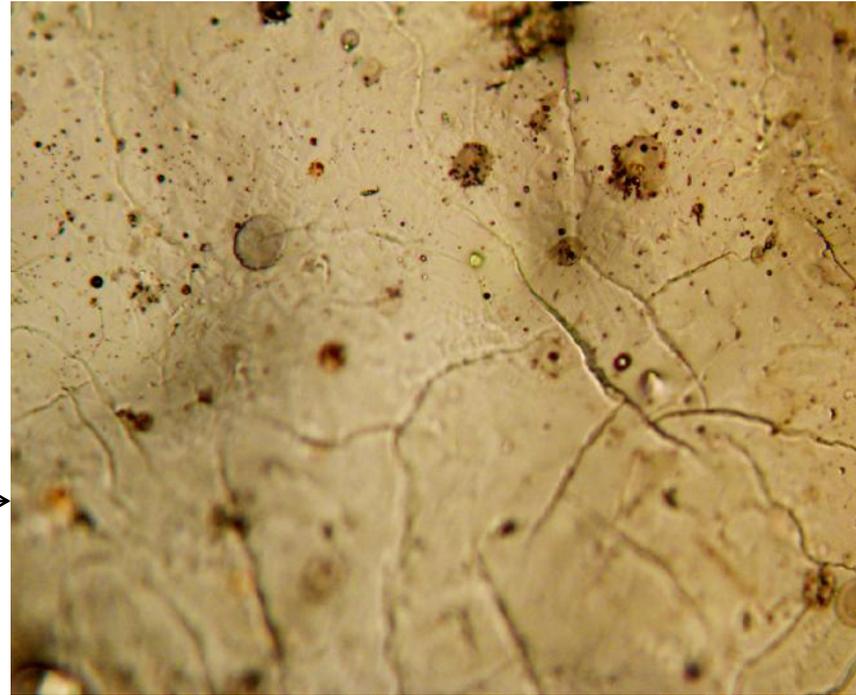
0-315 Disk 1 Serial Side -Debris

- Debris is scattered over the entire disk
- Diameter of splats $\leq 200 \mu\text{m}$

- Disk is Ta but there is a stainless steel (Cr, Fe, Ni) layer on top
