Combined Advanced Finishing and UV-Laser Conditioning for Producing UV Damage Resistant Fused Silica Optics

Joseph A. Menapace, Bernie Penetrante, Don Golini, Al Slomba, Phil E. Miller, Tom Parham, Mike Nichols and John Peterson

This article was submitted to
Laser-Induced Damage in Optical Materials, Nov. 1-2, 2001
Boulder, CO.

Lawrence
Livermore
National
Laboratory

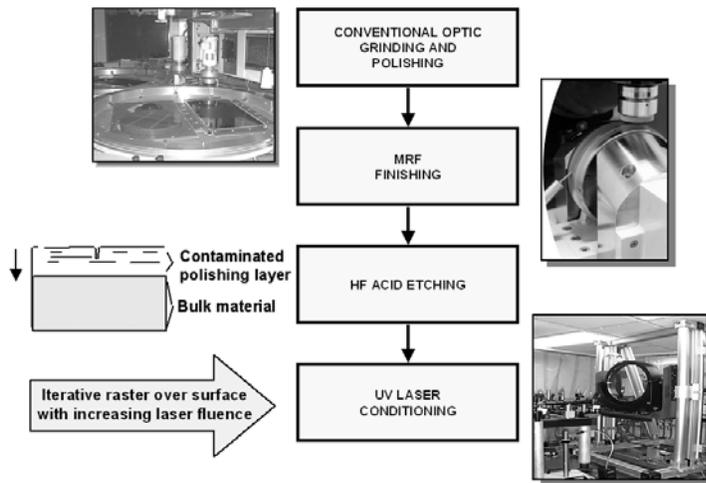
Figure 1: Combined advanced finishing recipe to improve UV damage resistance of fused silica optics.

provides a means of fabricating UV damage resistant optical components with minimal changes in the manufacturing process as shown in Figure 1.

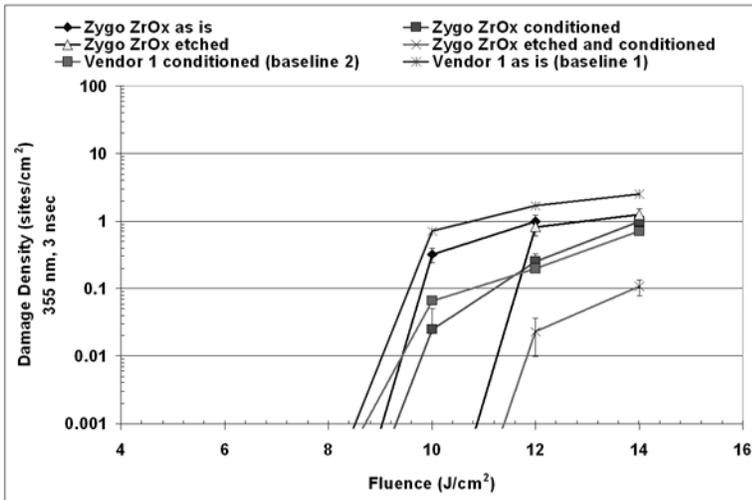
Figure 2: Damage density observed at 355 nm, 3 nsec, on 15.2 cm diameter by 1.0 cm thick fused silica samples polished by Zygo using ZrOx conventional polishing.

The finished optics supplied by Zygo demonstrate the feasibility of using MRF in fabricating 3ω damage-resistant optics. These experiments provide a direct comparison between the damage densities of the two optics that were prepared identically by lap polishing using ZrOx slurry, one of which was subjected to further finishing by MRF and one of which was not. The experiments also provide information central to the development of the combined MRF, wet etching, and 3ω post processing procedure used to yield superior performance optics. The results of large area damage testing conducted on each of the specimens are listed in Tables 2 and 3 and plotted in Figures 2 and 3.

Large area damage testing on the Zygo ZrOx conventionally finished parts yields damage densities comparable to those observed on optics that are conventionally finished using the best known methods for 3ω fused silica fabrication, Table 2 and Figure 2. The comparisons are based upon damage densities taken from measurements made in March 2001 on a 43-cm X 43-cm X 2.5-cm large aperture flat optic supplied by Vendor 1 that represented the best 3ω optic fabrication procedure known at that time. The unetched and unconditioned Zygo ZrOx finished part (Zygo ZrOx as is) exhibits damage performance about 1.5-2 times better than the unetched and unconditioned Vendor 1 supplied optic (baseline 1). This supports earlier experience that the using ZrOx slurry during the entire conventional finishing process reduces the deleterious effects arising from light absorbing species, such as CeOx slurry, which can be introduced into the

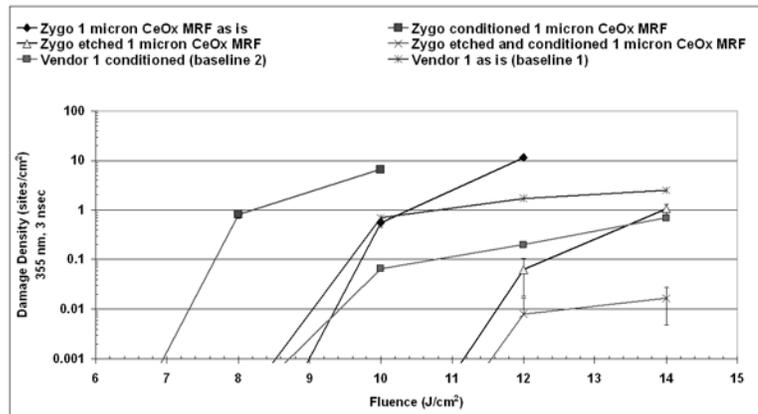
Figure 3: Damage density observed at 355 nm, 3 nsec, on 15.2 cm diameter by 1.0 cm thick fused silica samples polished by Zygo using ZrOx conventional polishing techniques and final polished using MRF to remove 1 μm of material.

Large area damage testing on the Zygo MRF finished parts, Table 3 and Figure 3, yields mixed results ranging from among the worst to the best-performing optic depending upon the post-MRF polishing procedures used.

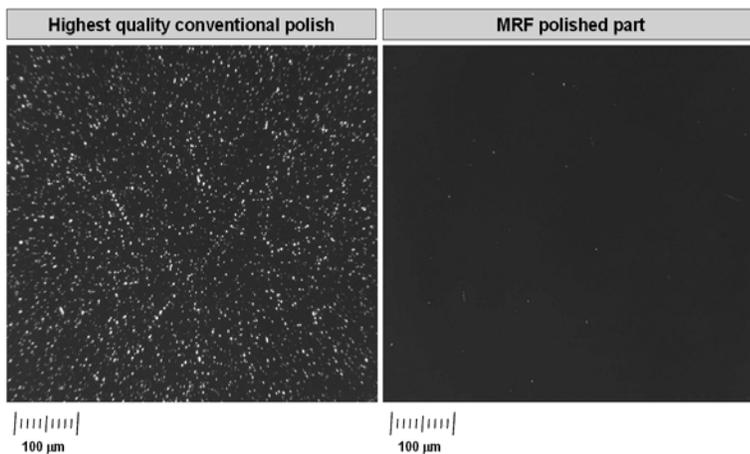
Figure 4: After etching, comparison of dark-field microscopy on highest quality, conventionally polished parts and MRF polished parts illustrate the dramatic decrease in scatter sites and “chatter marks” normally associated with subsurface damage from conventional finishing.

on the optic surfaces and can be easily removed with etching. Dark-field microscopy of the etched parts shows that MRF finishing results in a dramatic reduction in subsurface damage when compared to that present on conventionally polished parts, Figure 4. The large number of scatter sites and “chatter” on the conventionally lapped optical surfaces suggests that the subsurface damage layer is significant in spite of care taken to manage the damage during polishing. It also suggests that the large number of sites lead to a high probability for retention of absorbing species that can initiate

damage when irradiated at high fluence. In contrast, the etched MRF polished optical surfaces show a near absence of subsurface damage that explains the large improvement observed in damage performance when compared to the best performing conventionally polished optics.

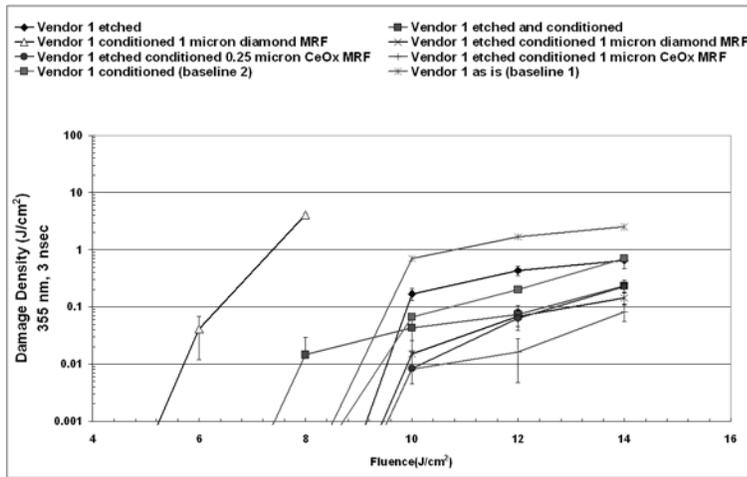
Figure 5: Damage density observed at 355 nm, 3 nsec, on 14.3-cm x 14.3-cm x 2.5-cm fused silica optic cut from full size NIF flat optic polished by Vendor 1.

The results of large area damage testing conducted on each of the specimens are listed in Table 3 and plotted in Figure 5. Etching 1 μm from the surfaces of the Vendor 1 supplied optic results in about a factor of 4 improvement in the damage

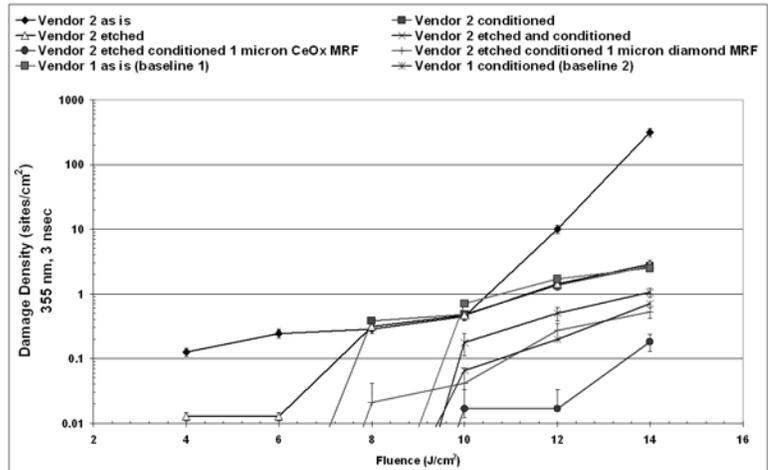
Figure 6: Damage density observed at 355 nm, 3 nsec, on 14.3-cm x 14.3-cm x 1.0-cm fused silica optic cut from full size NIF high aspect ratio optic polished by Vendor 2.

Application of MRF final polishing and 3ω post processing techniques to subsections cut from the fused silica flat provided by Vendor 2 are meant to illustrate that improvements in damage performance can be made on optics that are unacceptable for high fluence ultraviolet laser applications. These represent optics for which little to no attention was paid to the type of polishing slurry used nor to the extent of subsurface damage encountered during the fabrication process. The results of large aperture damage testing on the subsections are presented in Table 4 and Figure 6.

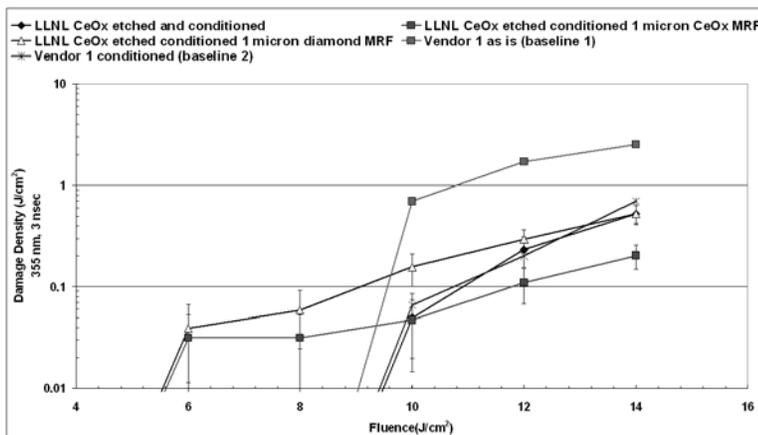
Figure 7: Damage density observed after illumination by 1 shot/site at 355 nm with no correction for beam shape. Fluences are scaled to equivalent values at 3-nsec.

Additional CeOx lap polishing of subsections cut from the Vendor 2 supplied conventionally finished optics is intended to test the possibility of improving performance through careful removal of fused silica from the optical surfaces prior to MRF final polishing. The goal in these experiments is to remove material under small normal loads to remove or minimize the subsurface damage layer present from prior fabrication steps. A further assumption is that additional lapping of 25 μm from the optical surfaces is sufficient to eliminate these effects. The results of large aperture damage testing on the subsections are presented in Table 5 and Figure 7.
